# **Arboricultural Report**

**71 Canfield Gardens**

**9<sup>th</sup> April 2007**

**John Lowe**

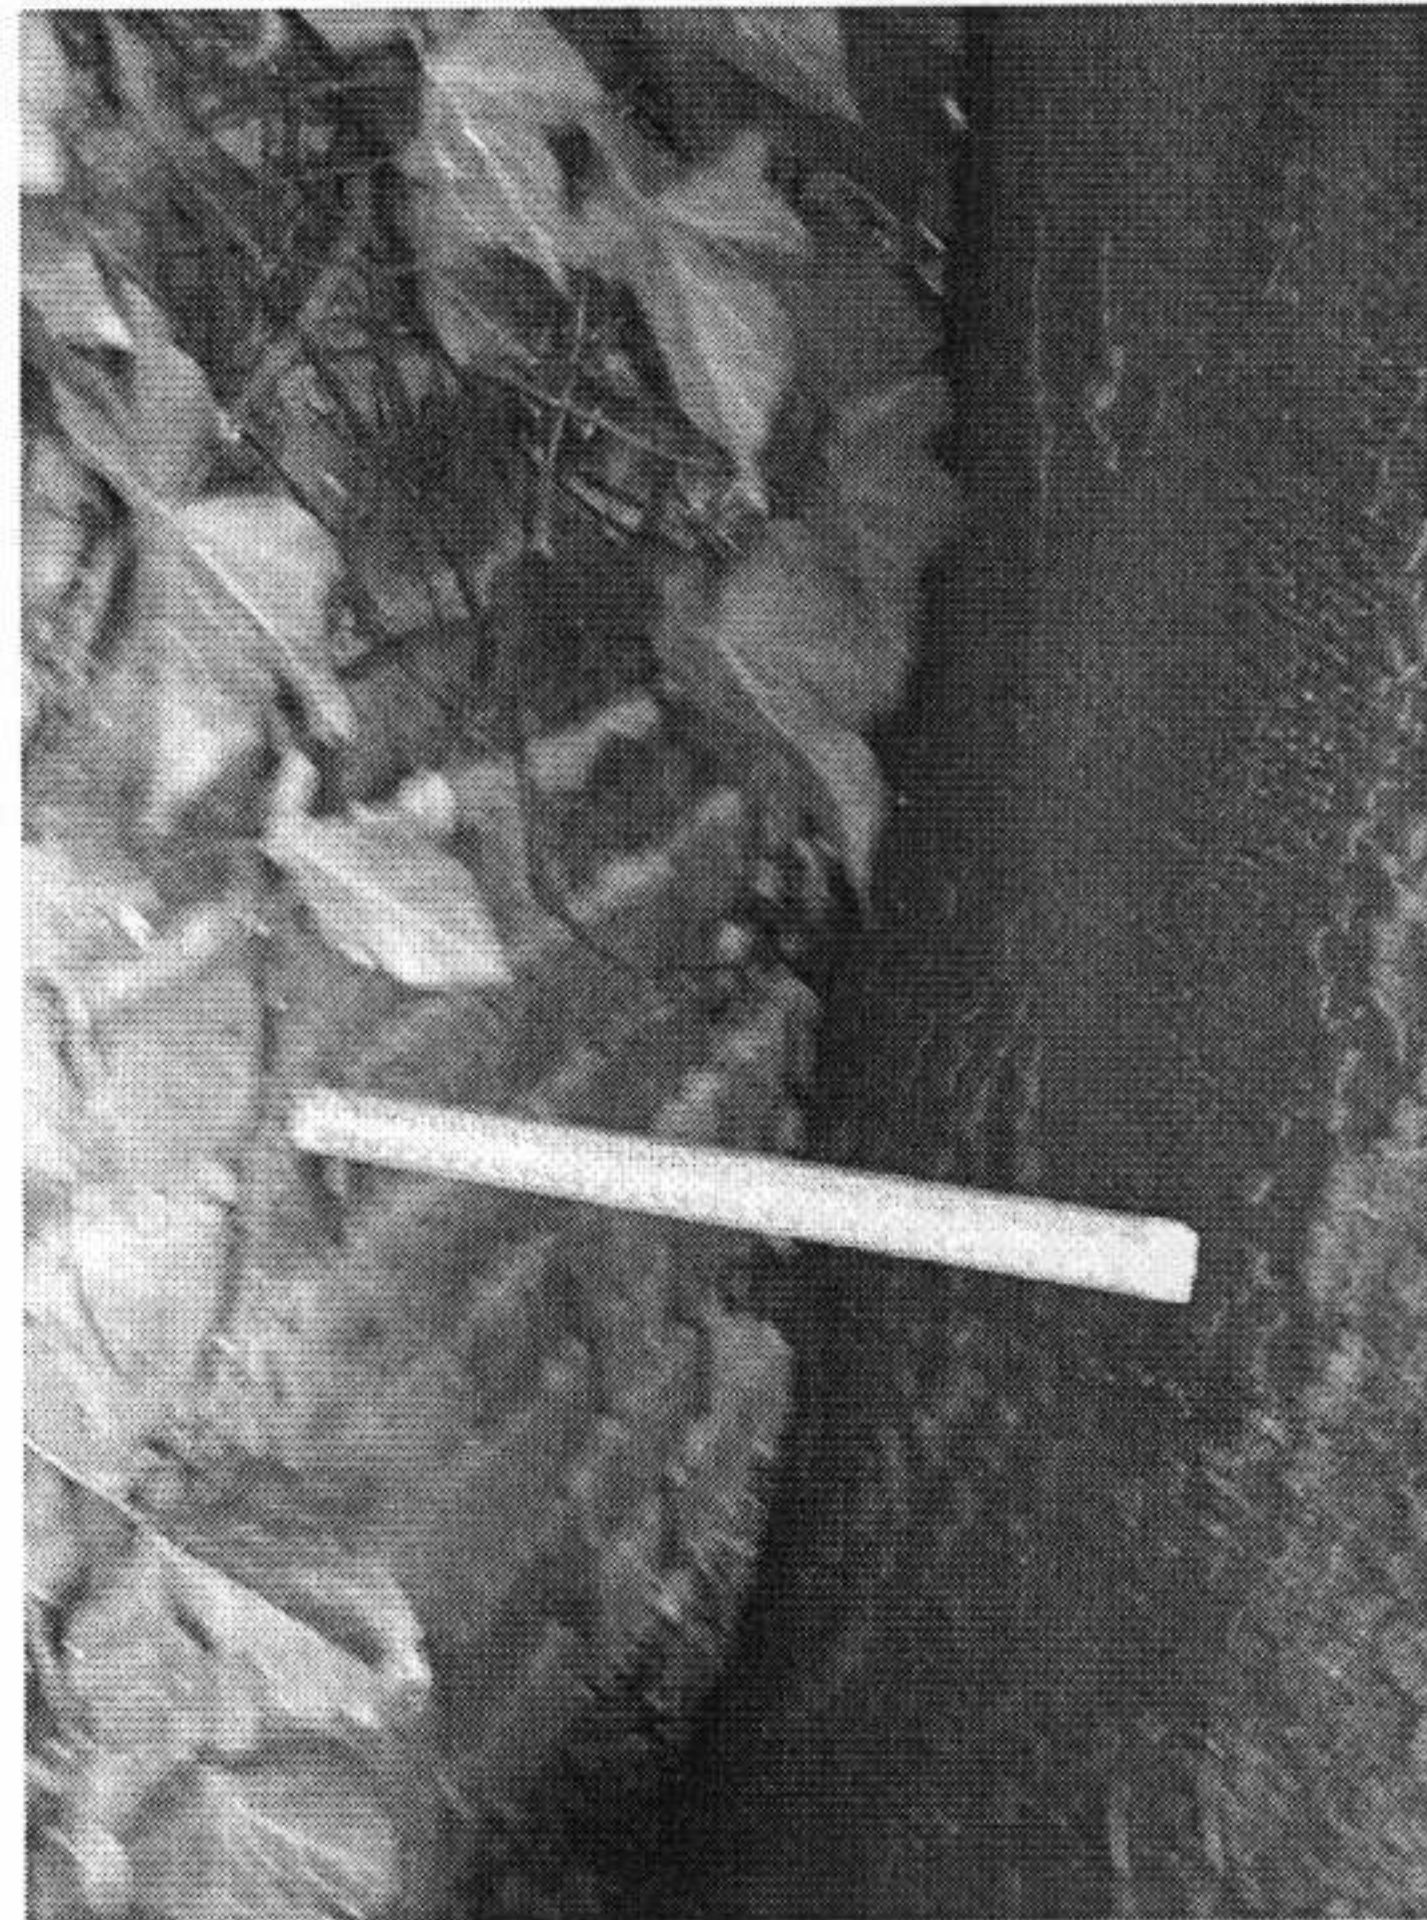
- The separation between the stem of this tree and the dividing brick wall is less than 10cm at ground level, as the stem continues to grow physical damage to this wall is likely.

**Photograph 1 - showing stem of T1 in relation to dividing wall**

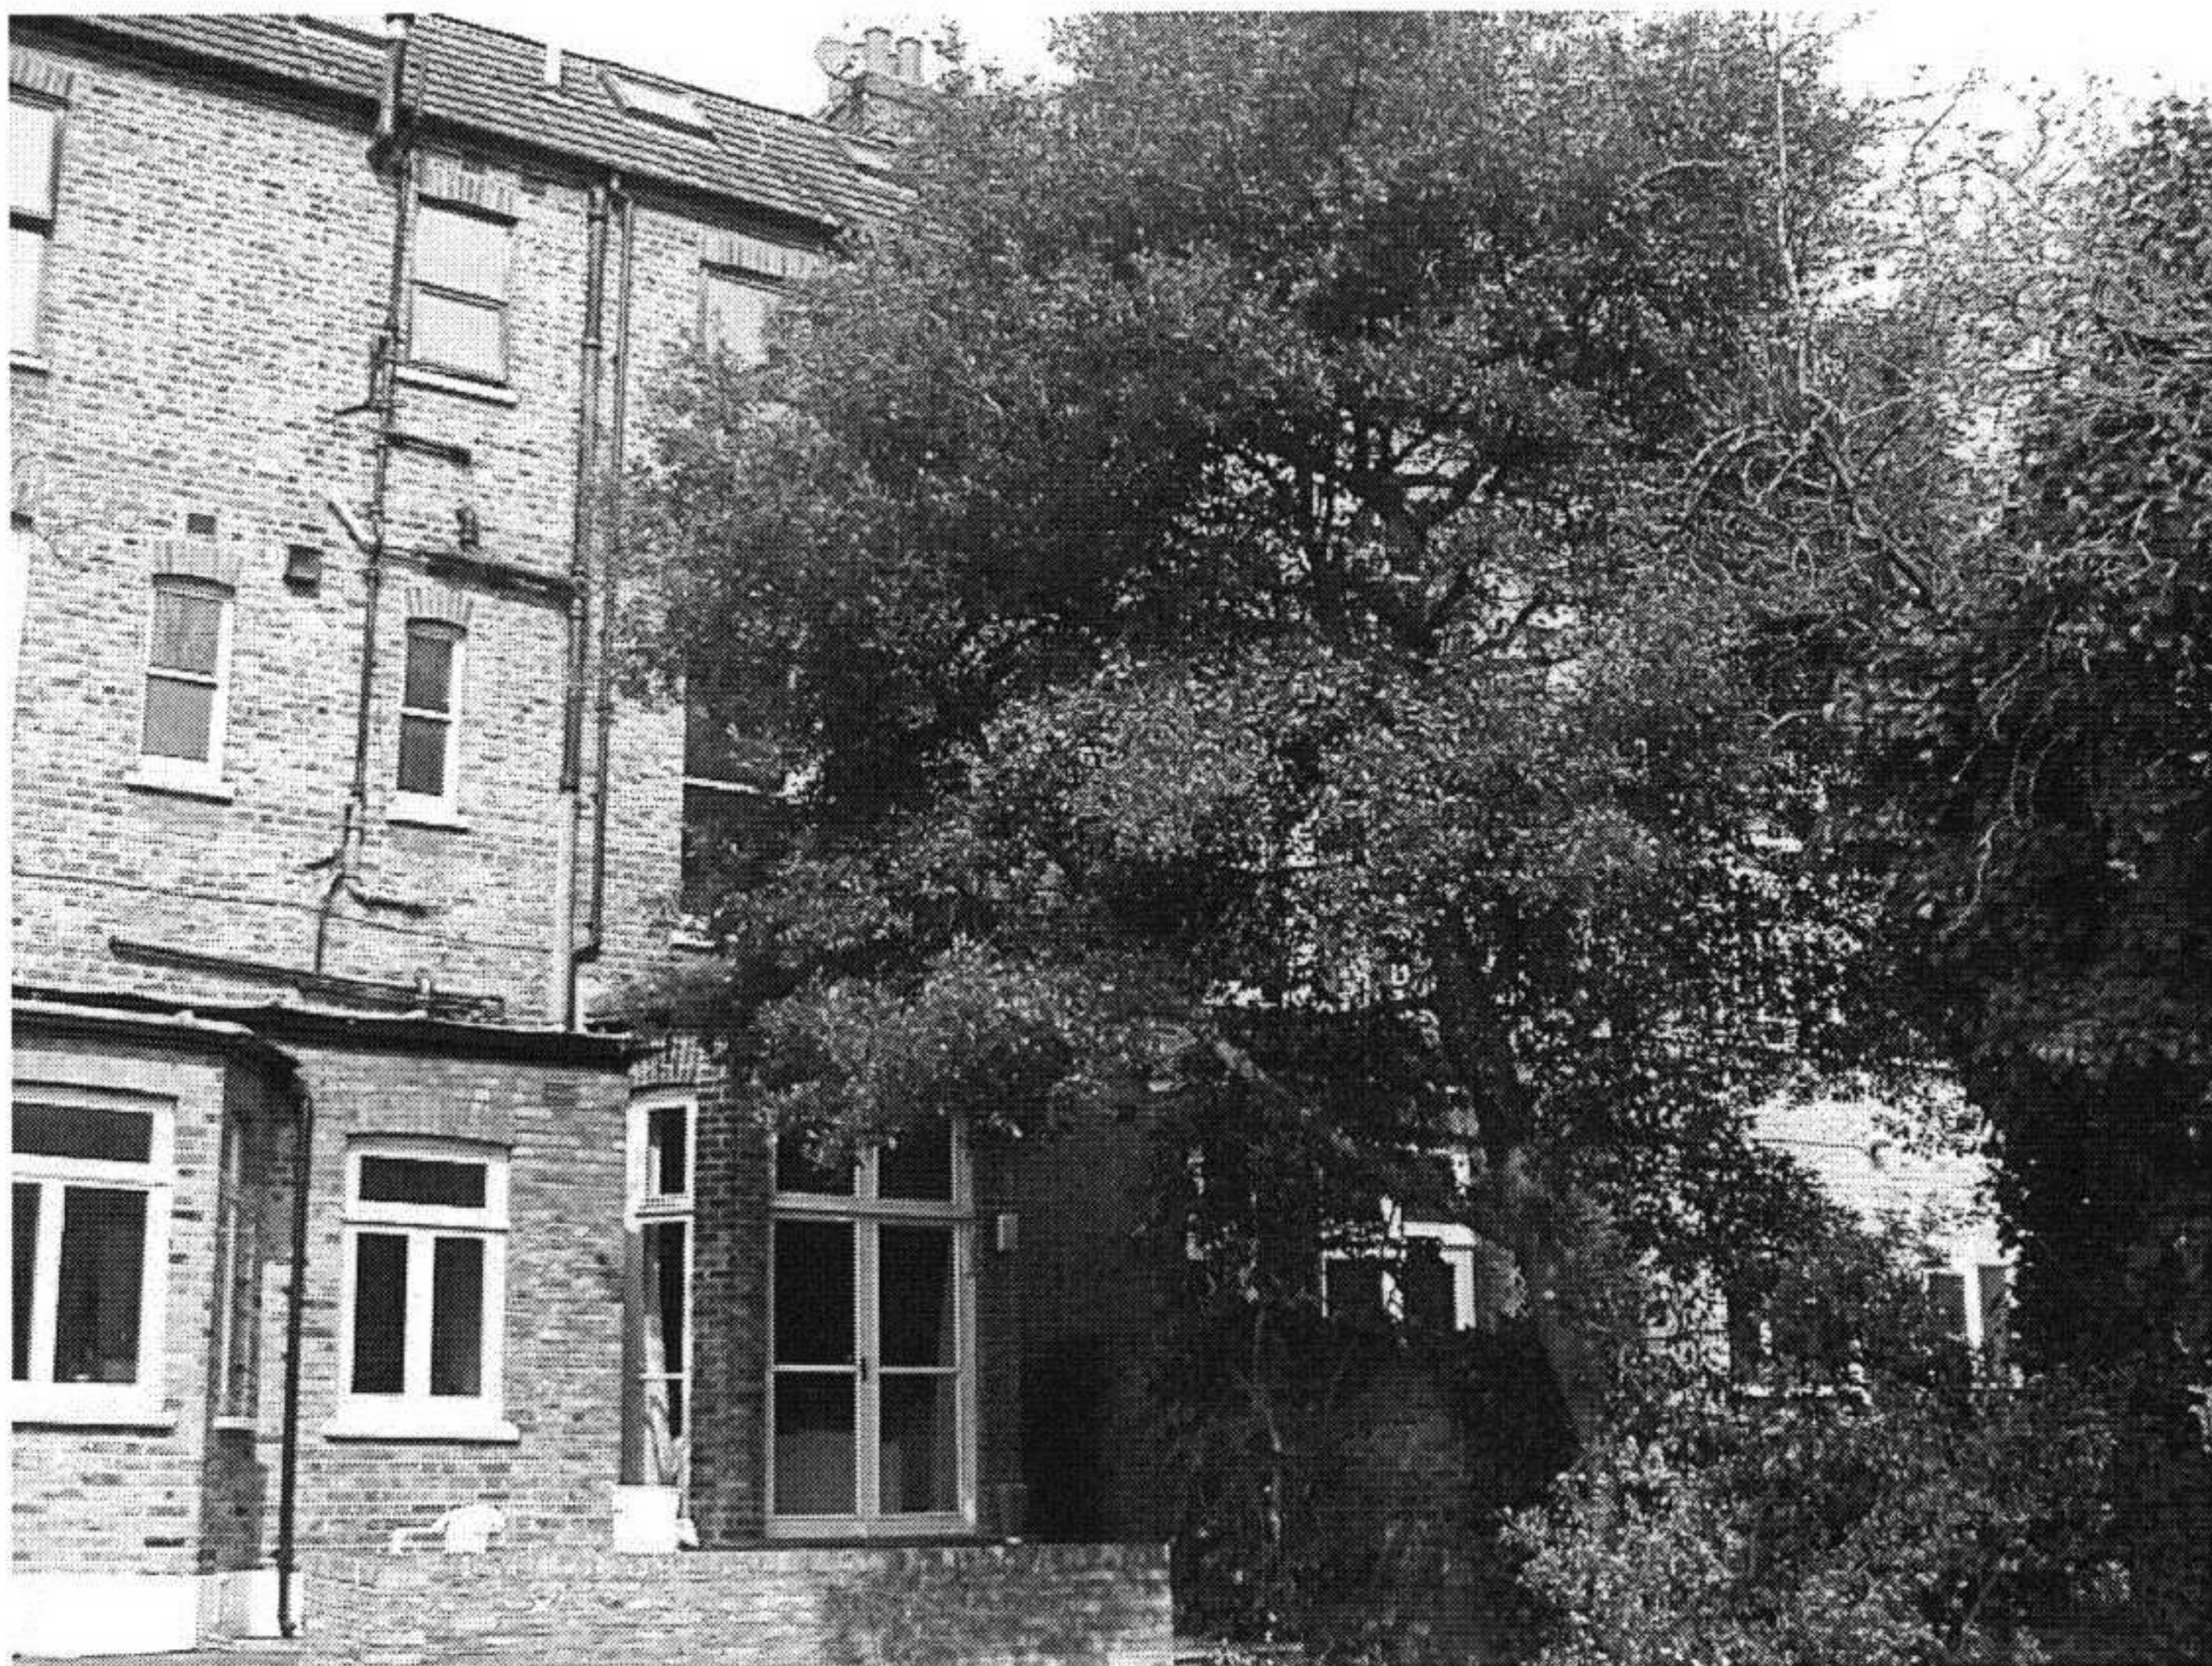
Given the current size, young age and species of T1- Holm oak, together with its close proximity to the existing building and the dividing brick wall it is considered that T1 is barely suitable for its location. The tree has been pruned in the past, most likely in order to reduce physical interference to the buildings and to reduce the problem of over shading.

- The fact that the tree is just 5m from the existing building means that the tree does not have enough space to attain the normal expected size for this species. The stem leans towards the building and the crown appears unbalanced. High levels of on going management would be expected.

- That the tree is evergreen and has dense foliage means over shading will continue to be an issue. Extensive and continual remedial pruning will be required to maintain the present levels of available light to the windows of the existing building in both of the affected properties. Its location in relation to direct sunlight means that at least six windows, three in each property, will be over shaded for the majority of the day. Being evergreen this will be an all year round issue.

**Photograph 2 – T1 in relation to existing building**

If it were to be agreeable to all parties concerned that the removal of this tree was the way to proceed, a suitable replacement tree could be planted to mitigate its loss. I would suggest that Holm oak is not a suitable species to be planted in a garden in close proximity to buildings. It would be worthwhile considering selecting a different species given the light issues. Silver birch, Whitebeam or Cherry are all suitable native species and being deciduous would not affect the available sunlight to the same degree as Holm oak does all year round. I would also recommend siting the tree

further from the building, there are a number of suitable locations available either side of the garden. It would be necessary to consult the local planning office in the first instance to ascertain if this would be acceptable to them.
