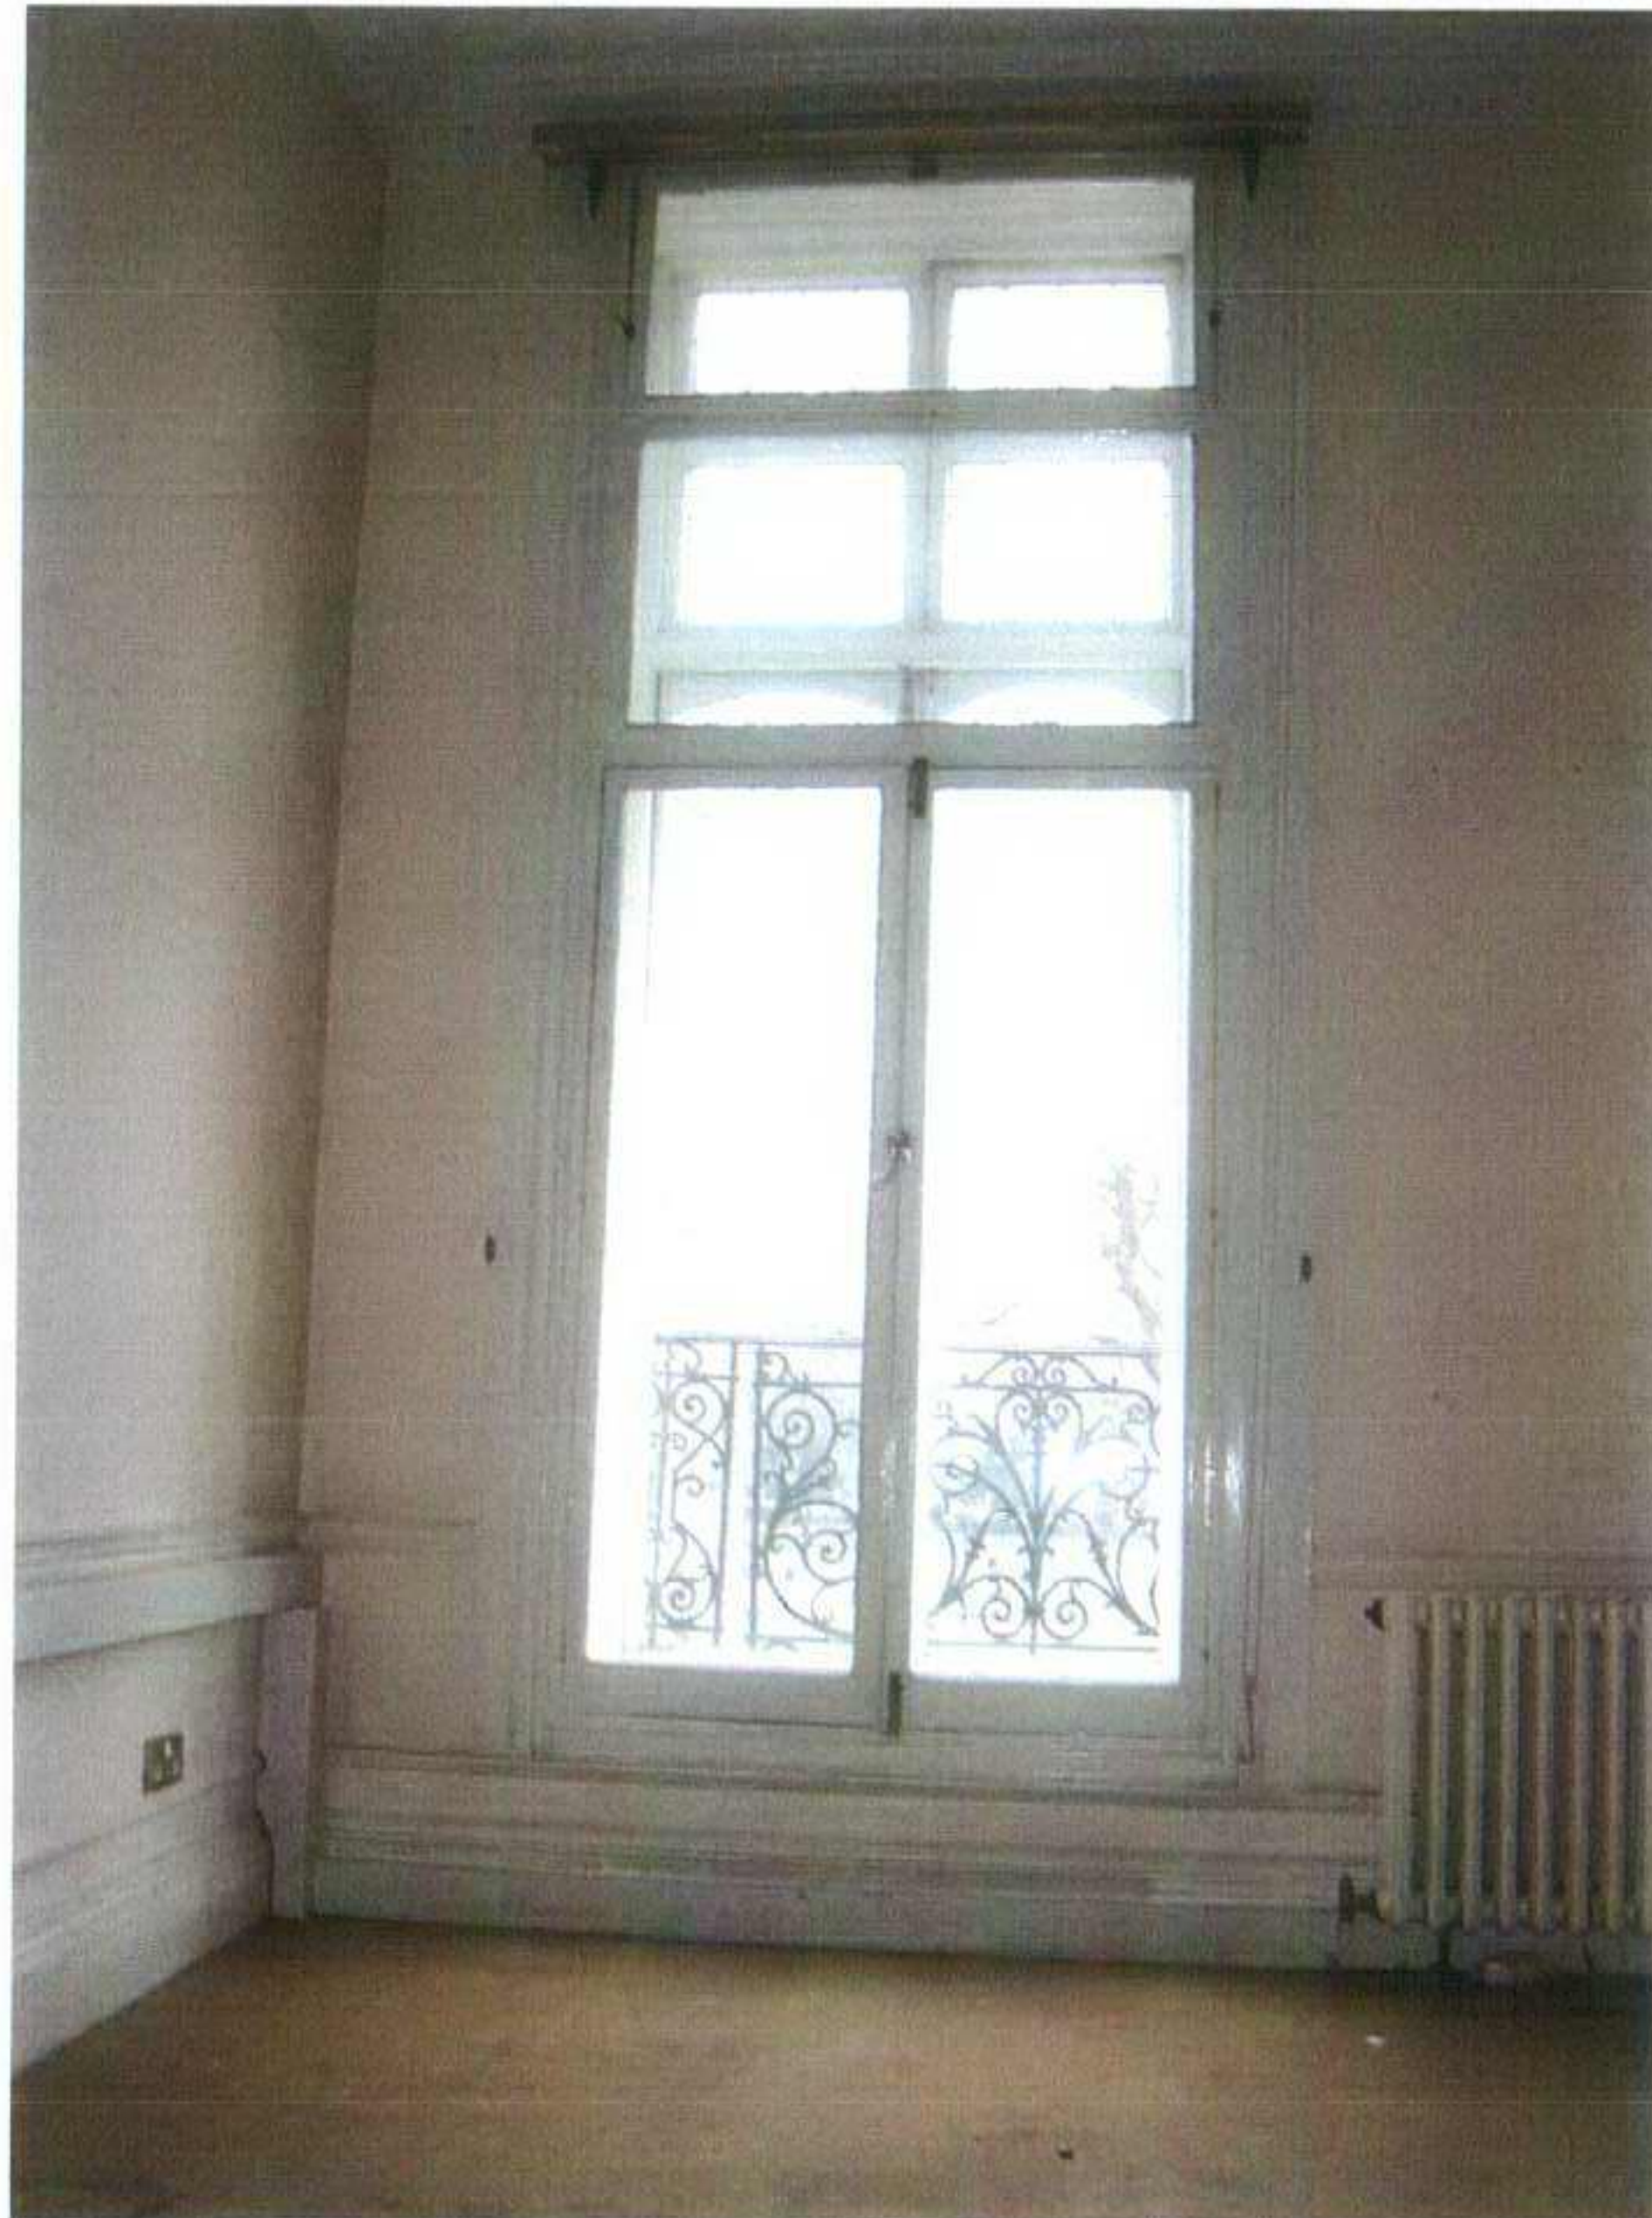
19 Existing mis-aligned secondary glazing first floor front room No.52

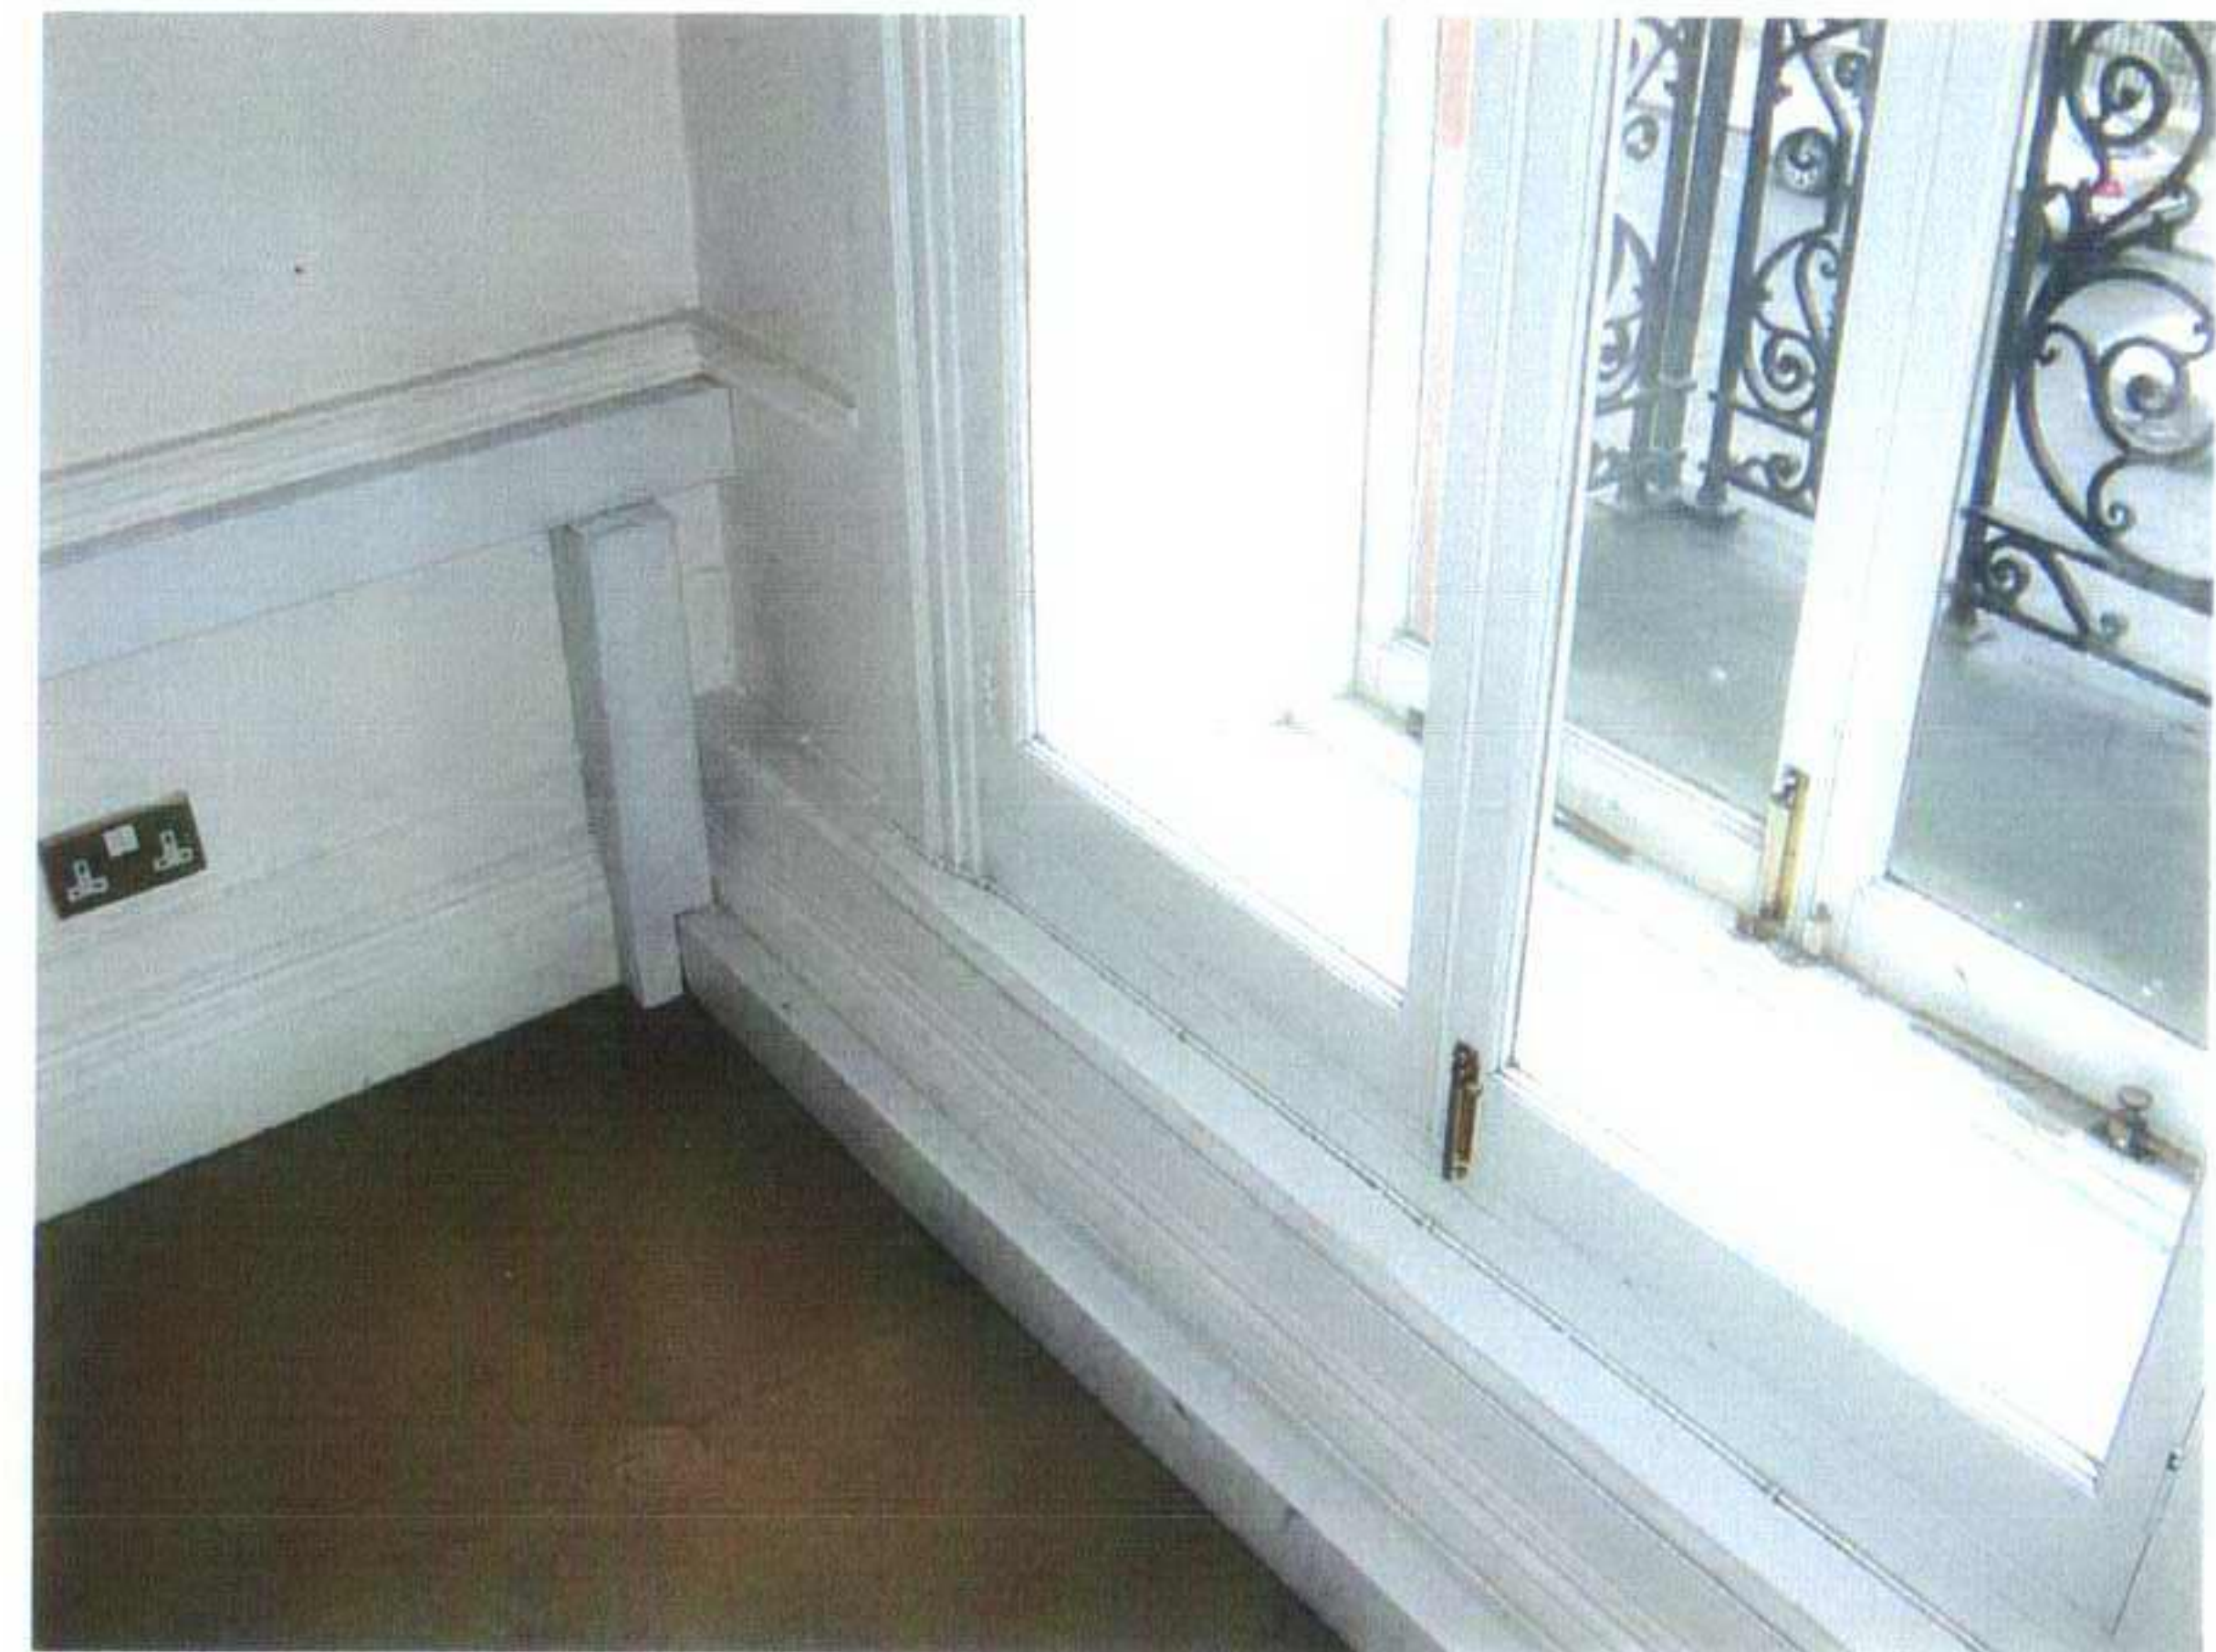
20 Existing secondary glazing first floor front room No.52
