JH/SMB/00/1006/1.1

29th August 2001

11 Netherhall Gardens, Hampstead

As instructed we have inspected the above property with respect to structural damage and the proposed refurbishment which might include the re-arrangement of internal partitions and the construction of extra accommodation in the roof space over the second floor, and can report as follows:-

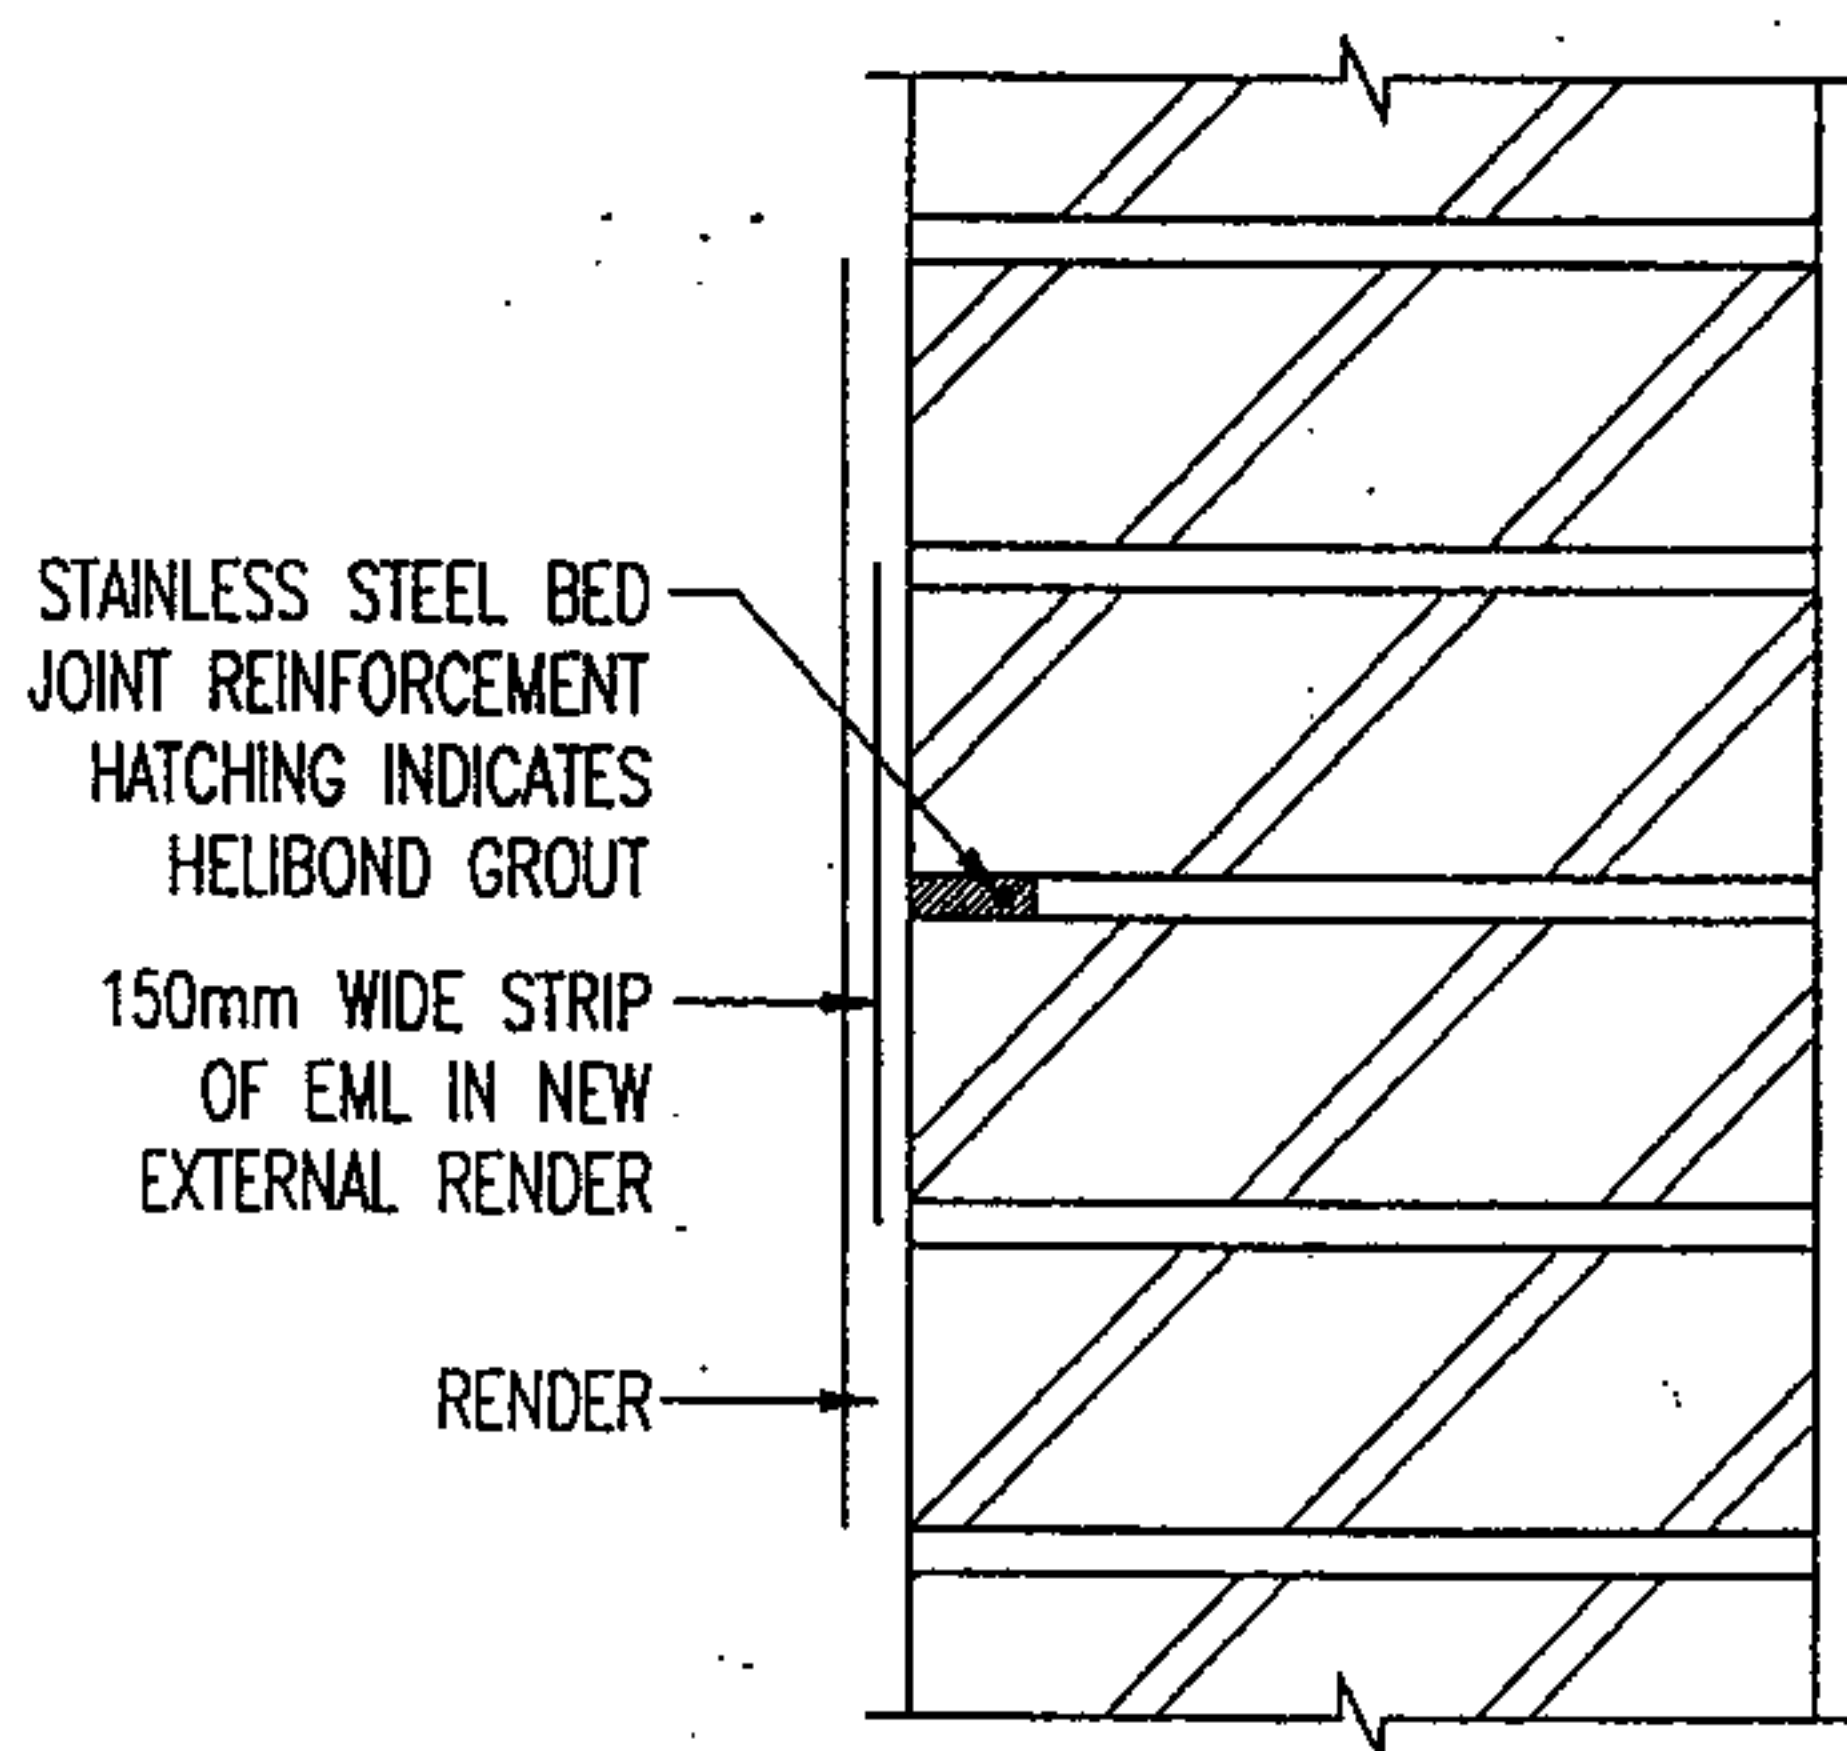
Project: 11 NETHERHALL GARDENS HAMPSTEAD	Job No. 00/1006	Drawing No. SK01
Title: CRACK REPAIRS DETAILS, METHOD STATEMENT AND SPECIFICATION	Prepared: CW	Date: JULY'01
	Checked: JEH	Date: JULY'01

There are cracks in the external walls due to foundation movement. These cracks should be 'stitched' using stainless steel bed joint reinforcement after underpinning works have been completed. We enclose a copy of our sheet number SK01 giving construction details, a method statement and a specification for the materials.

1. Cut grooves in the bed joints of the blockwork to a depth of about 35mm.
2. Blow dust and debris out of the grooves.
3. Soak the grooves with water.
4. Inject beads of HELIBOND grout into the grooves to a depth of 15mm.
5. Insert stainless steel bed joint reinforcement. If reinforcement is too short use minimum 300mm laps.
6. Inject more HELIBOND grout.
7. Make good plaster using 150mm wide strip of EML.

Reinforcement: 6mm ϕ stainless steel HELIBAR
Mortar: HELIBOND MM2 non shrink grout.

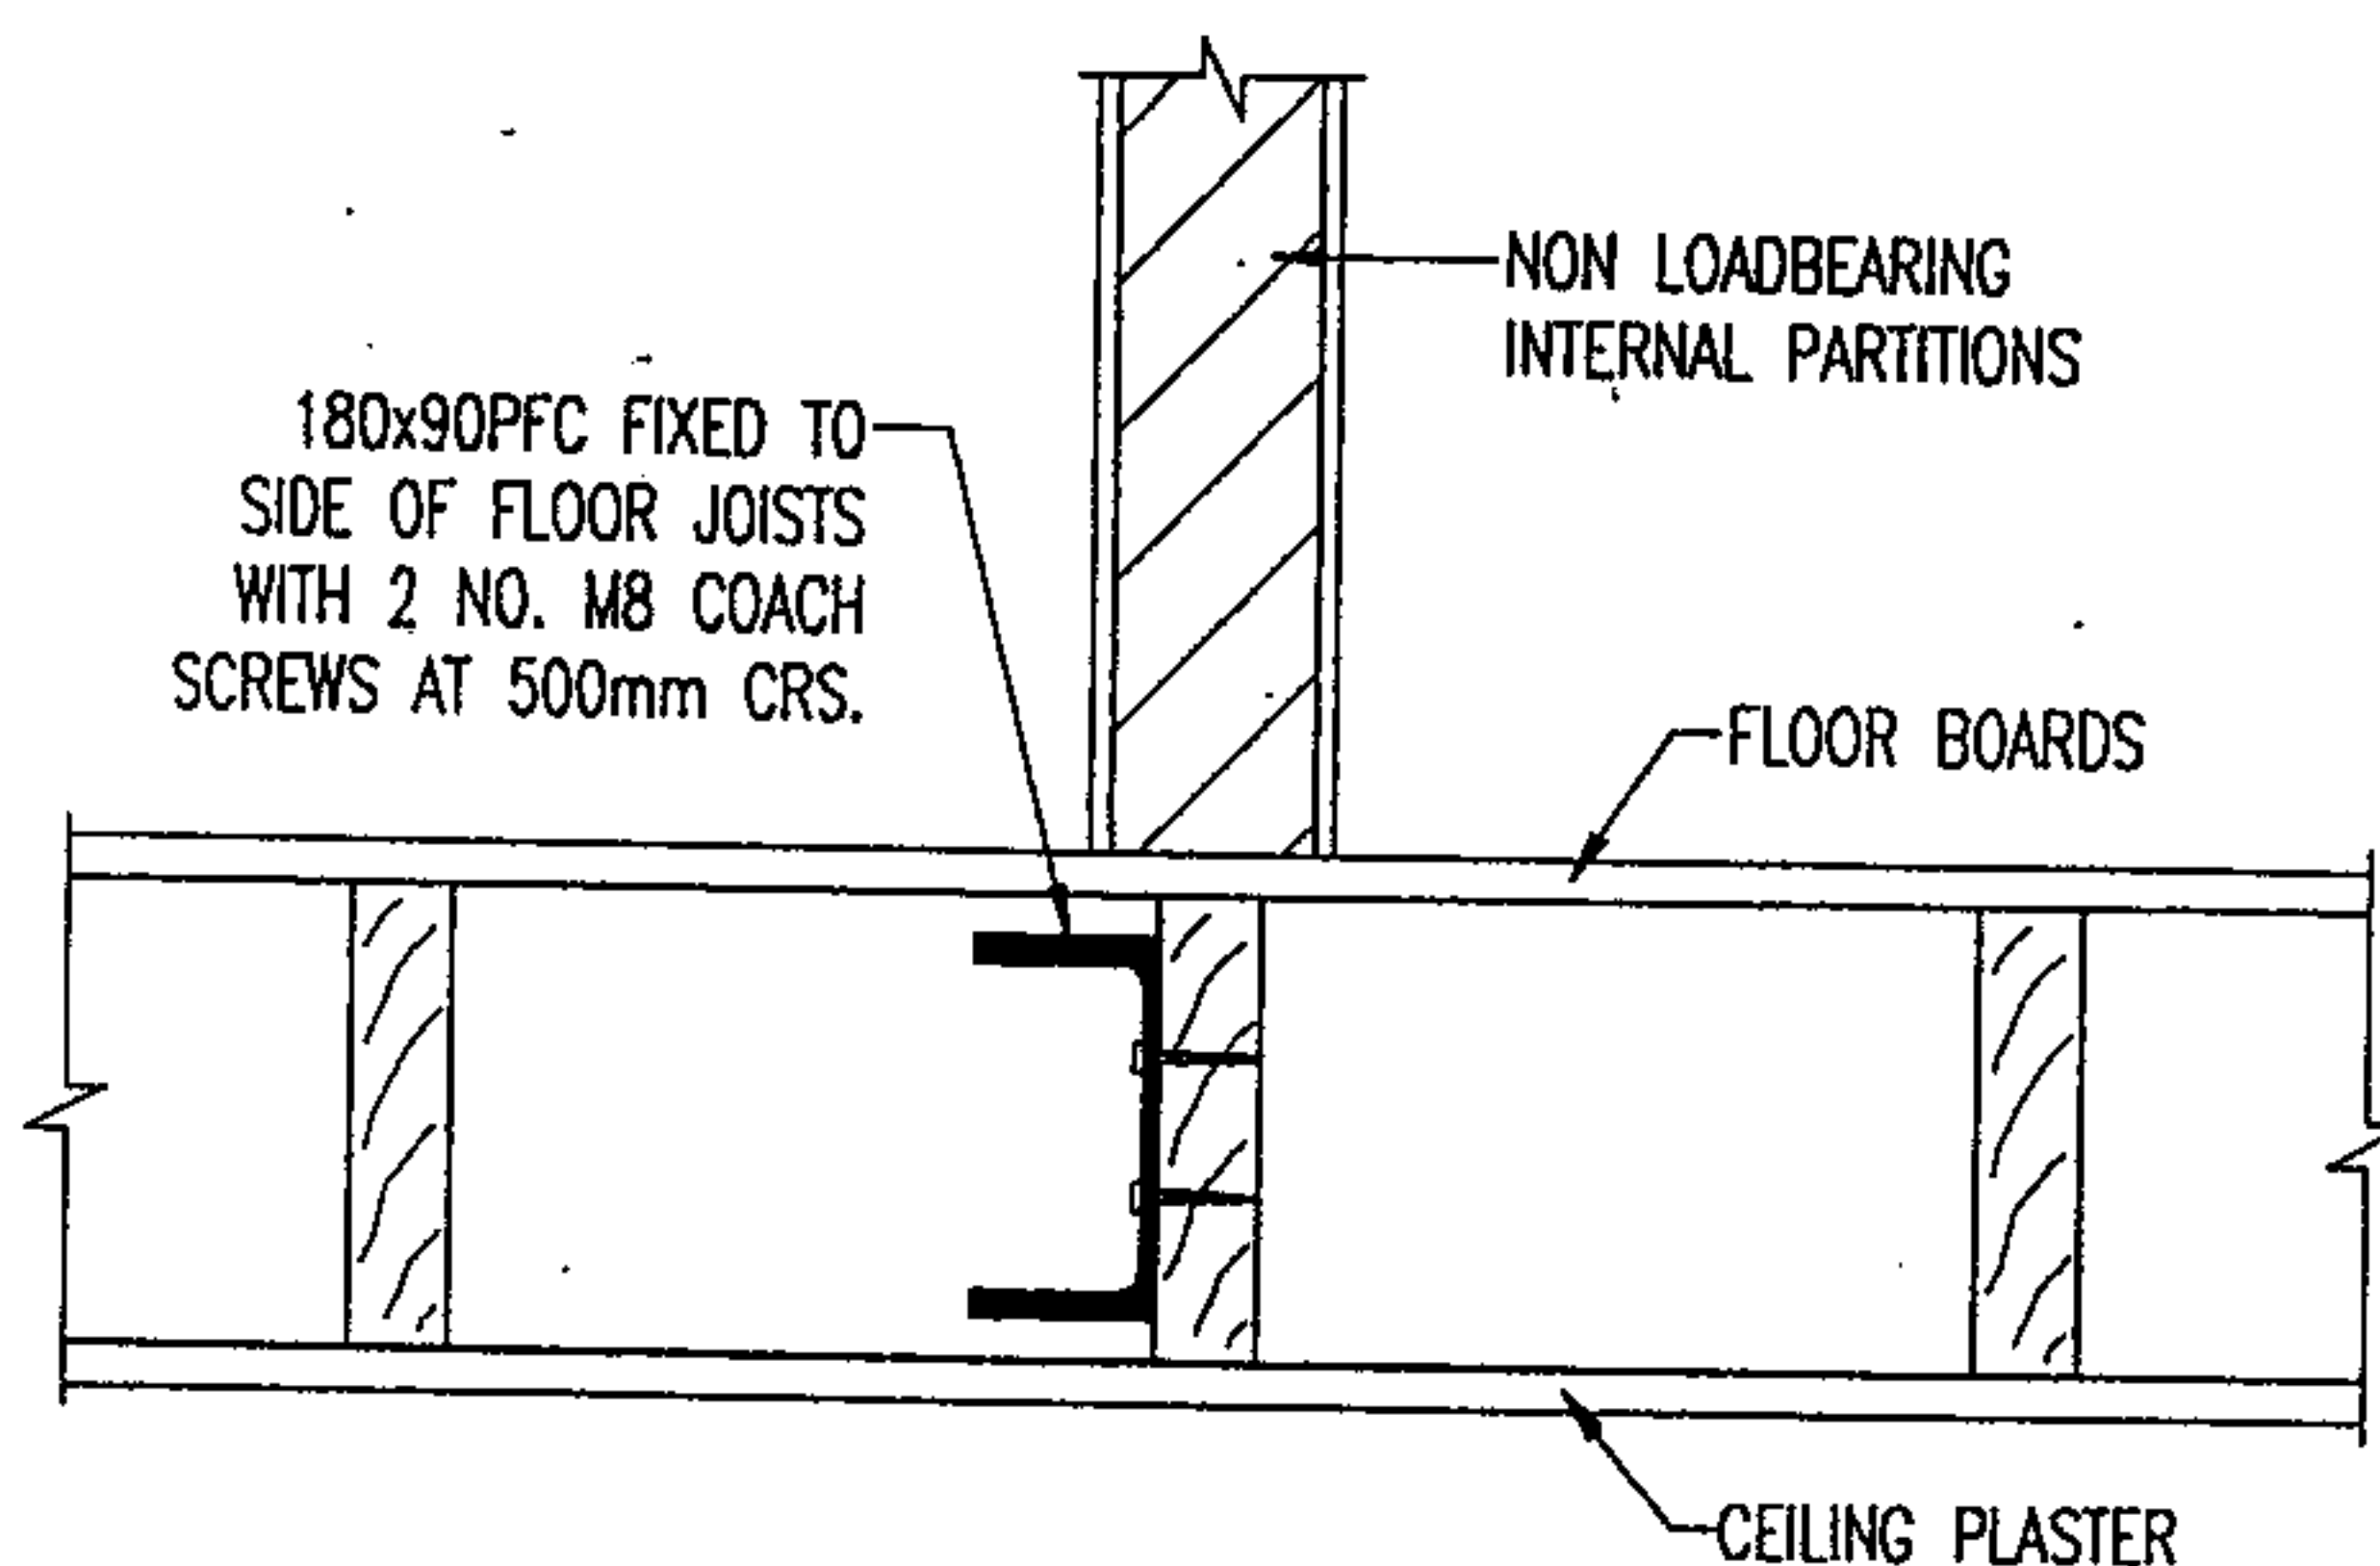
Project:	11 NETHERHALL GARDENS HAMPSTEAD	Job No. 00/1006	Drawing No. SK02
Title:	STRENGTHENING UPPER FLOORS BELOW PARTITIONS	Prepared: CW	Date: AUG'01
		Checked: JEH	Date: AUG'01

The cracking in the internal partitions on the first and second floors has been caused by excessive deflection of these floors. This excessive deflection has been caused by

the weight of the blockwork partitions built on the timber floors. We recommend that these walls be demolished and rebuilt. New steel beams will be required, inserted into the floors to support new thicker blockwork partitions. Some of the partitions on the second floor are not unstable and could be retained. If you decide to retain the present partition layout the timber joists directly under each of these cracked partitions could be strengthened by fixing a 178 x 102 rolled steel channel to its side face, as indicated on sheet number SK02. This would entail the removal of part of the ceiling below, and often complications arise due to the presence of plumbing and wiring within the floor. Therefore, although the cost of each steel channel is fairly nominal, the cost of the labour to install the beam and the cost of making good finishes and diverting wiring and plumbing could be significant.
