Condition survey of roof coverings

21 & 22 Russell Square, London

2006 / 9342 / LR1

Survey of condition of main roof coverings

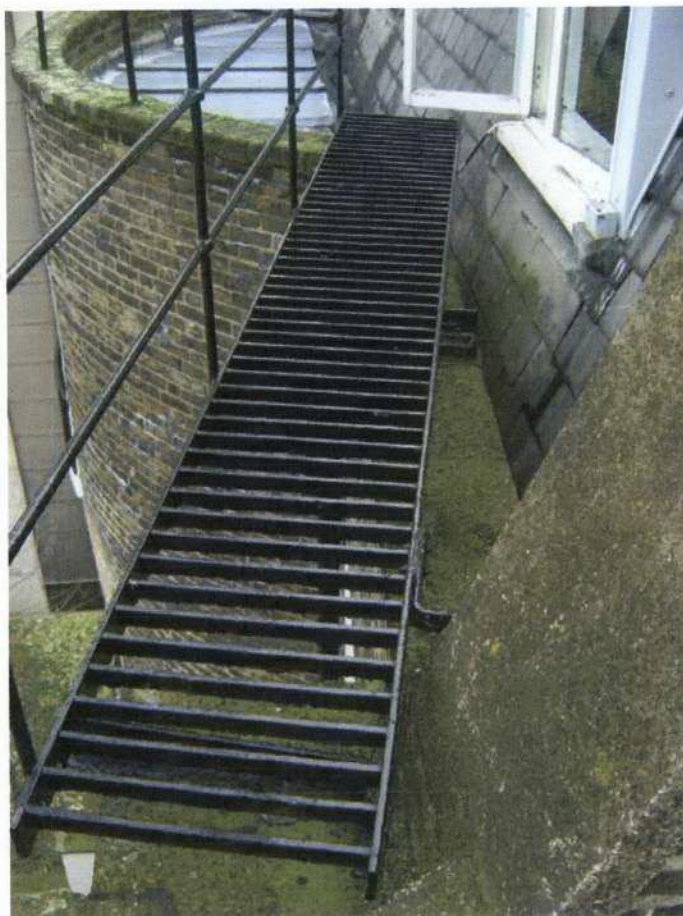
As has already been noted, access to view the roofs over 21 and 22 Russell Square is gained through a rear attic level dormer window set in the lower slope of a slated mansard roof. Once through the window, the viewer steps out onto a painted metal grated walkway, mounted on iron bearers, which themselves are seated on concrete copings at the head of the parapet over the rear external wall of the building [1]. This walkway oversails a full drop to the ground below and, somewhat alarmingly, the protective balustrade on its outer edge has large gaps between each horizontal rail. In wintry conditions, such as at the time of our inspection, the walkway is distinctly slippery. Iron components, including fixings, are corroding badly. In the past, we understand with Fire Brigade approval, the walkway has also been designated as an escape route in the event of a fire occurring within the building. In our opinion, this walkway is unsafe for use in any circumstances, given its current configuration and condition.

1: Access and escape walkway to rear of no. 21

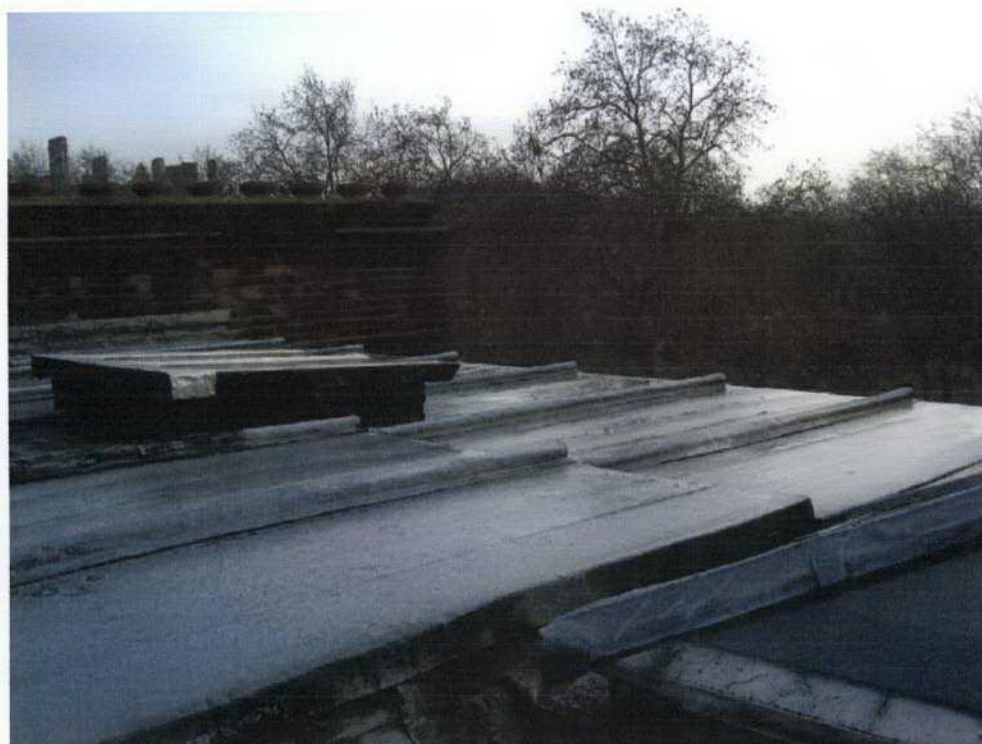
Access to the upper roof areas over 21 Russell Square is gained off the metal walkway described above. An unfixed timber roof ladder is located, resting against the slated mansard slope and standing on the leaded parapet gutter mid way along the length of the walkway. The top of the ladder does not give direct access to any flat and level surface. Instead, the user has to step sideways onto a narrow valley gutter against the dividing chimney stack between the two properties, holding onto the deformed and truncated section of downpipe for support. Whilst this method was used to gain access to the valley gutter over no.21 with the assistance of Mr Fletcher of JONAP for the purposes of this survey inspection, it is entirely unsuitable as a permanent means of access to the upper roof and must be regarded as being unacceptably dangerous for any unaccompanied user to the roof area. The topmost flat leaded roof area over no.21 is notionally accessed using a second unfixed roof ladder lying against a slated slope and standing on the narrow valley gutter reached from the head of the lower ladder. The upper roof area is small and completely unprotected [2]. In our view, this means of access and the configuration of the top leaded roof area are unsafe.

2: Upper rear roof over no.21 without edge protection

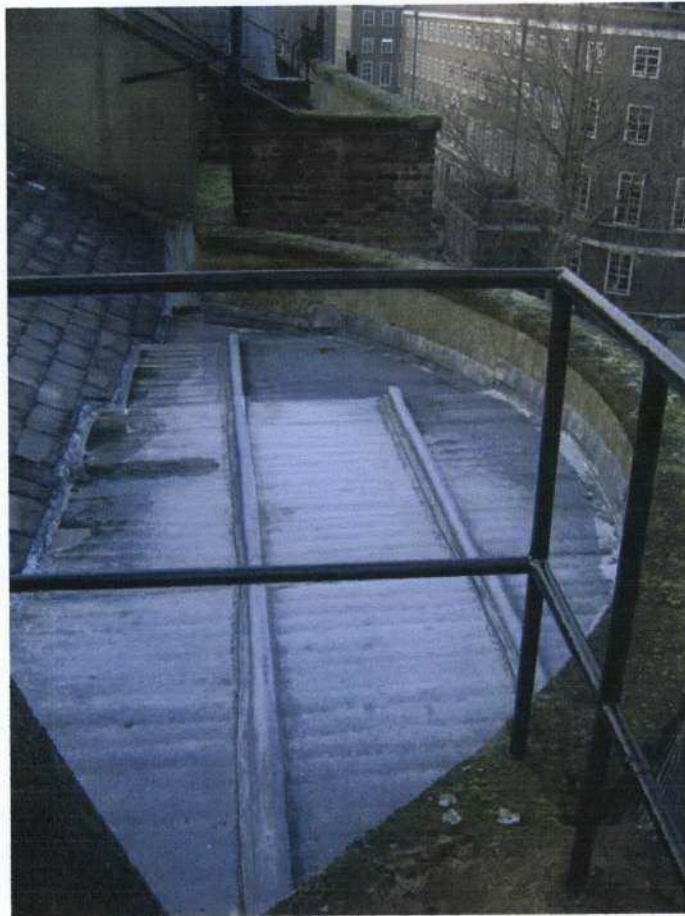
Access to the lower roof area over 22 Russell Square is gained by ducking through a metal railing after crossing the walkway [3]. There is no satisfactory edge protection to this section of roof, making access for maintenance a considerable risk.

3: Lower roof over no.22

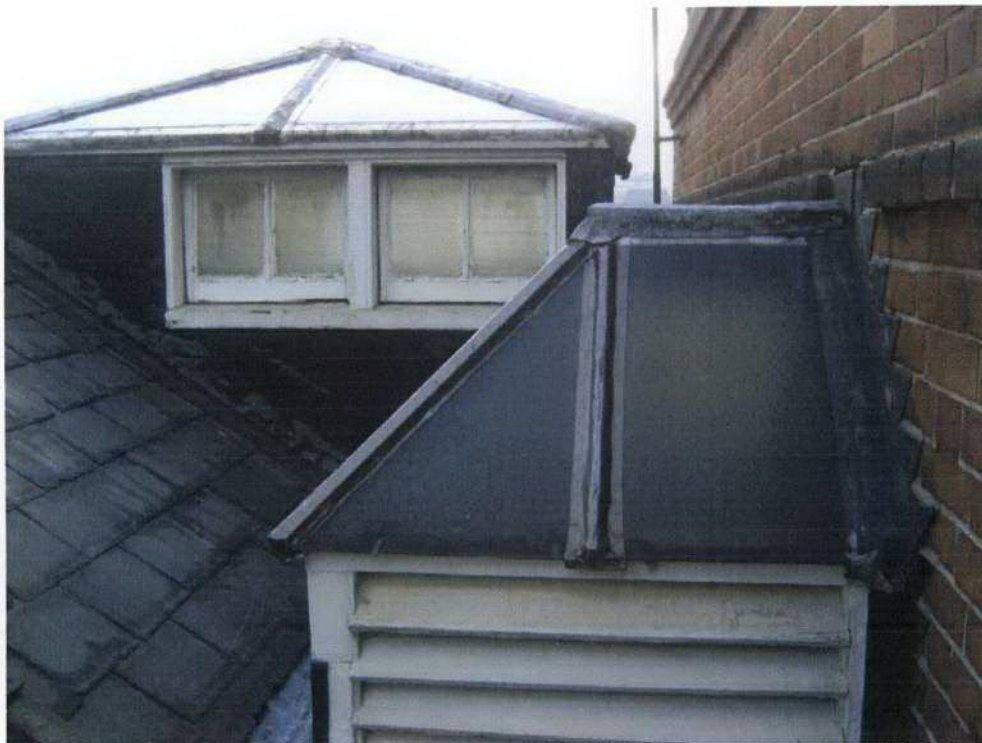
There is a single access hatch cover set into the uppermost flat leaded section of roof. Three timber framed rooflights block the front to rear running valley gutter against the chimney stack shared with no.22 and two further grp or similar rooflights have been inserted into the lower rear mansard slope [4].

Extensive patch repairs have been carried out in recent years to the timber rooflight structures, mostly using flashband [4]. Decay is evident in exposed sections of timber. Considerable deterioration can be anticipated in the surrounding concealed fabric. Major overhaul of these structures will be required at the same time that the roof is recovered. The lower grp rooflights are in serviceable order, but are wholly out of keeping with the character and listed status of the building. Ideally, these should be replaced with dormer windows of more appropriate design when the re-roofing works are carried out, recognising, nonetheless, that the one dormer window currently provides the only means of access to the roofs.

4: Upper roof over no.21 with rooflights

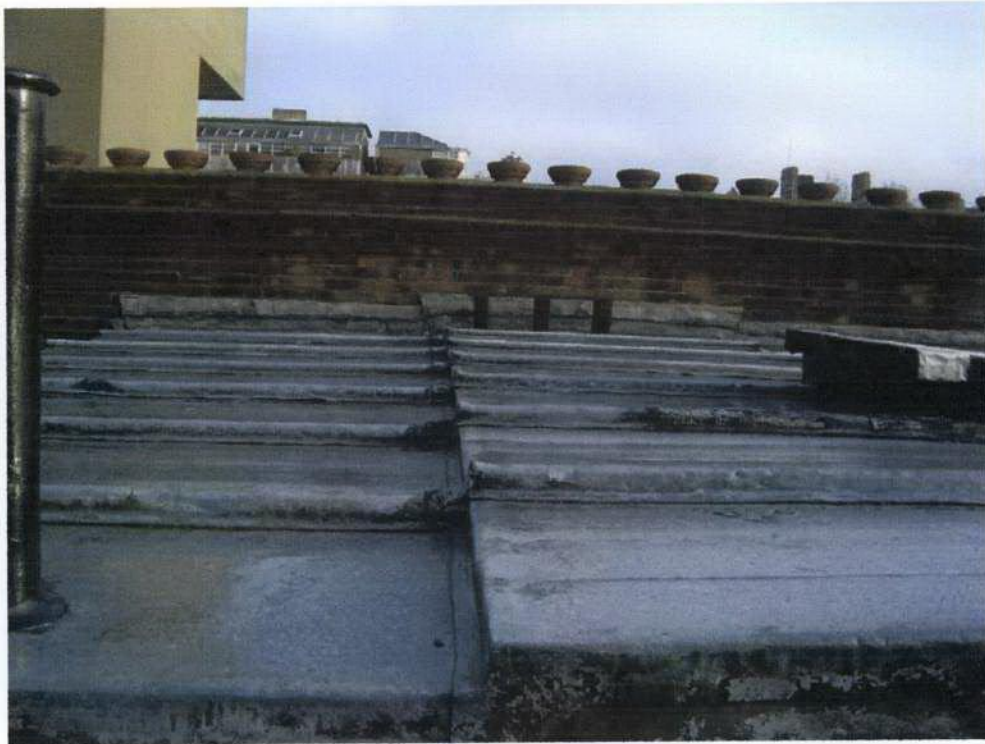
Patch repairs are evident on the upper leadwork, many using flashband, which can be considered to be of temporary palliative benefit only. The lead is old, heavily indented and softened [5,6]. It is probable that considerable corrosion of the underside of the lead sheet is occurring. Where visible, the lead rolls are distorted and some are clearly split and failing. Our limited view suggests that this covering has reached the end of its useful life. Immediate repair is required to defective areas (including failing past repairs), if there is any delay before recovering takes place. Otherwise, the covering should be renewed in a suitable code milled or sand cast lead sheet. Care needs to be taken with the specification of this work to ensure the appropriate detailing is used. Amongst other things, a chalk emulsion should be applied to the underside of the new sheet to reduce the risk of corrosion occurring in the future. It is likely that extensive repair of timber decking and perhaps parts of the supporting structure will be required prior to recovering of the flat roof. Improved access and edge protection arrangements to the upper roof areas for maintenance purposes are also regarded as being essential.

5: Upper leaded roof area over no.21

Lead flashings and valley gutters should be renewed at the same time as the recovering of the lead roof.

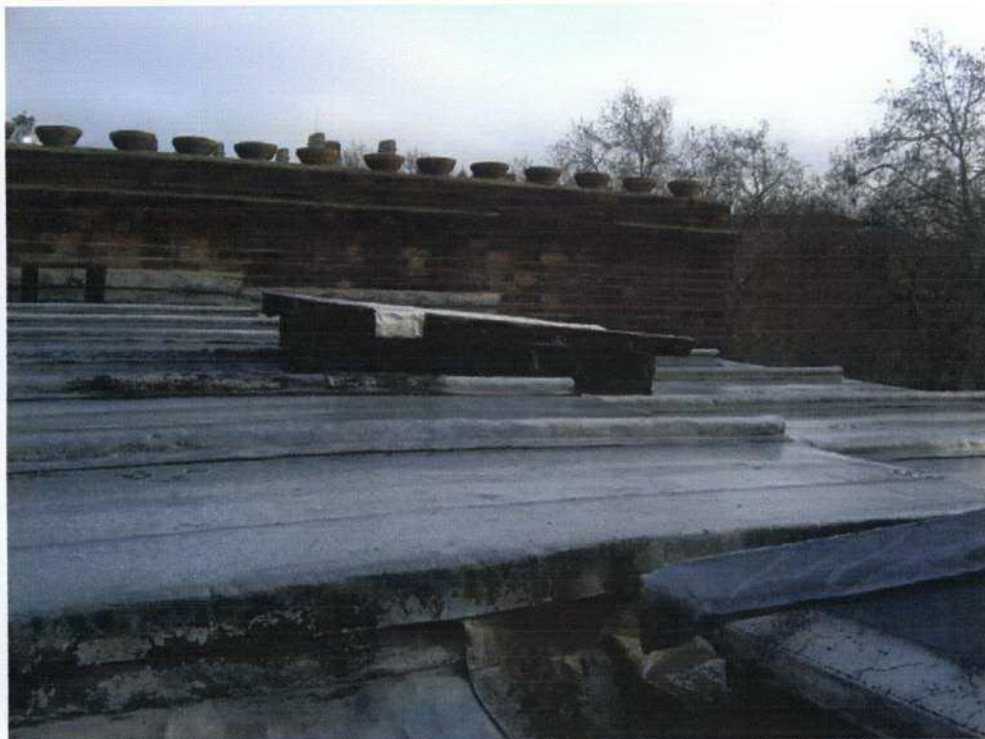
6: As (5), upper roof over no.21

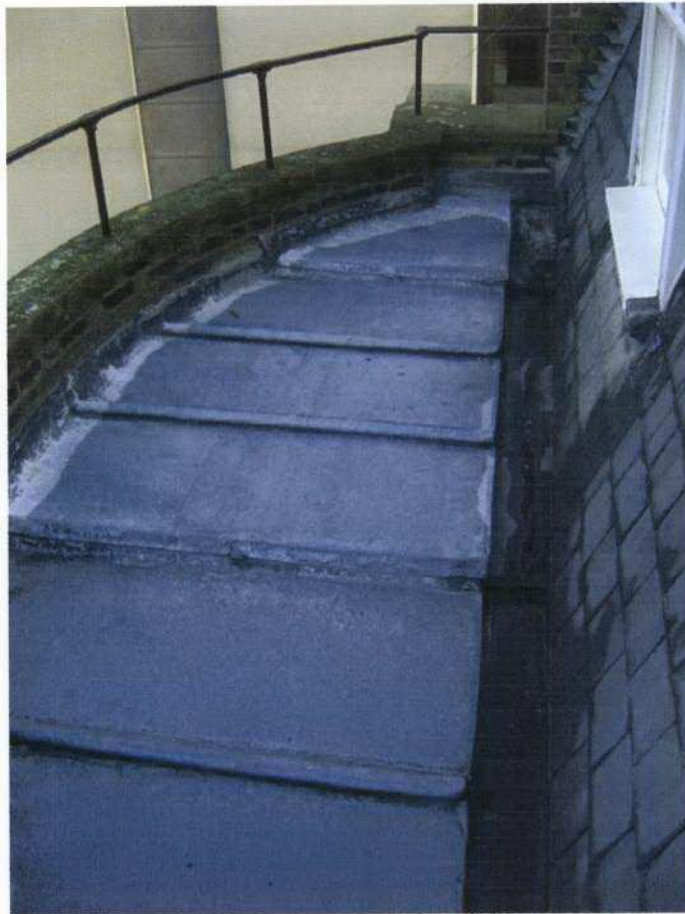
There is a lower lead covered flat roof over the rear bay to no.21 [7]. Rainwater from this roof drains into a valley gutter at the base of the slated mansard roof. Splits are evident in the lead covering, which is also aged and soft. Again, it is anticipated that corrosion is occurring on the underside of the lead sheets. Upstands on the roof are of inadequate depth and the lead rolls are deformed. The sump at the lower end of the valley gutter was found to be choked with leaves and other debris at the time of our inspection. The roof is almost at the end of its useful life and should be recovered in the

7: Lower roof to no.21

next two to three years. If this work is not undertaken immediately, temporary repairs will need to be put in hand to keep the roof watertight in the short term.

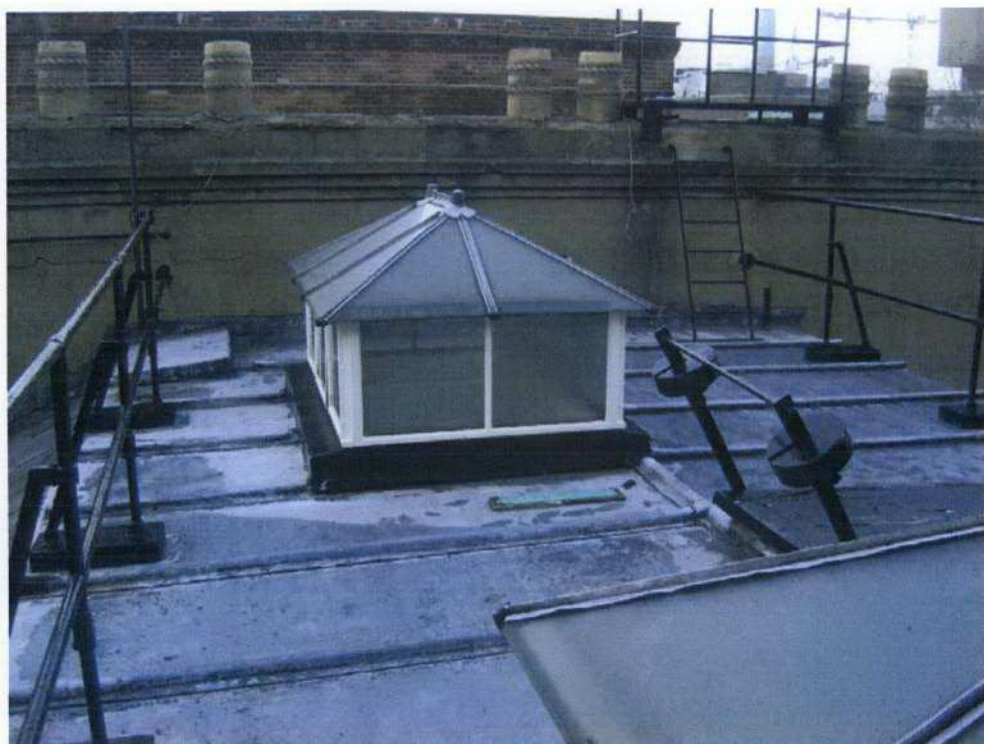
There are two timber and metal framed roof lights set into the upper flat leaded roof section, along with a large painted iron or steel hatch cover. As has already been noted, inadequate edge protection is in place on both sides of the roof [8].

8: Upper roof over no.22

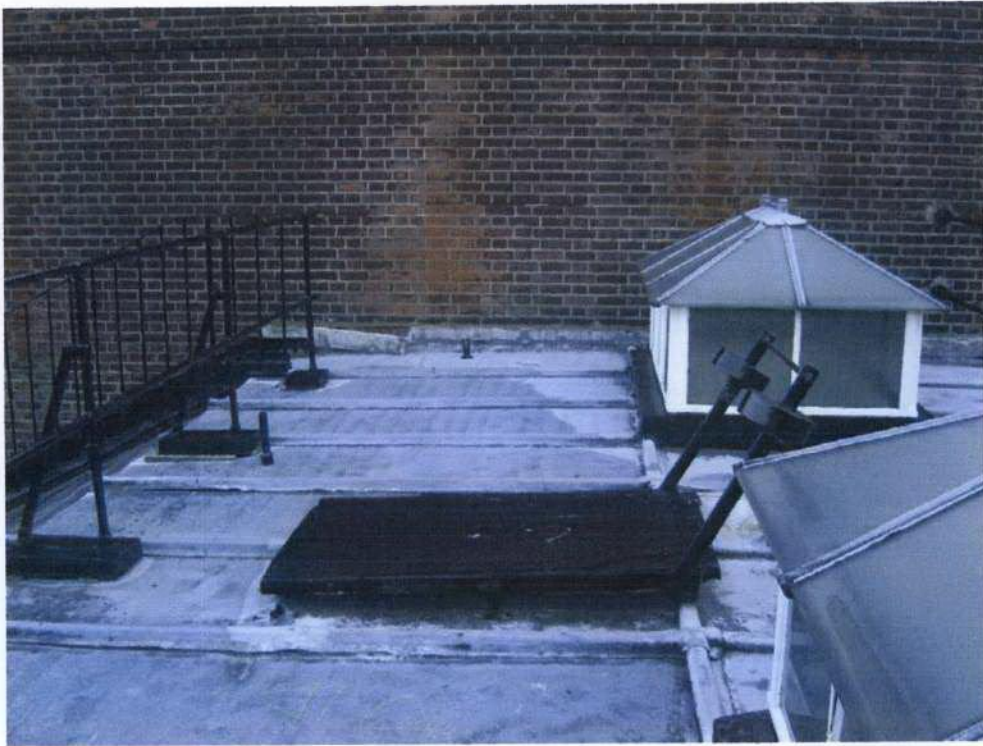
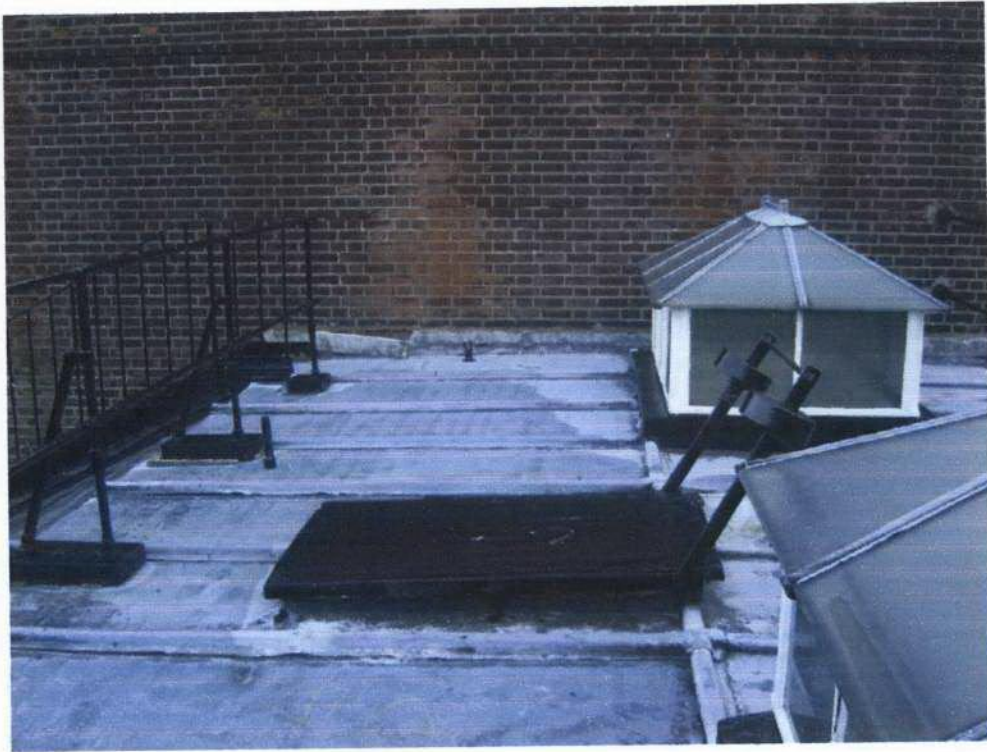
The leadwork has been repaired in the past with soldered patches and more recently with a bitumen coating and flashband. The latter temporary repairs are now failing again. The lead sheeting is old, heavily indented and softened. Some sheets are overly long, given the thickness of lead sheet that has been used. Areas of ponding are visible and the outline of the timber boarding to the deck beneath is clearly visible across the whole roof [9]. It is probable that considerable corrosion of the underside of the lead sheet is occurring. In at least one area, decay of the timber deck is also evident, with a marked depression in the surface of the roof. Elsewhere, minor splits and rucking of the lead can be found [10]. The lead rolls are badly distorted and particularly liable to splitting. Lead flashings protecting the upstand between the covering and adjacent walls are loose and in places have dropped out of their joint entirely [10]. In summary, the covering has reached the end of its useful life. It should be renewed at an early date using a suitable code and detailed milled or sand cast lead sheet. As before, care needs to be taken with the specification of this work to ensure the appropriate detailing is used. It is probable that extensive repair of timber decking and perhaps parts of the supporting structure will be required prior to recovering of the flat roof. Improved access and edge protection arrangements to the upper roof area will be needed for maintenance purposes.

9: As (8), upper roof over no.22

Overhaul of the rooflights will need to be undertaken at the same time as recovering of the flat roof. Corrosion and decay were noted in the framing and cills to these structures and the lead cappings are reaching the end of their useful life.

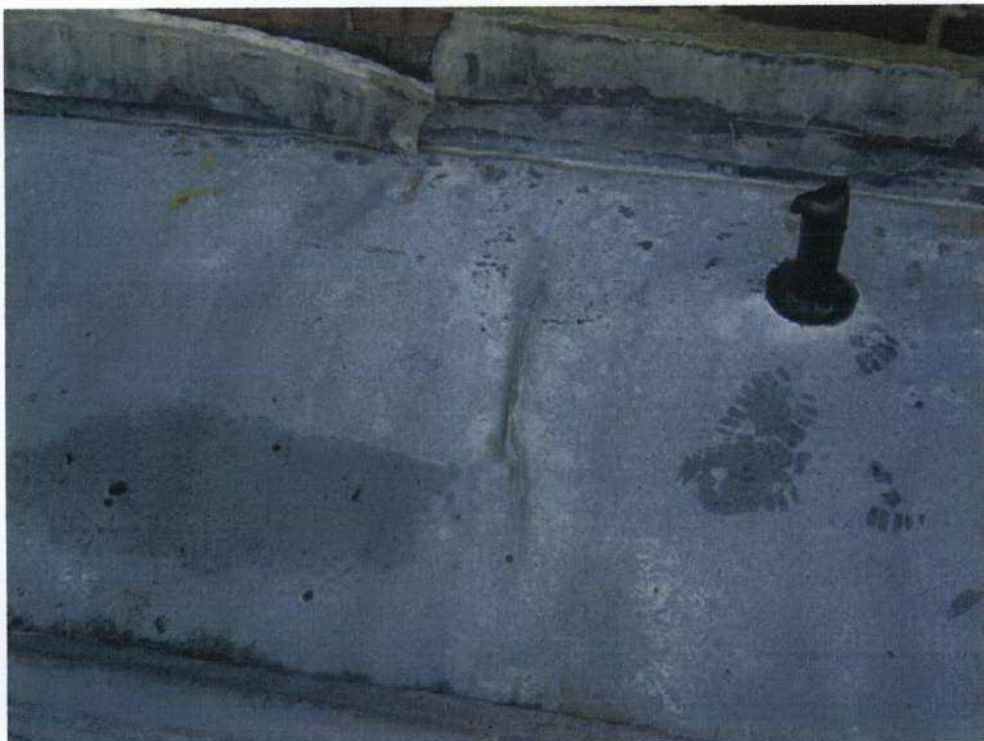
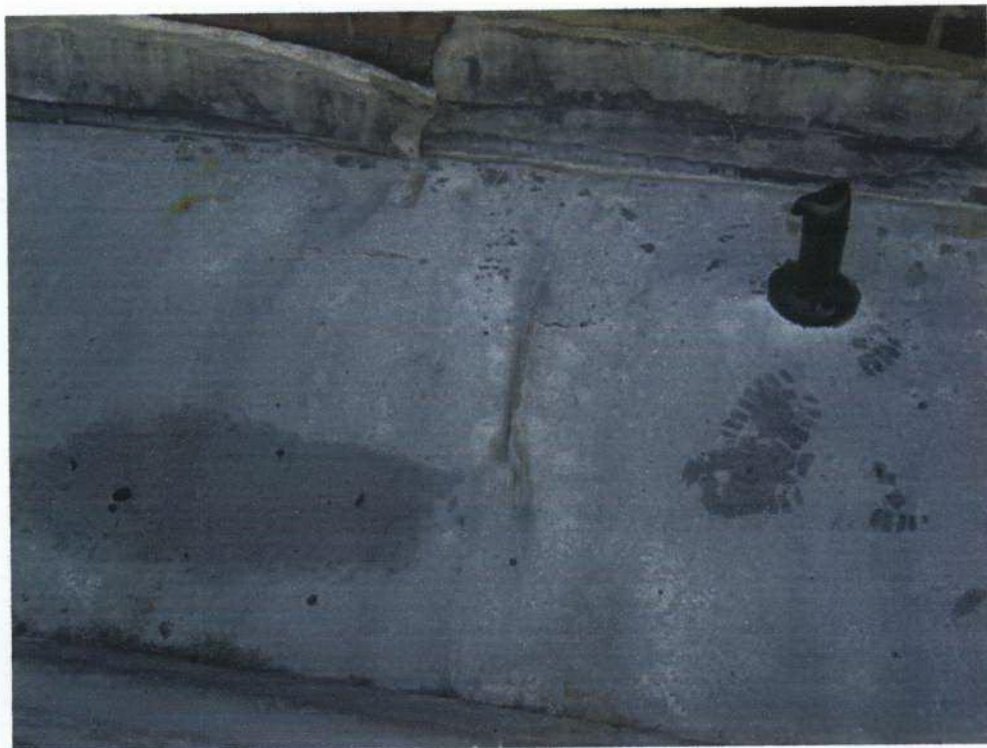
10: Loose flashing and rucked lead sheet over no.22

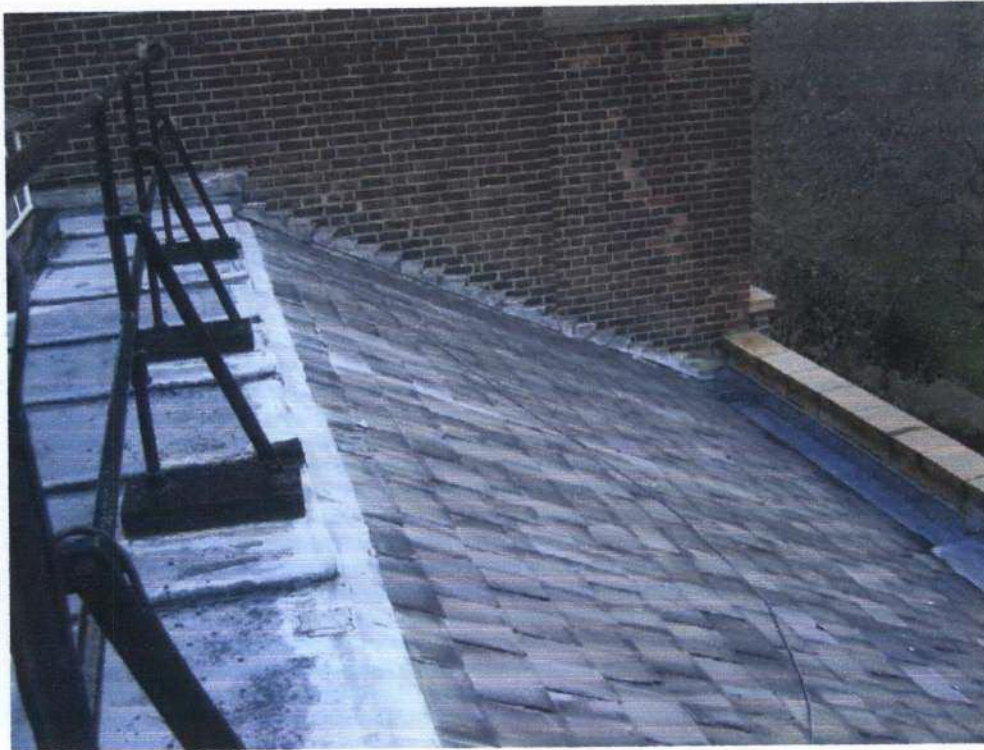
The front slated roof slop to no.22 has been repaired extensively in the past. At some time, the slates have been stripped and reinstated. Since then, further slippage has occurred with at least 15no. slates being refixed with tingle clips [11]. Continued slippage of slates was noted at the time of our inspection. Other slates are fractured or badly damaged at their edges and some delamination is occurring. The rear slated slope has somewhat fewer tingle clips, but a number of slates are displaced or loose. Clearly, extensive failure of nail fixings is taking place. As with the slated coverings over no.21, short term repairs can be effected to these slopes, but ongoing slippage will undoubtedly be a regular and increasing problem. Complete renewal of the slate coverings will be required in the next five years or so. Accordingly, it is recommended that this work is brought forward to coincide with the other essential roofing works. It is unlikely that many slates can be salvaged for reuse given the evidence of previous refixing and signs of delamination. Timber repairs may be required to the concealed timber mansard structure. The lead sheet covering to the dormer structure in the rear slope is in similar condition to other leadwork on the two properties [12] and, consequently, this structure should be repaired and recovered at the same time that the roof coverings are renewed.

11: Front slope over no.22

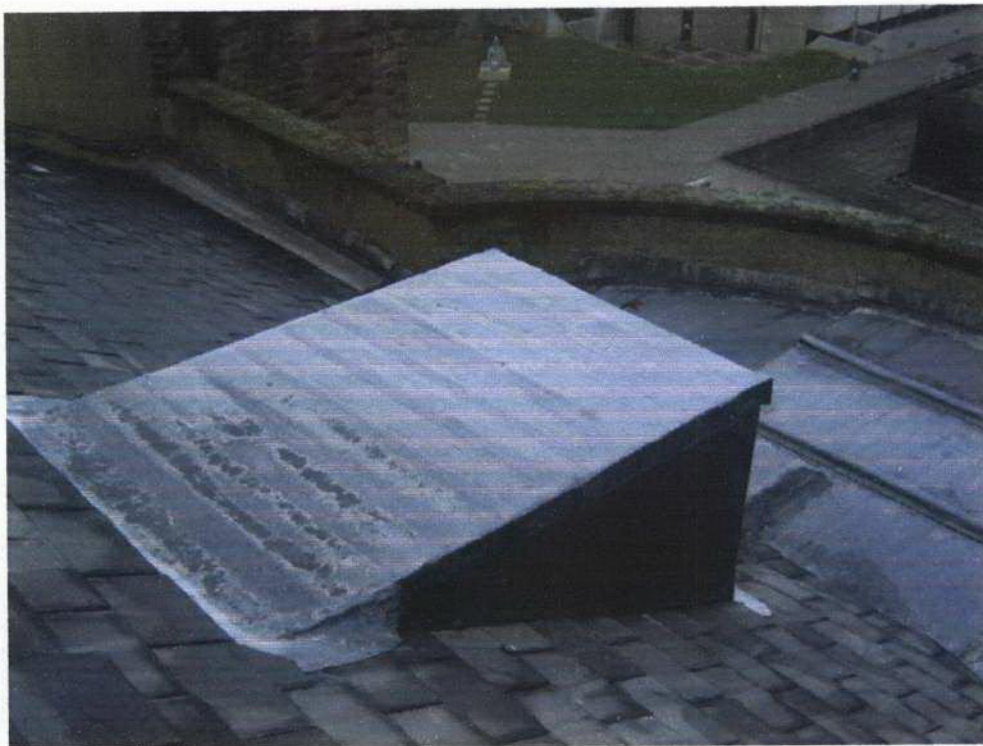
12: Dormer structure in rear slope of no.22

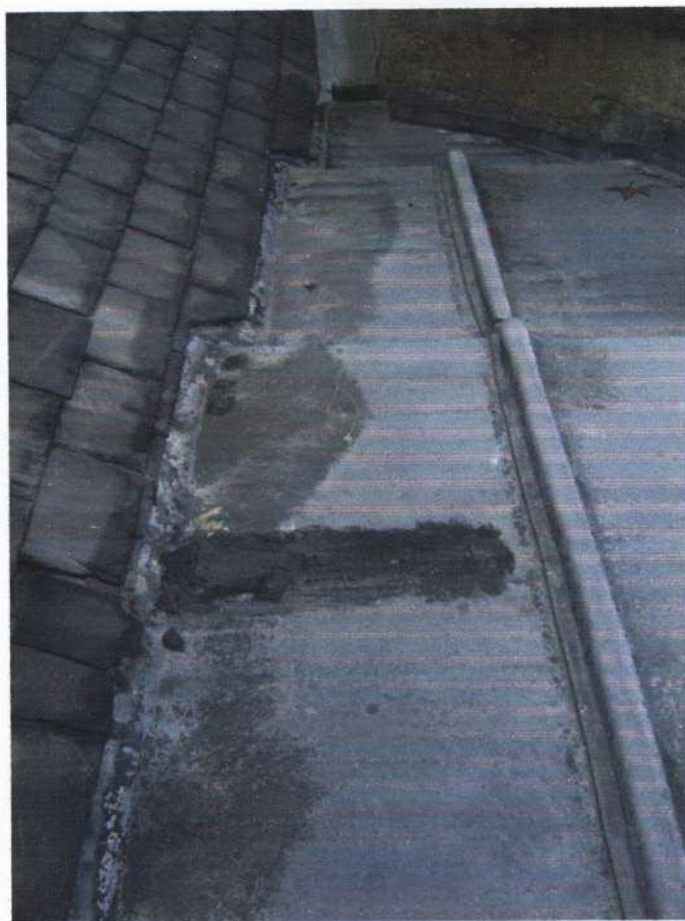
The lower lead covered roof to the rear of no.22 is in similar condition to the upper leaded area. There is a significant depression in the centre of this roof, indicating the substantial water ingress and

consequential decay to the timber deck has occurred [13]. This roof may not be structurally sound, as a result, and access should only be attempted with considerable care.

13: Depressed areas and defective leadwork on the lower roof to no.22

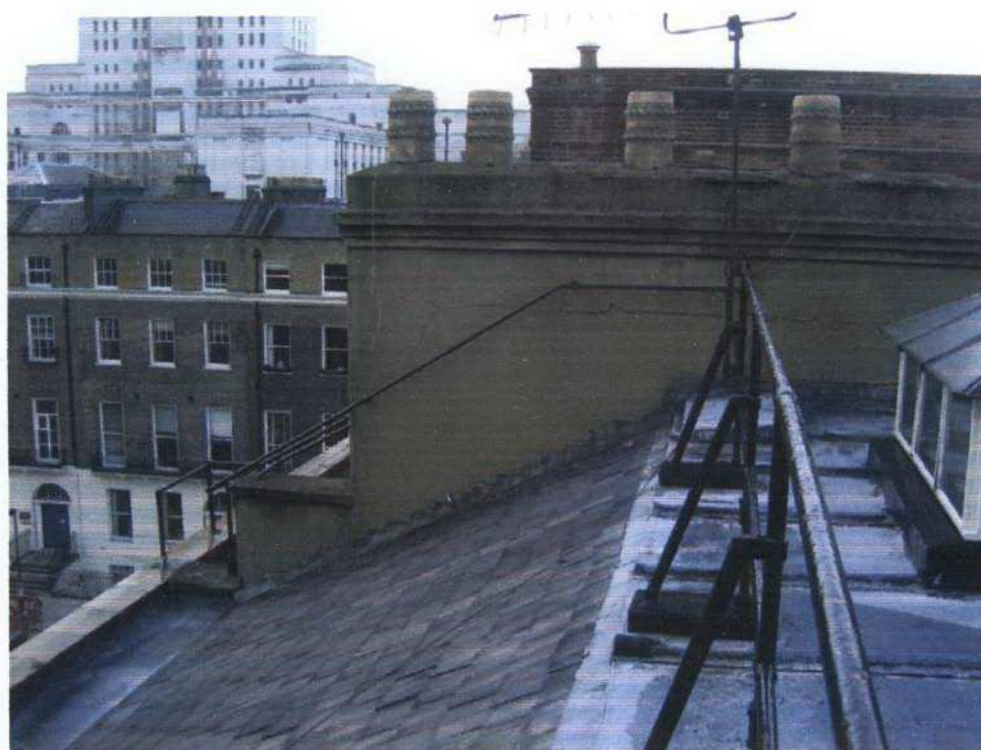
The chimney stacks forming part of the dividing parapets on each side of these roof areas require localised repointing, extensive renewal of failed render [14], and attention to flaunching and cappings. All these repairs need to be carefully considered and specified to ensure that the historic character and interest of the buildings are not compromised.

14: Defective render to shared chimney stack with no.23
