# Arboricultural Constraints Report

Relating to Trees at 14a Redington Road, Hampstead, London

Ref: 846.CS.Hampstead.Sokel

Date of Inspection: 17<sup>th</sup> October 2005

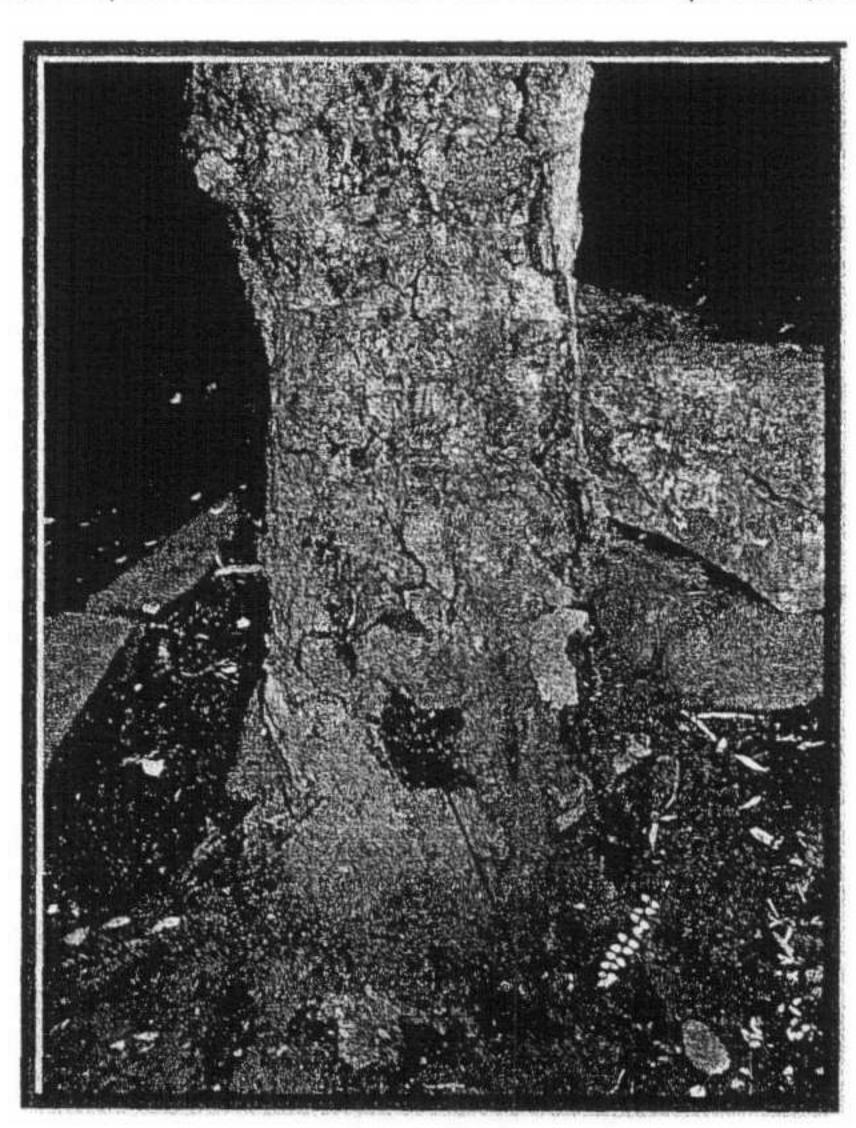
| Tag<br>No | Species | Height (m) | Main stem<br>diameter (mm) | Maximum Crown<br>Spread | Age class | Condition | Amenity Value | Recommendations | Estimated<br>Remaining<br>Contribution | Retention category | RPA<br>(radius) |
|---|--|---|---|---|---|---|---|--|--|---|---|
| 904 | Magnolia<br>(Magnolia<br>macrophylla) | 5.0 | 320 | 3.0 | O/M | Poor. Low vigour. Bark death and basal decay on lower main stem. | L | Fell and replace | 0-10 | R | / |

- 8.4 The Magnolia (904) is in poor condition and must be felled and replaced. (See fig 1.)

- Fell and replace Bay Laurel (901), Leyland Cypress (902) and Magnolia (904). The adjacent properties (14 and 16 Redington Road) have Silver Birch at the front and this may be an acceptable species for proposed replanting at the front of this site. They are tolerant of a wide range of site conditions and cast light, dappled shade.
