Existing Condition Images

Centre Point 20th Floor North

To be read in conjunction with diagrammatic existing floor plans

ROLFE JUDD

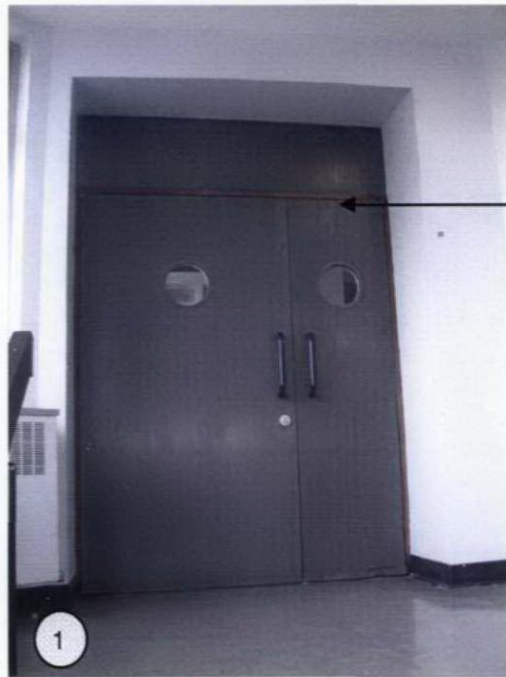
Existing grilles to be removed and plastered over

Existing non original door sets to be replaced.

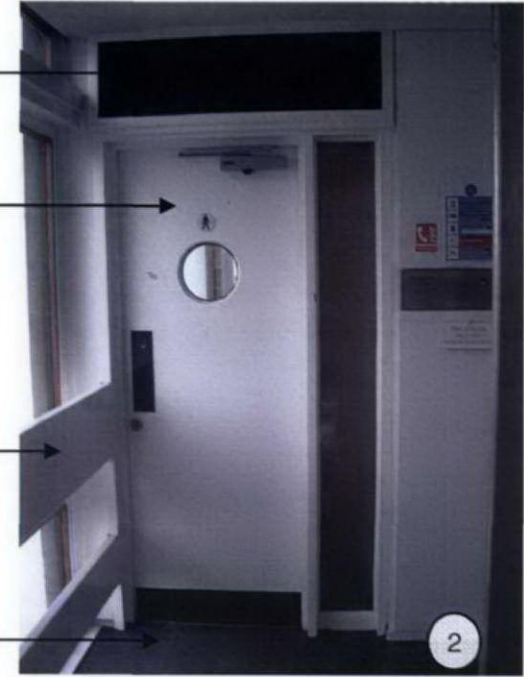
Existing barrier to be refurbished and repainted

New carpet to be installed on existing terrazzo, with skirtings over clad in stainless steel

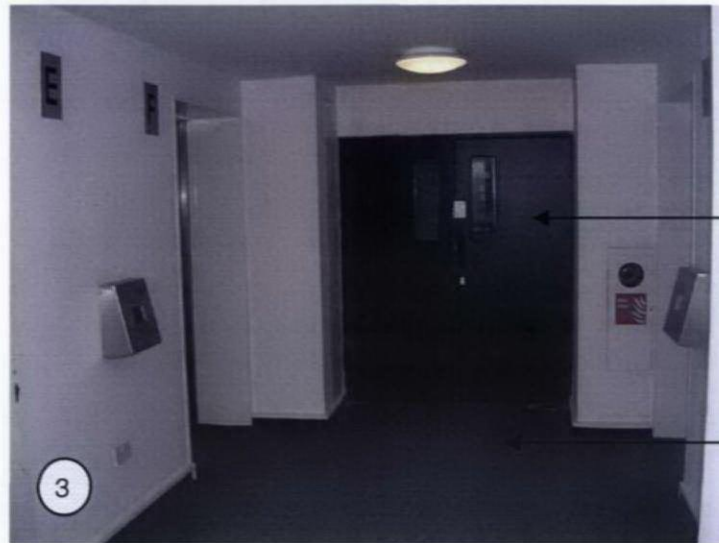
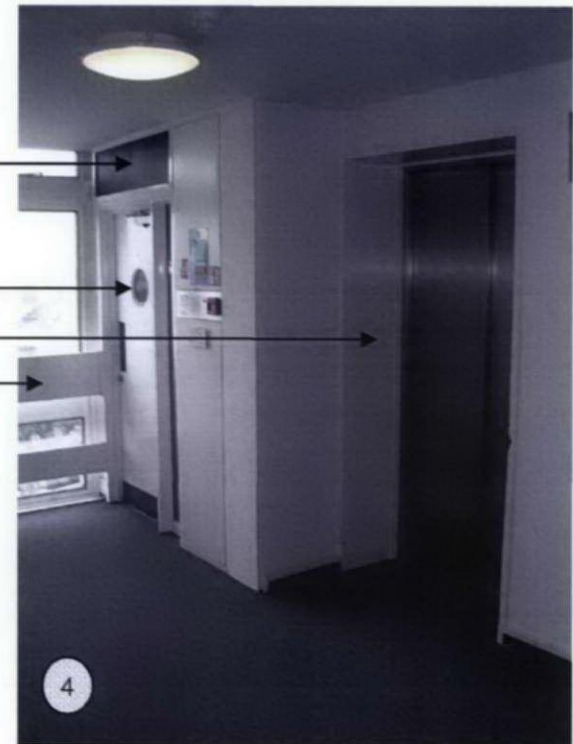
- 1 Non-original door set to be replaced.
- 2 Existing lift surround to be over clad with stainless steel to match lift doors.
- 3 Existing grilles to be removed and plastered over.
- 4 Existing barrier to be refurbished and repainted.
- 5 New carpet to be installed on existing terrazzo, with skirtings over clad in stainless steel.

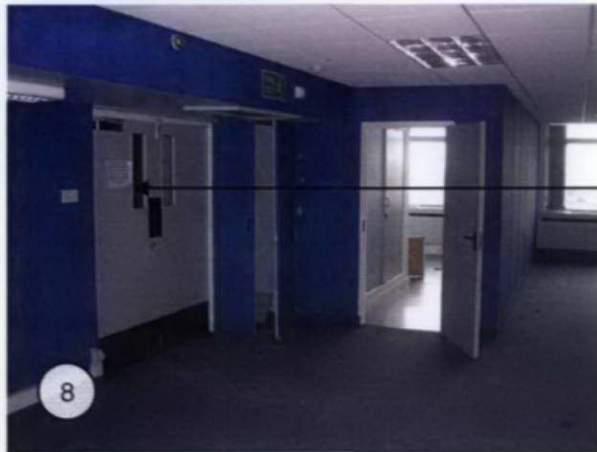
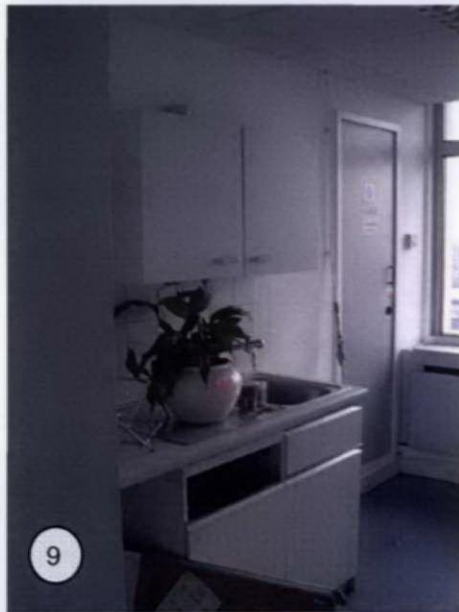
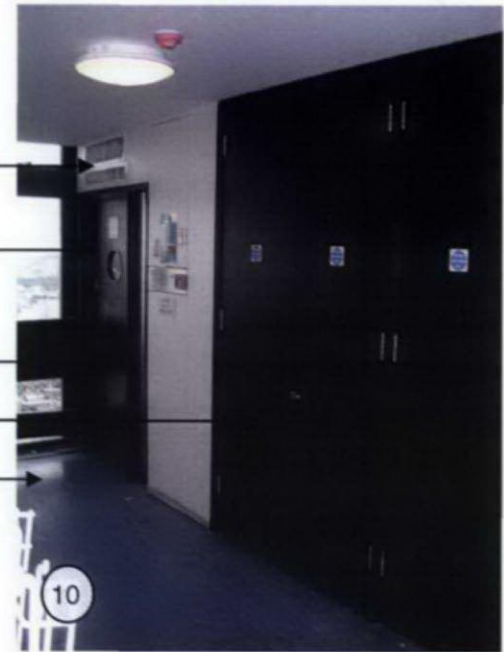
- 1 Non-original door set to be replaced.
- 3 Existing grilles to be removed and plastered over.
- 4 Existing barrier to be refurbished and repainted.
- 5 New carpet to be installed on existing terrazzo, with skirtings over clad in stainless steel.
- 6 Cupboard doors to be removed.

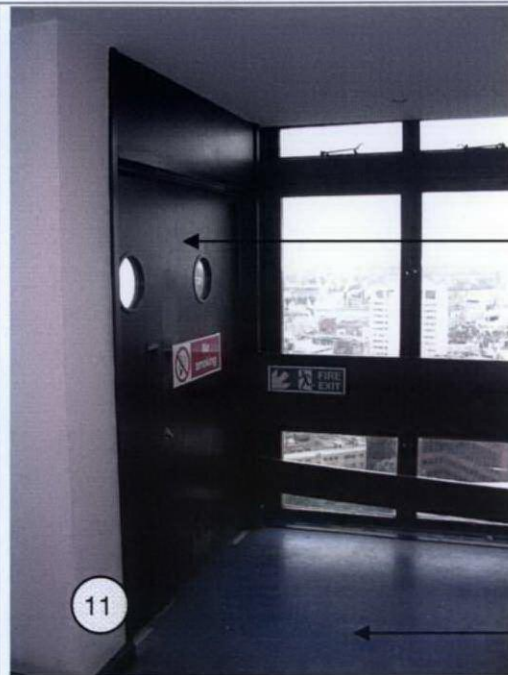
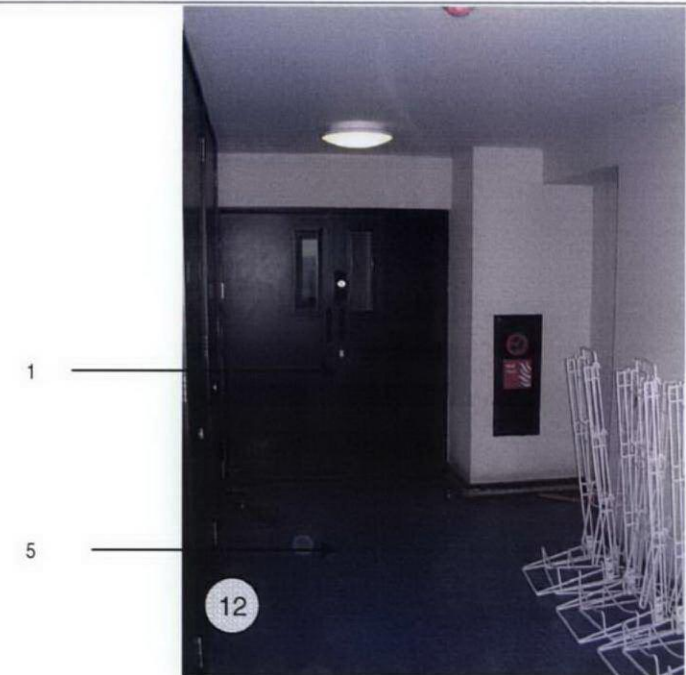
- 1 Non-original door set to be replaced.
- 3 Existing grilles to be removed and plastered over.
- 4 Existing barrier to be refurbished and repainted.
- 5 New carpet to be installed on existing terrazzo, with skirtings over clad in stainless steel.

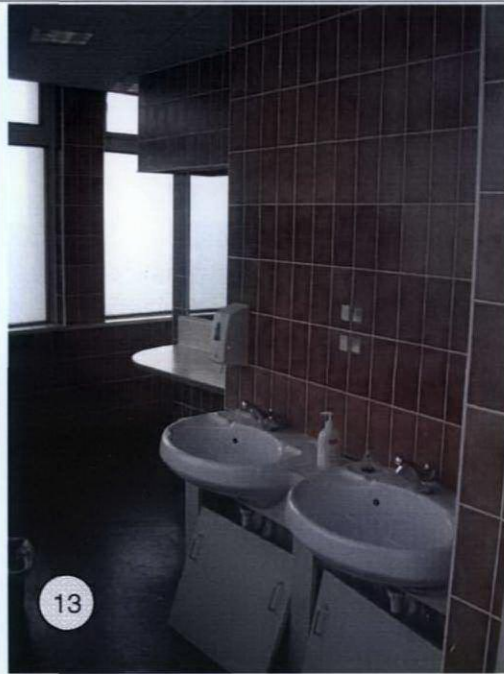
Existing toilet interior non-original. All non-original partitions, fittings and finishes to be removed.

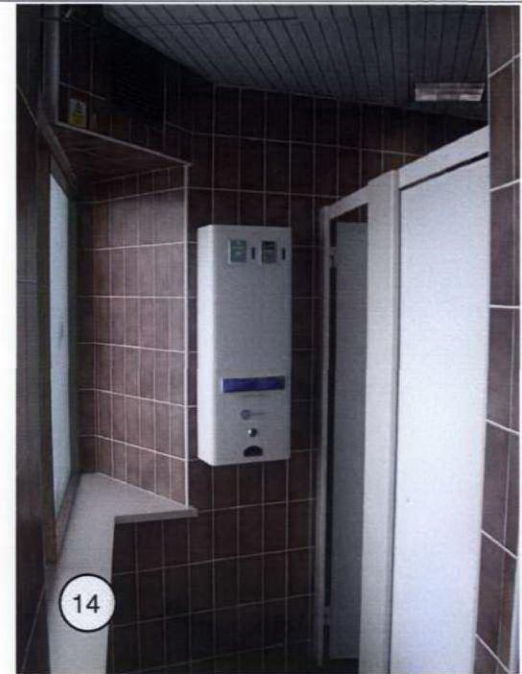
Original terrazzo partitions and flooring have been removed during previous fit out.
New terrazzo partitions to match the original are to be installed.

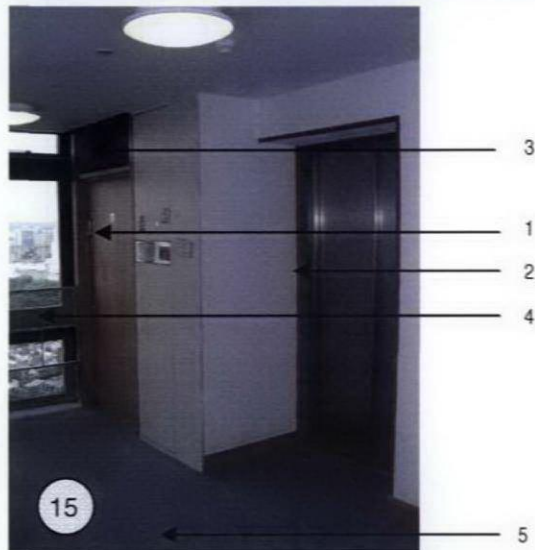
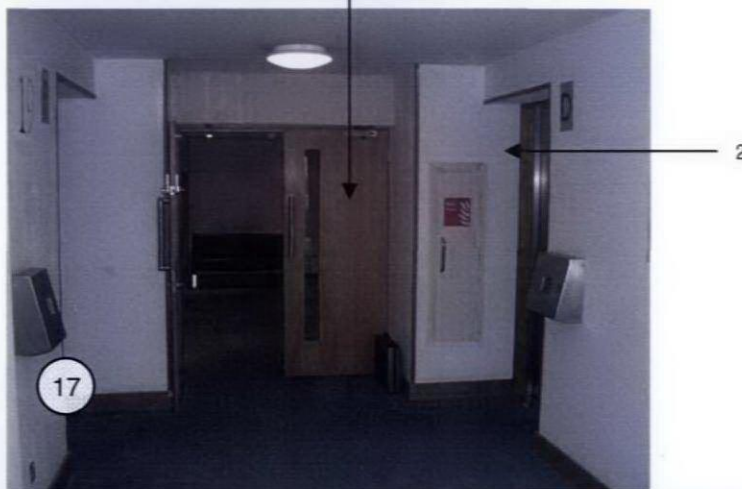
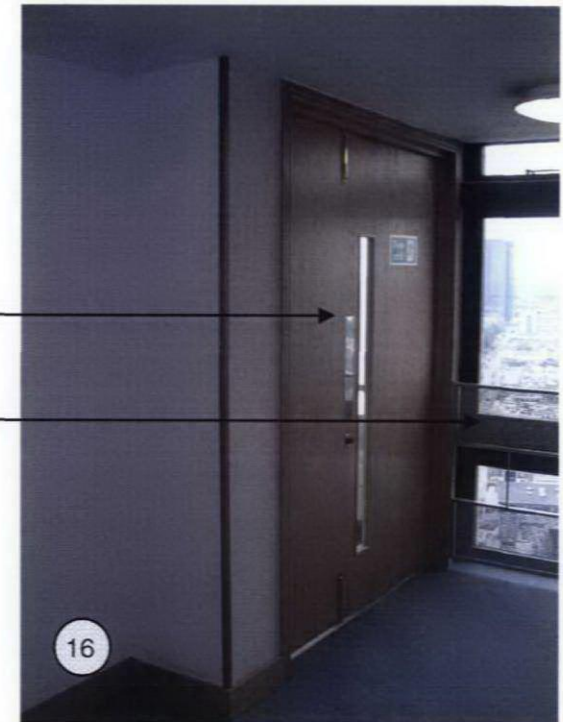
- 1 Non-original door set to be replaced.
- 2 Existing lift surround to be over clad with stainless steel to match lift doors.
- 3 Existing grilles to be removed and plastered over.
- 4 Existing barrier to be replaced to match original and painted.
- 5 New carpet to be installed on existing terrazzo, with skirting's over clad in stainless steel.

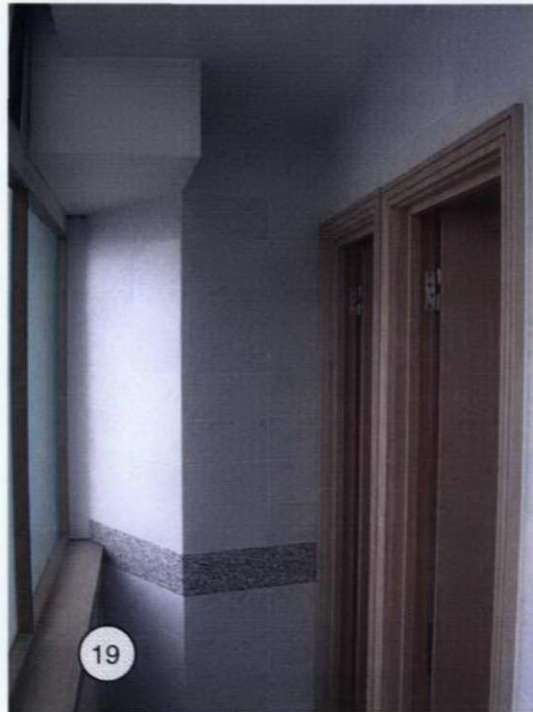
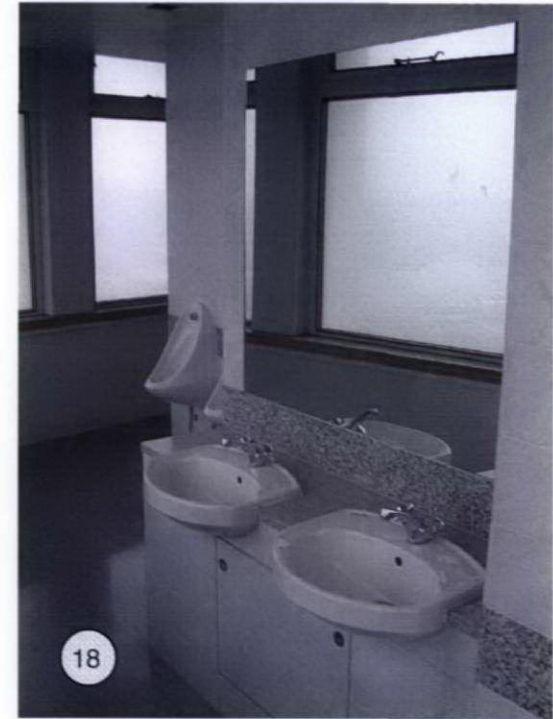
Existing toilet interior non-original. All non-original partitions, fittings and finishes to be removed.
New terrazzo partitions to be installed to match the original..

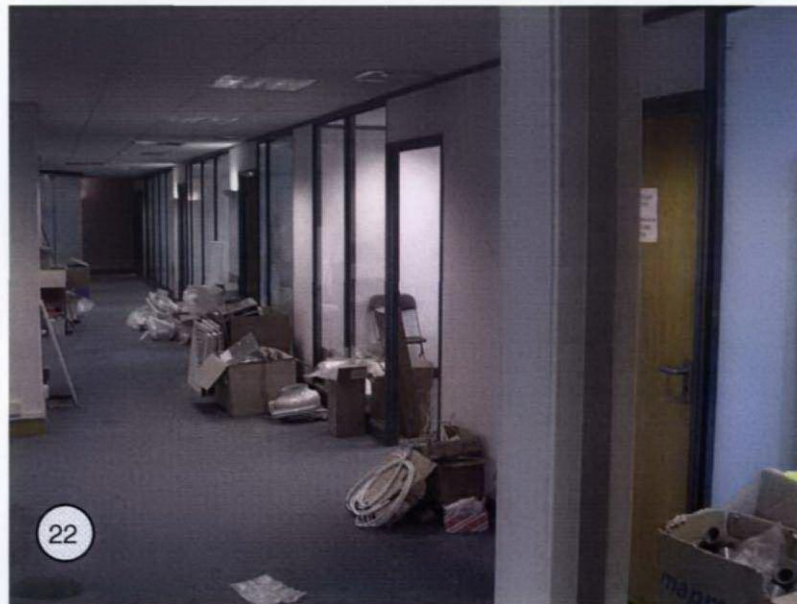
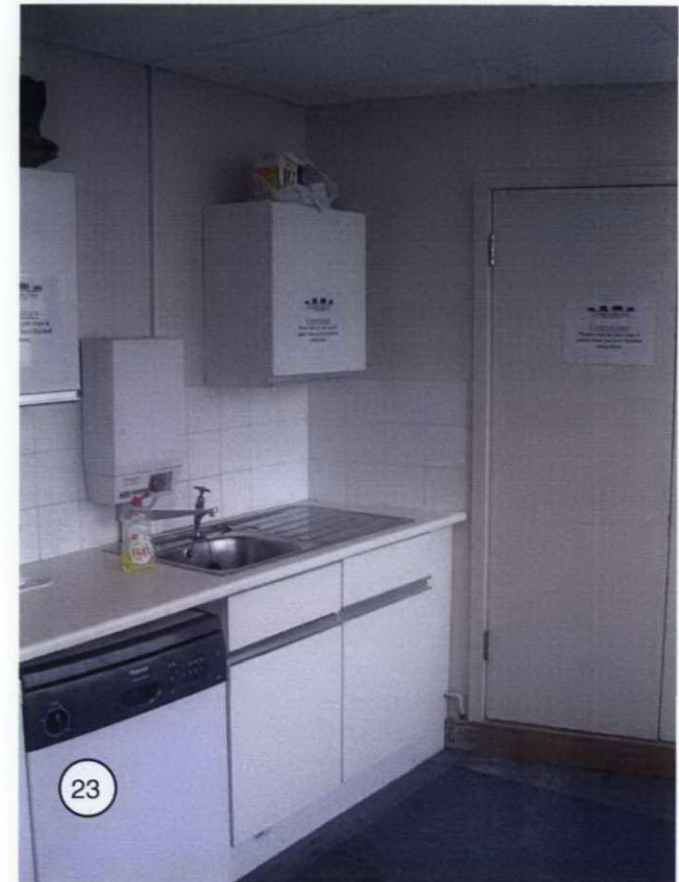
All existing partitions, kitchenette, fixtures, fittings and finishes to be stripped out.

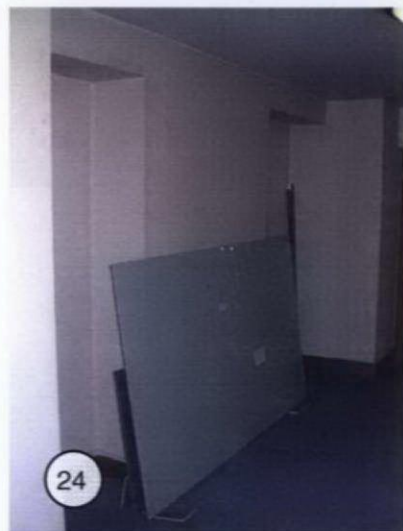
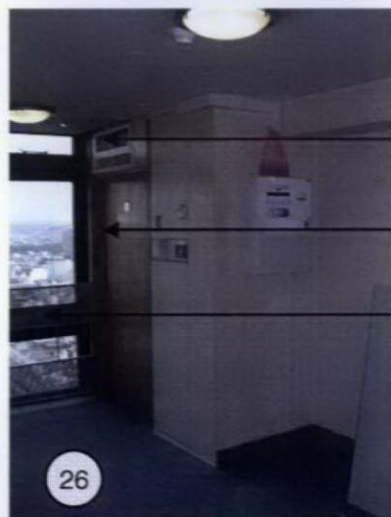
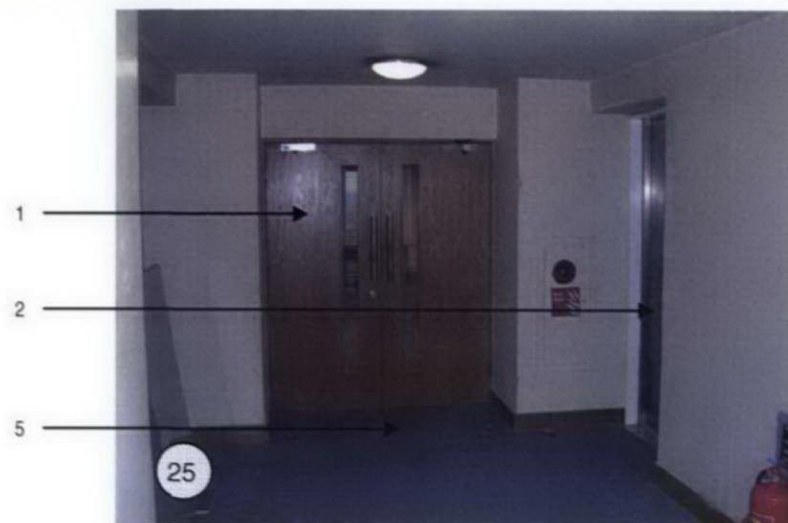
- 1 Non-original door set to be replaced.
- 2 Existing lift surround to be over clad with stainless steel to match lift doors.
- 3 Existing grilles to be removed and plastered over.
- 4 Existing barrier to be replaced to match original and painted.
- 5 New carpet to be installed on existing terrazzo, with skirtings over clad in stainless steel.

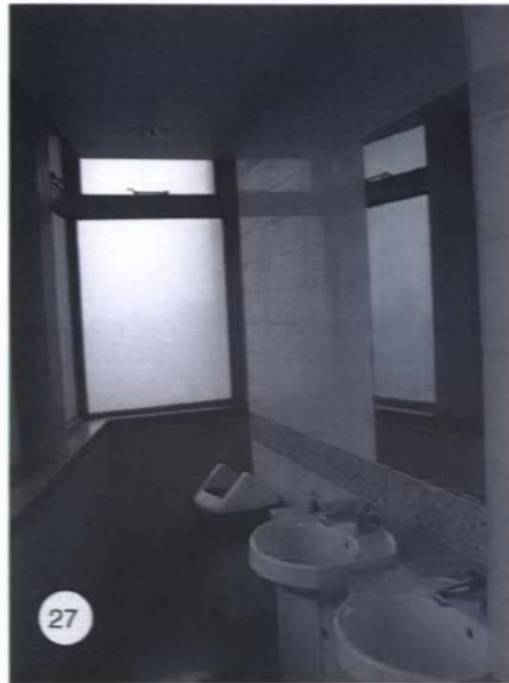
Original terrazzo partitions and flooring have been removed during previous fit out.
New terrazzo partitions to match the original are to be installed.

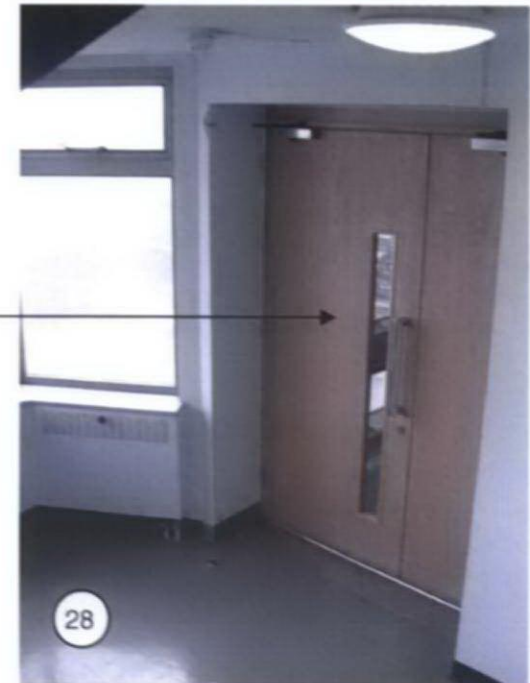
Non-original door set to be replaced.

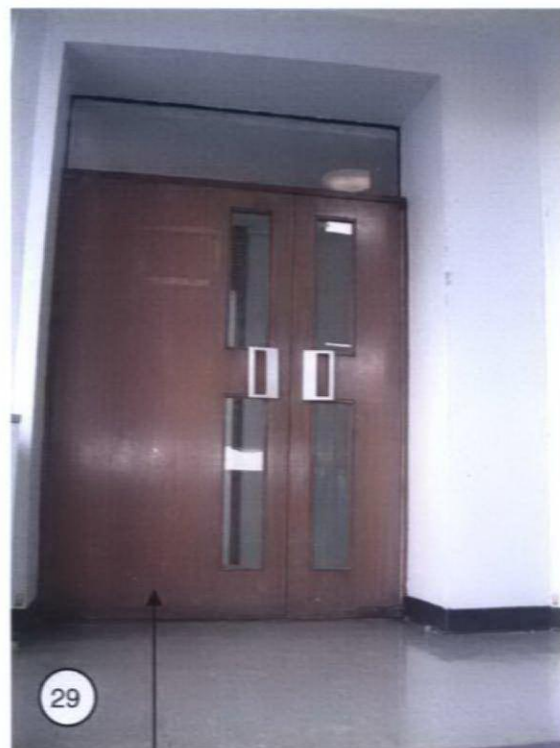
Existing door set to be refurbished and painted on lift lobby side to match toilet door.

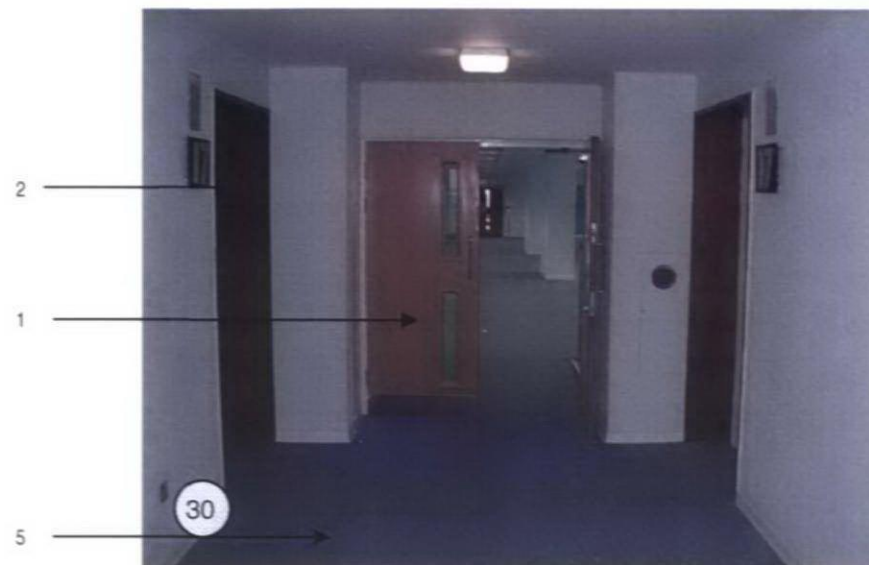
- 1 Non-original door set to be replaced.
- 2 Existing lift surround to be over clad with stainless steel to match lift doors.
- 5 New carpet to be installed on existing terrazzo screed, with skirtings over clad in stainless steel.

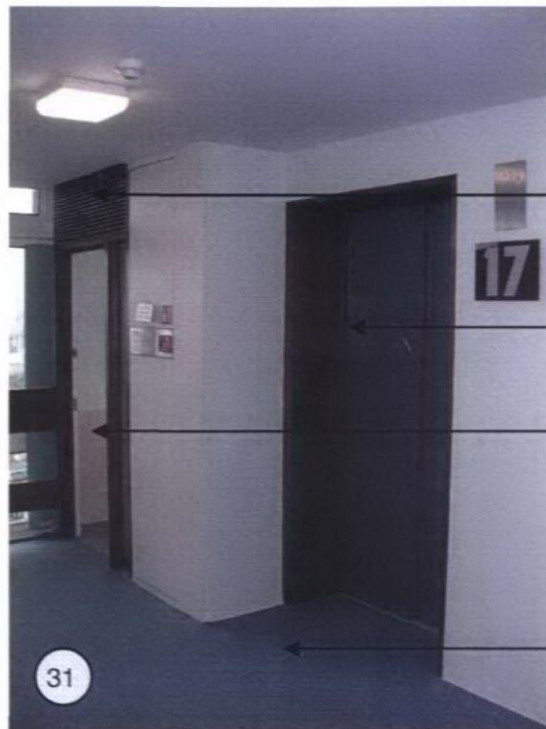
Existing door sets to be refurbished and painted.

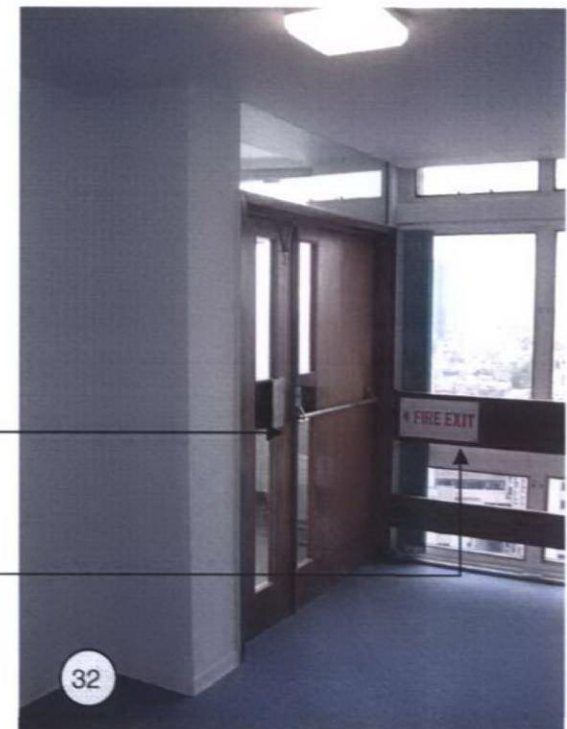
- 1 Non-original door set to be replaced.
- 2 Existing lift surround to be over clad with stainless steel to match lift doors.
- 3 Existing grilles to be removed and plastered over.
- 4 Existing barrier to be refurbished and repainted.
- 5 New carpet to be installed on existing terrazzo, with skirtings over clad in stainless steel.

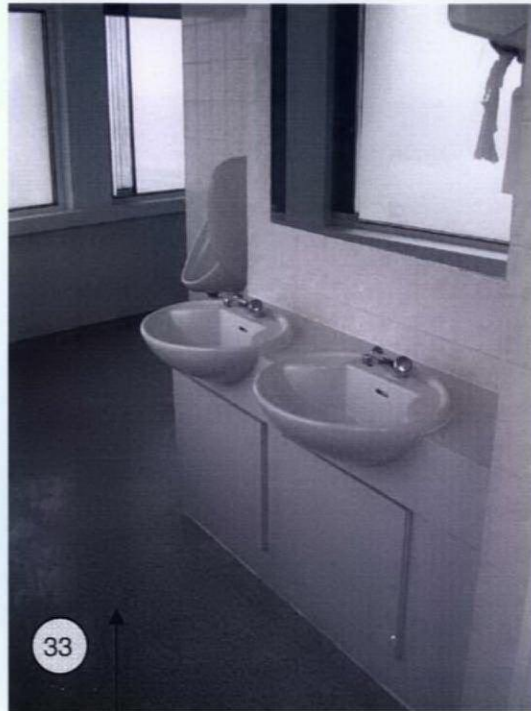
Existing terrazzo to be refurbished and replaced with matching material where necessary.

Existing toilet interior non-original. All non-original partitions, fittings and finishes to be removed.

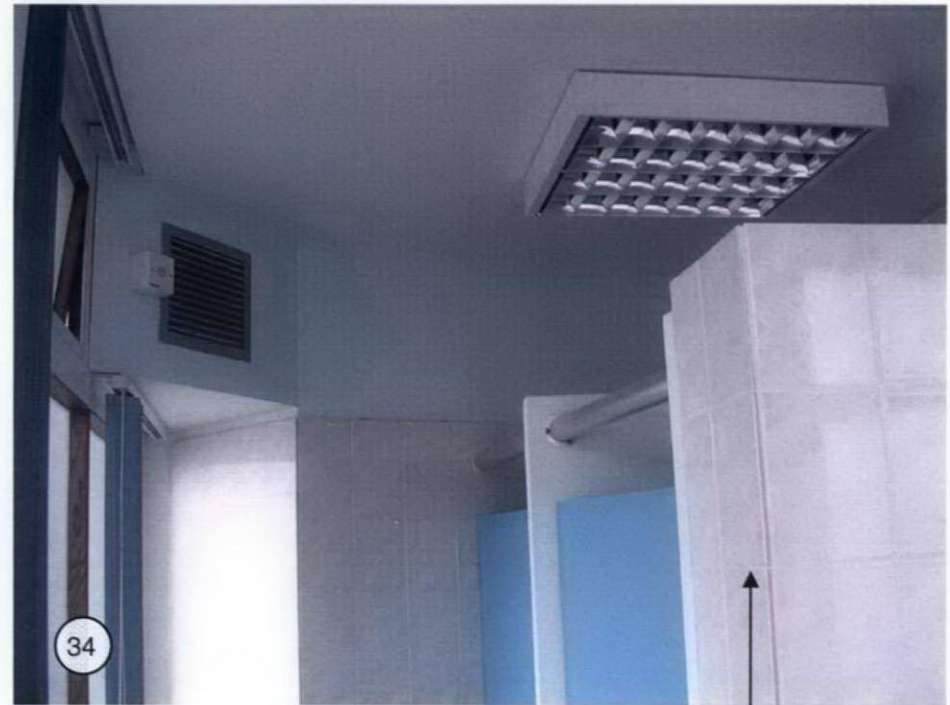
Paint to be removed from original terrazzo partitions and surfaces refurbished.

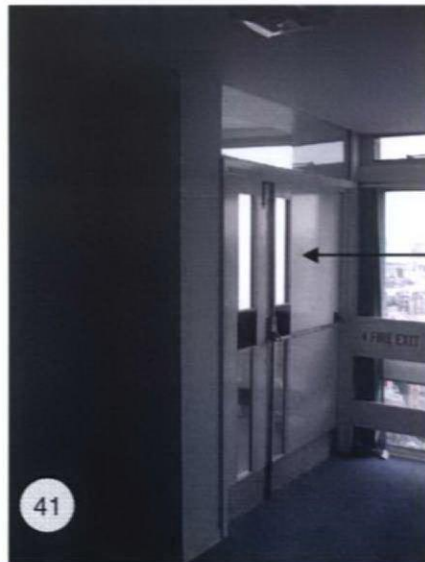
Existing door set to be
refurbished and repainted

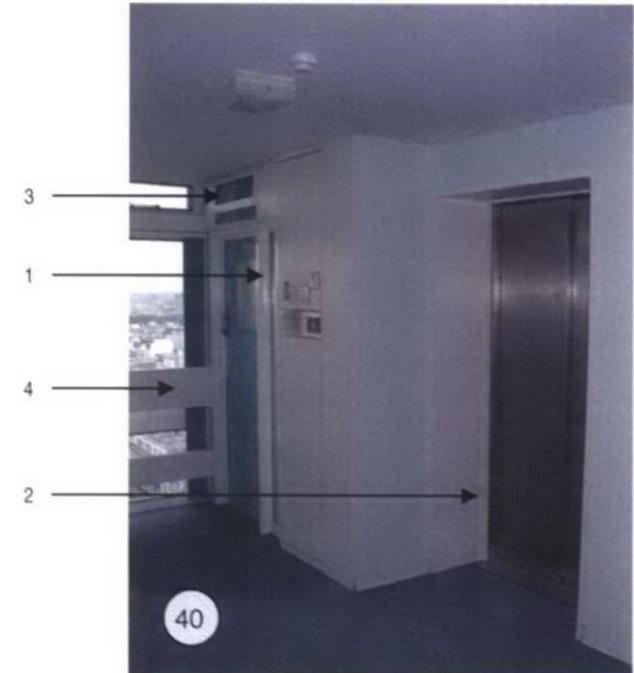
- 1 Non-original door set to be replaced.
- 2 Existing lift surround to be over clad with stainless steel to match lift doors.
- 3 Existing grilles to be removed and plastered over.
- 4 Existing barrier to be refurbished and repainted.
- 5 New carpet to be installed on existing terrazzo, with skirtings over clad in stainless steel.

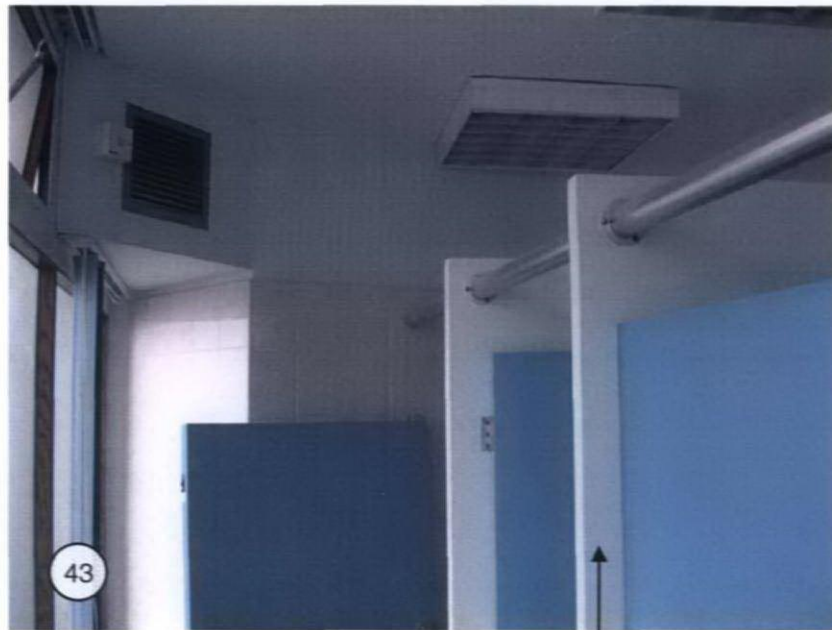
Paint to be removed from original terrazzo partitions and surfaces refurbished.

Existing toilet interior non-original.

All non-original partitions, fittings and finishes to be removed.

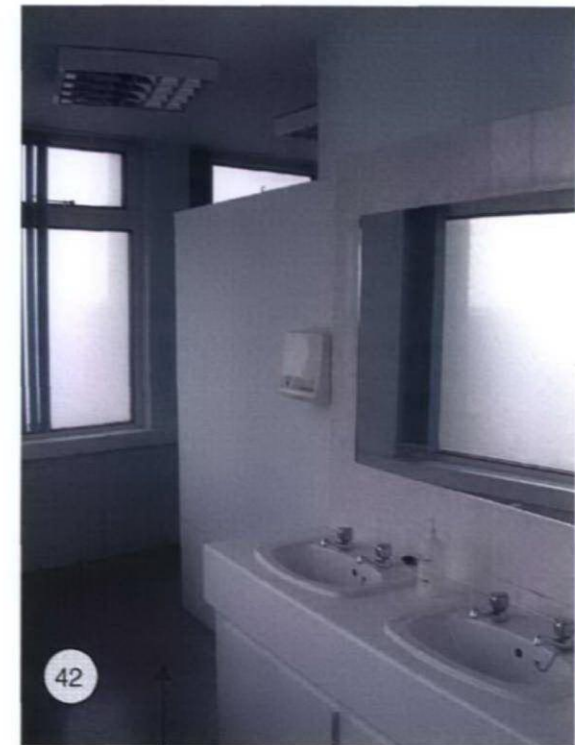
Existing terrazzo to be refurbished and replaced with matching materials where necessary.
