WATERLOW PARK HIGHGATE NI9

RESTORATION OF WATERLOW PARK, HIGHGATE

Terraced Garden Walls, Waterlow Park, Highgate

Report on the condition of the brick terraced garden walls with recommendations for repair, conservation, and reinstatement

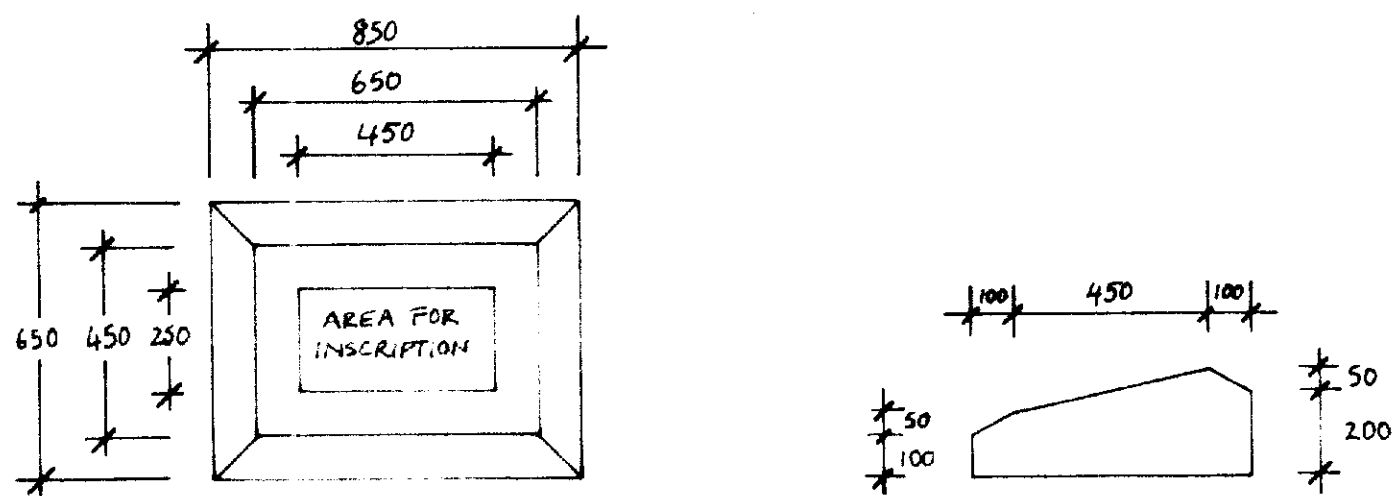
figure 9. Plan and Cross Section of Plaque to be placed at base of Statue

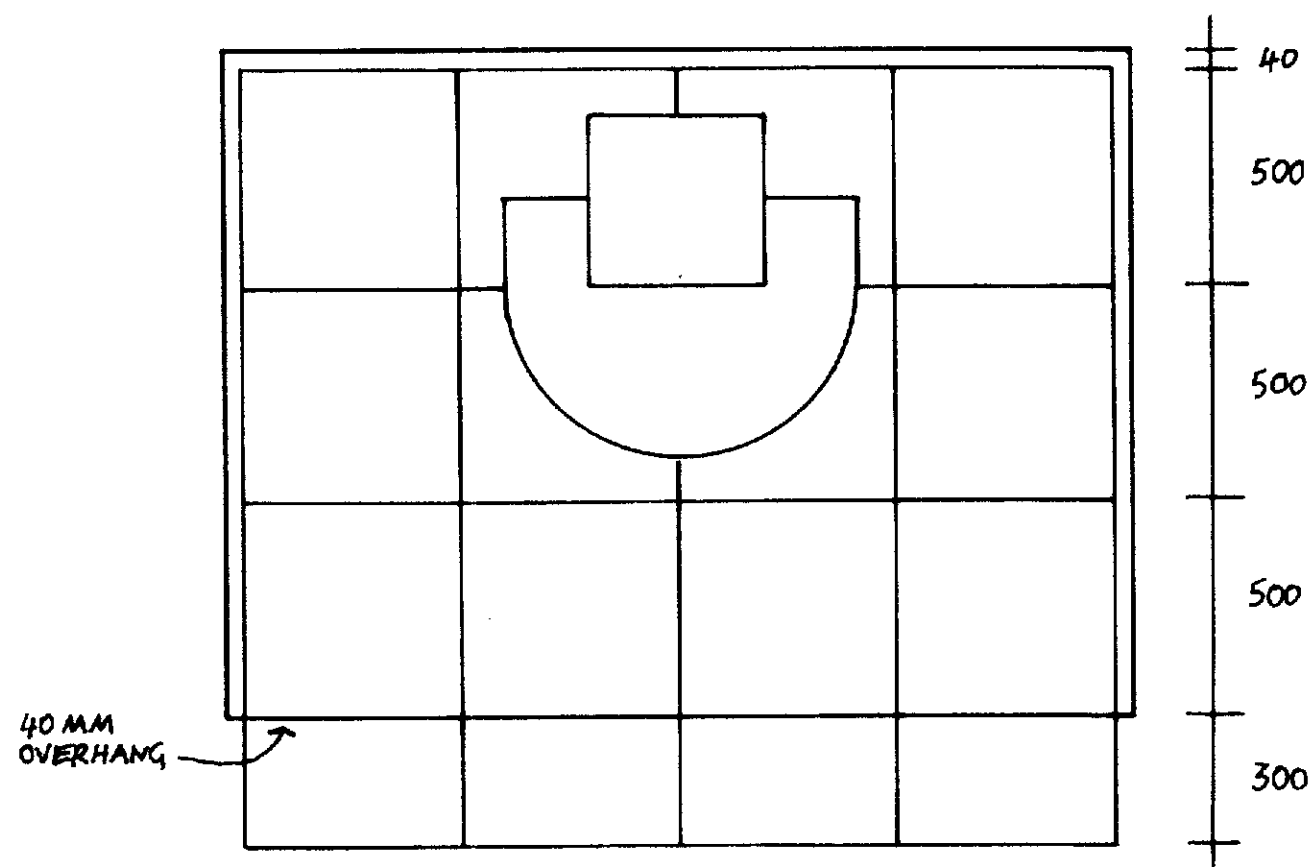
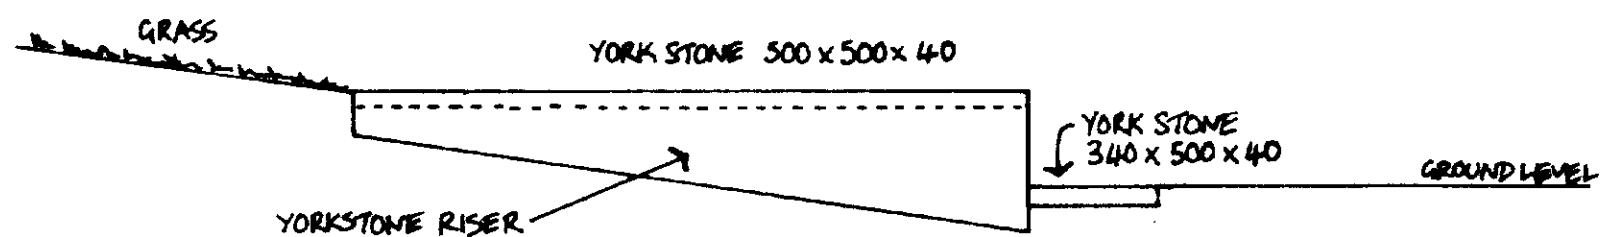
figure 29. Plan and Cross Section of paving proposals to base of cast iron drinking fountain

Sand blast metalwork on cast iron fountain and repaint in gunmetal grey (colour to be approved) insitu.

Unblock Water collection tray at base to ensure no future standing water.

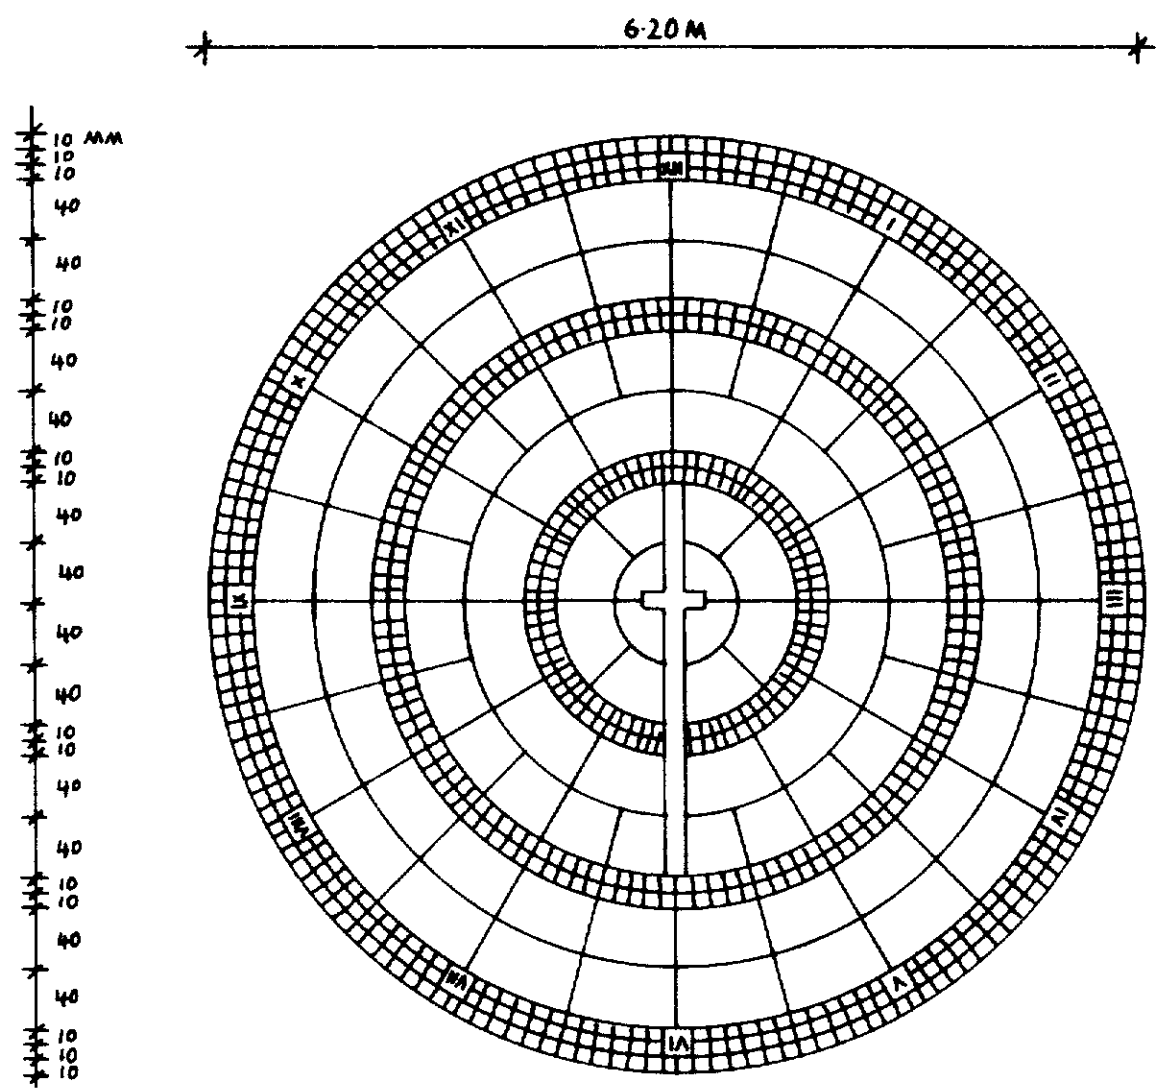
Yorkstone slabs and granite setts with carved detail.

Figure 34. Plan of suggested paving to base of Large Sundial. Detail to be agreed.

Relocate metal sundial to new position as indicated on drawing no. 607 – Masterplan.

See sketch figure 34 for plan of indicative paving proposals to base of Sundial.
