SITE INVESTIGATION FACTUAL REPORT

Report No: 169121
Client: Cunningham Lindsey - Maidstone
Site: 14, Eldon Grove, London
London
Client Ref: 7441220-Mrs E Schneider Goldernberg
Date of Visit: 21/11/2013

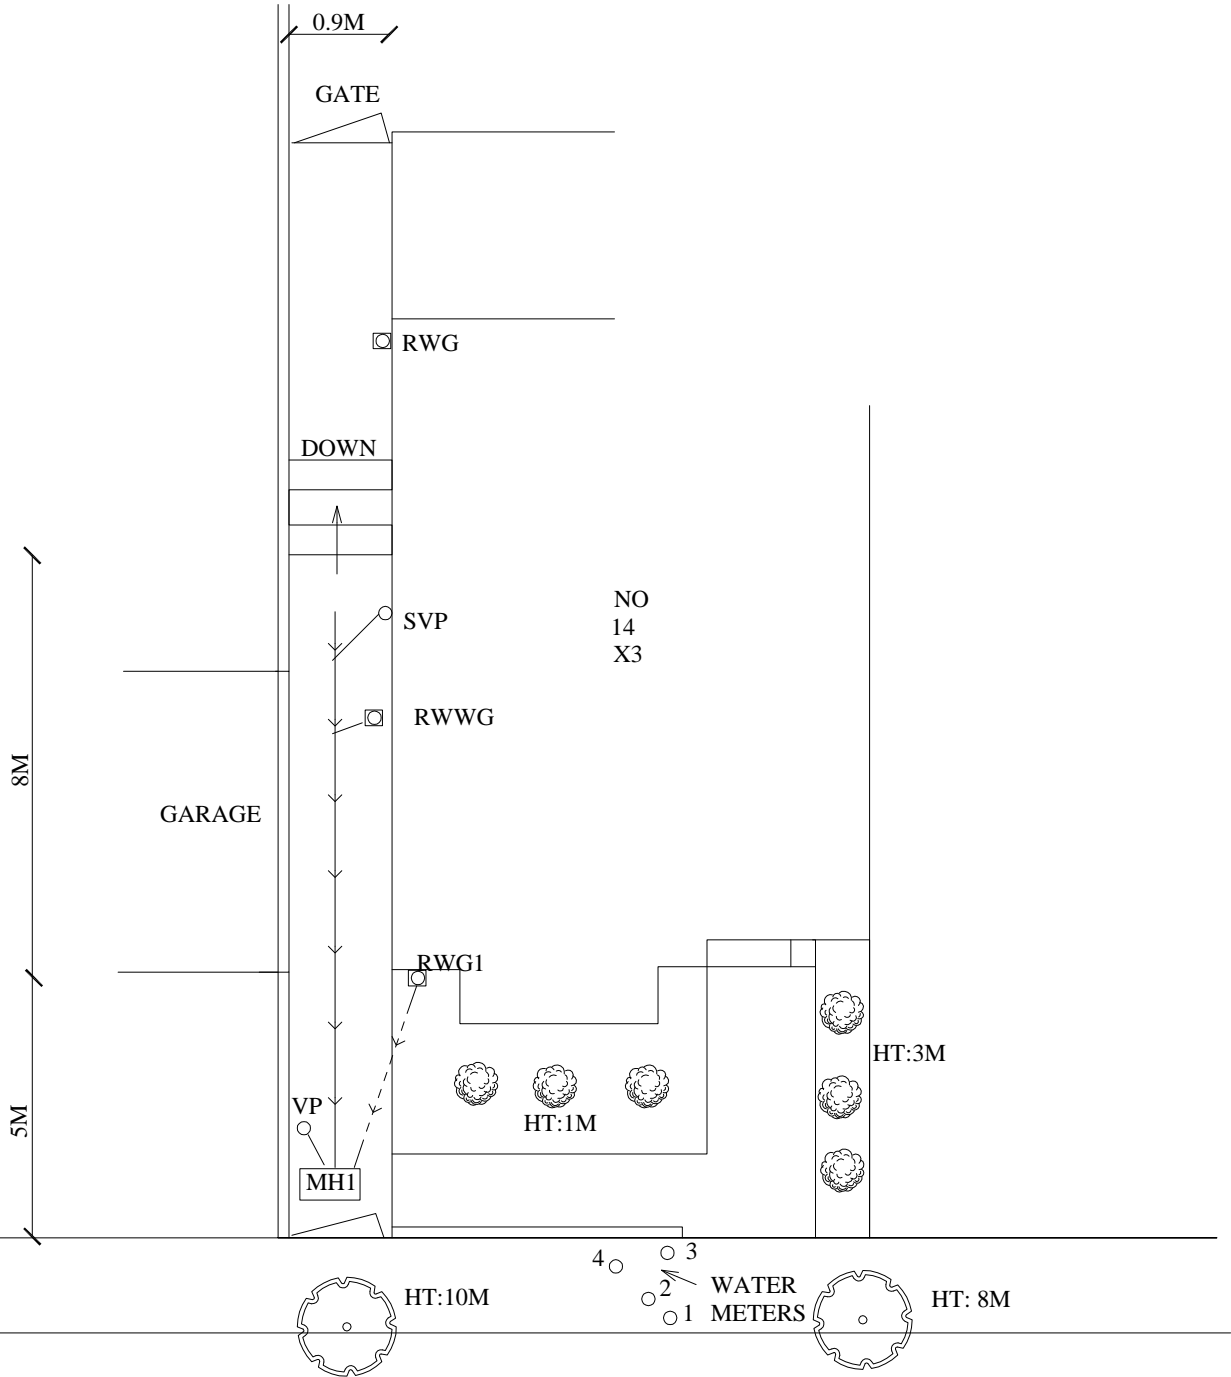
Investigation Layout Plan

Continuouss
movement of top
four water meter
with no sign of
appliances on

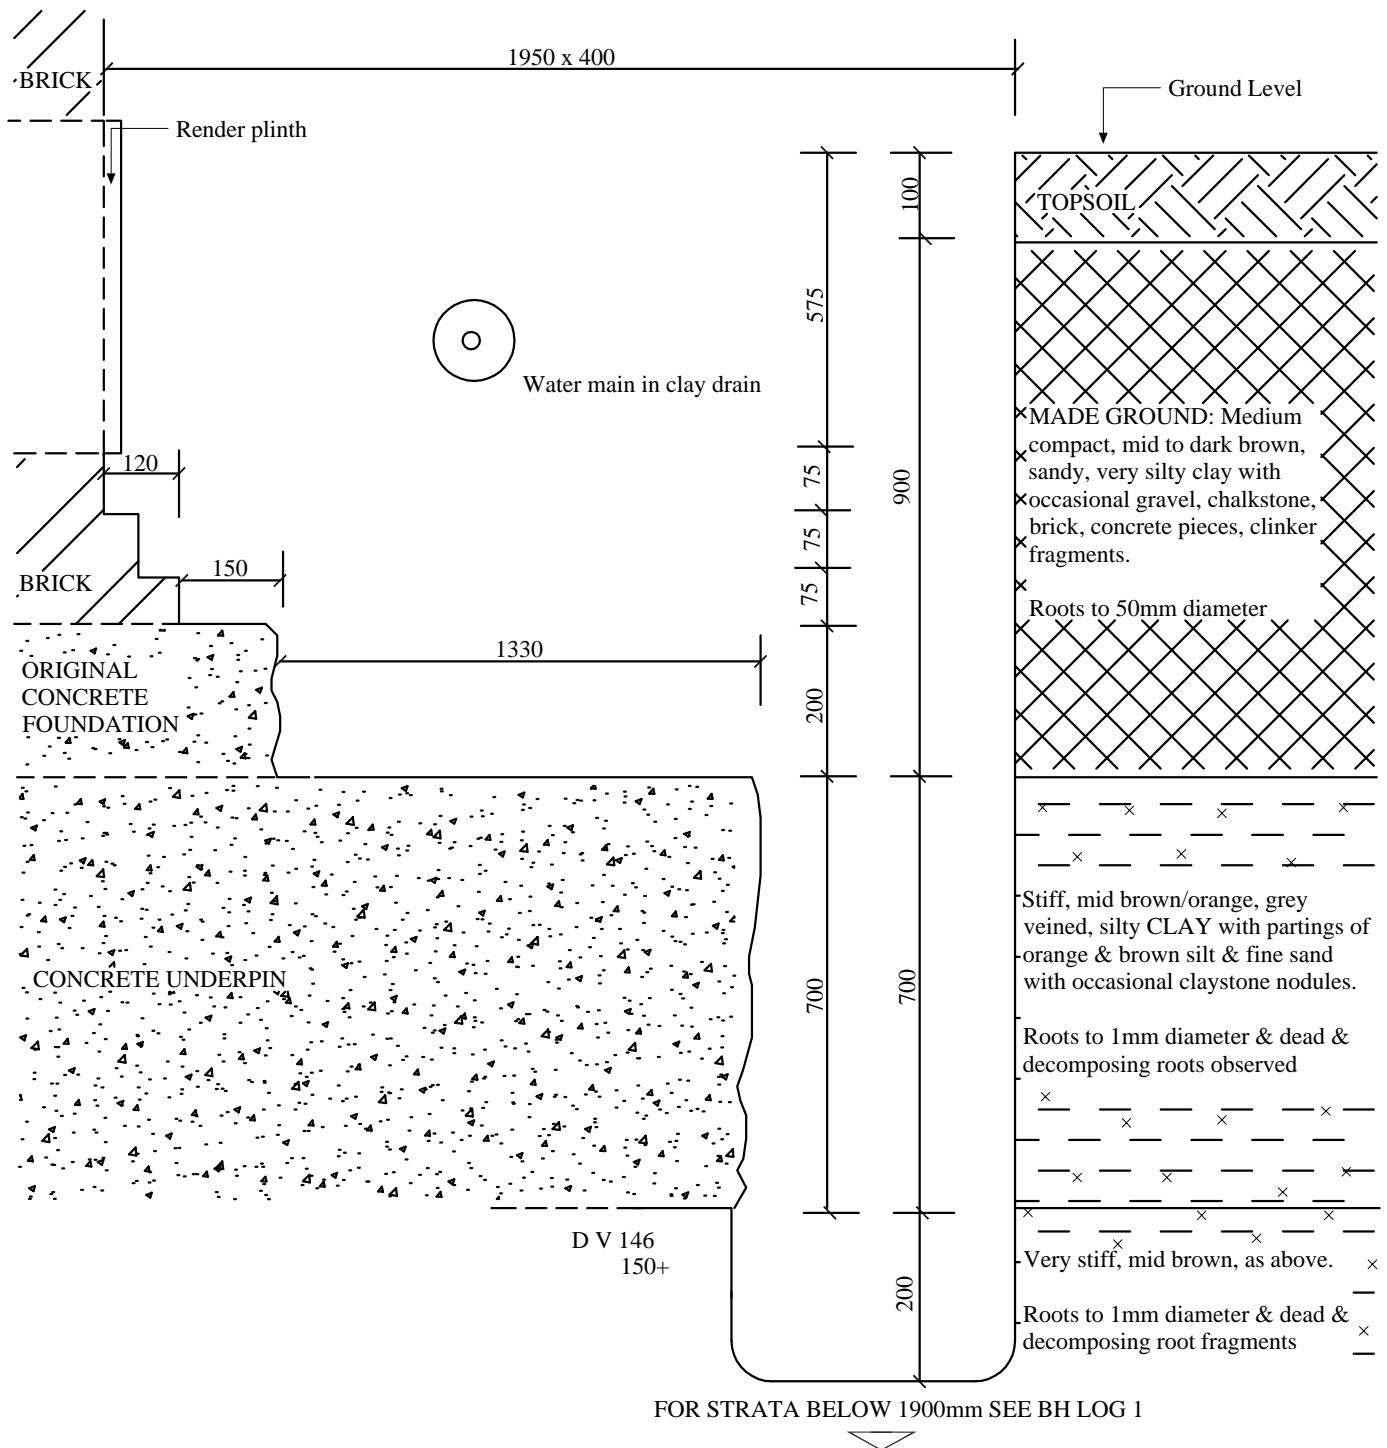
Trial Pit No: 1

Remarks: All measurements in millimetres. Thought to be underside at 1700mm. Curved steel pin hammered 300mm beyond concrete foundation. House and bay foundations are similar depth
