JRT2/5 CHURCH HILL ROAD FOOTBRIDGE

## BRICKWORK REPAIRS

LNE/129588/ECV/DRG/IAB/103

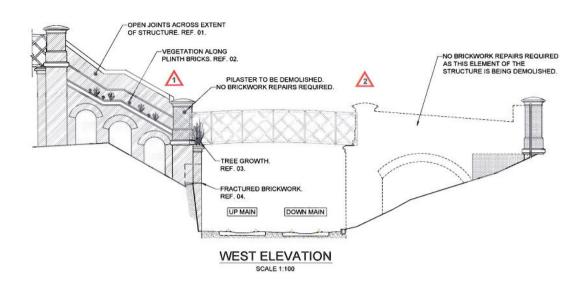
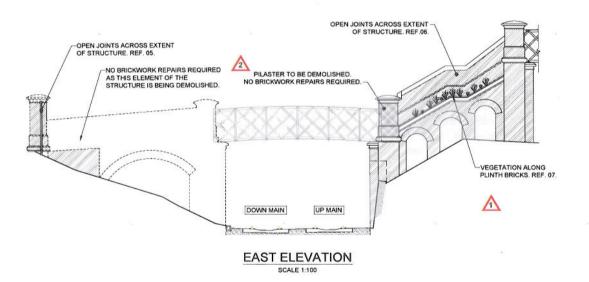
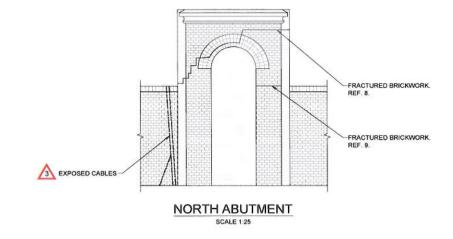
Ref:	Location	Defect	Quantity	Repair Details
01.	West Elevation North Abutment	Open Joints	30m²	Rake out and repoint in accordance with Drawing NR/CIV/SD/101

02.	West Elevation North Abutment	Vegetation Growth	1.5m²	Treat Vegetation with Glyphosate and allow to die off, resulting debris to be removed from site. Resulting open joints to be raked out and repointed in accordance with Drawing NR/CIV/SD/101.

03.	West Elevation North Abutment	Tree Growth	1No.	Treat Vegetation with Glyphosate and allow to die off, resulting debris to be removed from site.
04.	West Elevation North Abutment	Fractured Brickwork	1m	Stitch fracture in accordance with NR/CIV/SD/109

05.	East Elevation South Abutment	Open Joints	4m²	Rake out and repoint in accordance with Drawing NR/CIV/SD/101
06.	East Elevation North Abutment	Open Joints	30m²	Rake out and repoint in accordance with Drawing NR/CIV/SD/101

07.	East Elevation North Abutment	Vegetation Growth	1,5m²	Treat Vegetation with Glyphosate and allow to die off, resulting debris to be removed from site. Resulting open joints to be raked out and repointed in accordance with Drawing NR/CIV/SD/101.

08.	North Abutment	Fractured Brickwork	4m	Stitch Fracture in accordance with Drawing NR/CIV/SD/109
09.	North Abutment	Fractured Brickwork	0.7m	Stitch Fracture in accordance with Drawing NR/CIV/SD/109
