**Internal Renovation Report
28 Tottenham Street
London W1**

**Planning Application For
Listed Building Refurbishment**

June 2014

Norton Ellis Architects
14 Baltic Street
London EC1Y 0UJ
www.nortonellis.co.uk

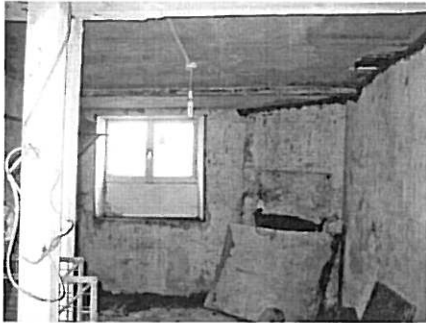
1.1 Existing Walls and Floors

All walls, internal and external, are damaged and have numerous cracks. The existing basement floor is in very poor condition.

Walls are to be repaired and damp-proofed. Then they will be lined with insulated drylining. The floor will be removed and then reinstated with insulation beneath.

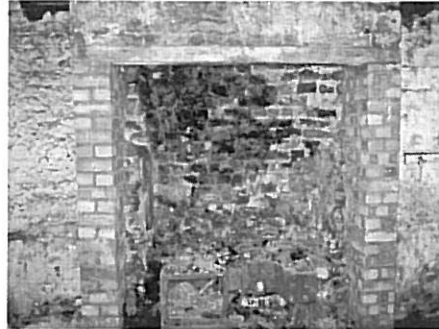
1.2 Existing Fireplace:

The existing fireplace is in a severe state of disrepair. The stove is broken into many pieces and is unrecoverable.

The fireplace opening is to be retained and repaired, and integrated into the refurbished retail unit. The severely damaged stove will be removed completely.

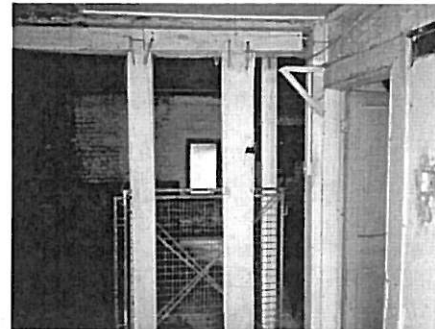
1.3 Existing Structural Support Columns:

New structural elements have been added to the basement over time.

Structural elements that are original are significant features and will be preserved. More recently added beams and columns will be removed and replaced as part of an overall strategy to strengthen the building. The new partition to the proposed stair lobby will remain in its original position.

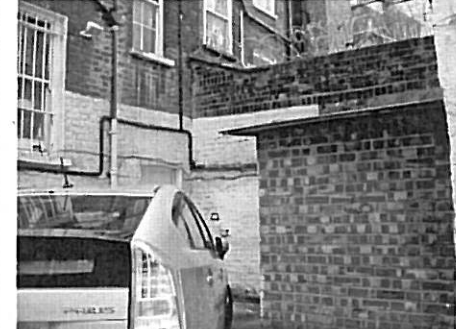
1.4 Existing External WC

The WC block at the rear corner of the former yard has been extended with a modern fletton brick section at the front.

The external WC block will be completely demolished.

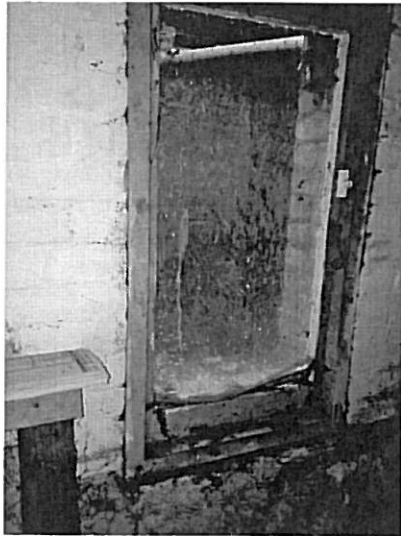
1.4 Existing Windows:

A small timber window to the vaults is in very poor condition. Originally, there were two windows into the light well, which have since been closed up.

The scheme seeks to return to the original plan form of the Georgian terrace, by opening up the basement to the light well. The original windows will be reinstated and taken down to skirting level. This will create more usable commercial space, and will return the building to its historic use. They will also improve natural light levels.

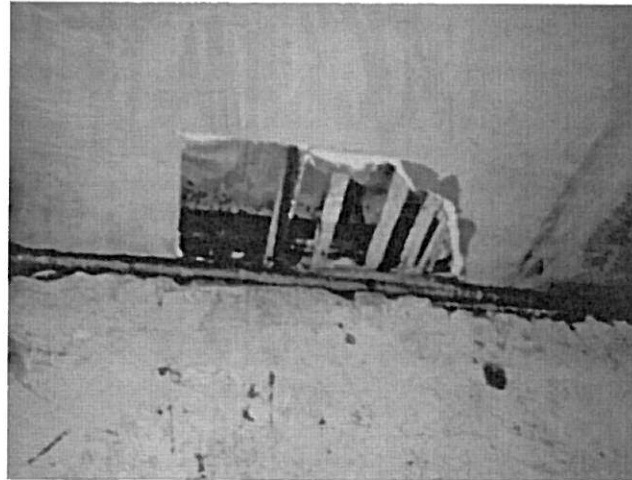
1.5 Existing Ceiling:

The ceiling in the basement is badly damaged, almost beyond repair.

The proposal will retain as much of the existing structure as possible. Where replacement of the ceiling is required, it will match the materials and details of the original building.

A new opening will be made in the ceiling for a new accommodation staircase.

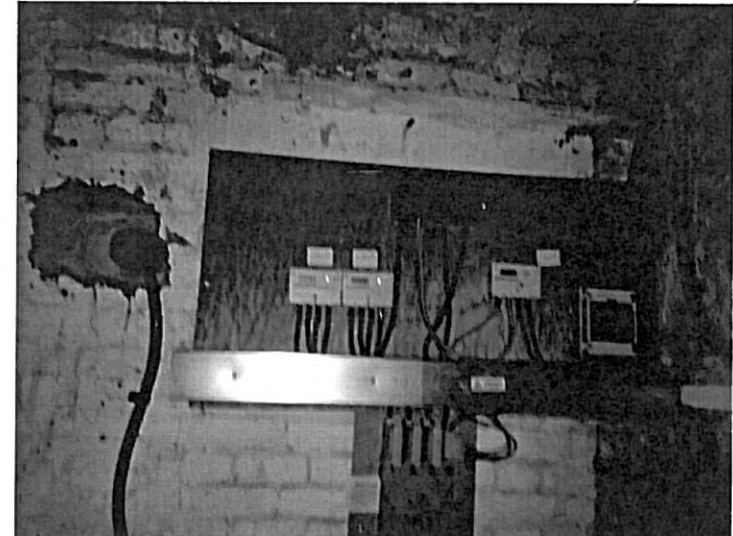
1.6 Existing Electrics:

The electrics are currently obstructing access to the vaults.

We will re-position the electrics on the side wall to allow access to the vaults and open up the space. The building works require up to date wiring and plumbing facilities. These works have the potential to create numerous small interventions into the historic fabric both in the stripping out of old defunct facilities and in reinstating the new elements. All works of this nature will be carried out with care to ensure that interventions into fabric are minimised and that wherever possible pre existing openings are reused, including within floor voids.

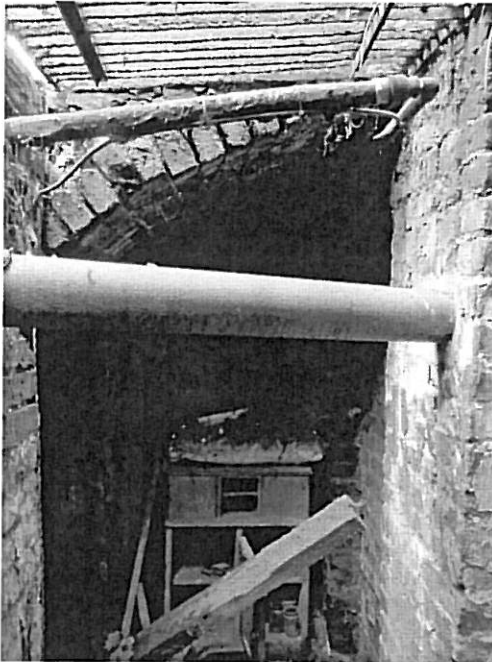
1.7 Existing External Lightwell:
Currently the external lightwell is obstructed by service pipes and is in a poor state of repair.

The services will be carefully re-routed where possible to minimise damage to decorative features. Any repairs will use materials relevant to the period, including cast iron for gutters and down pipes. Brickwork is to be repaired.

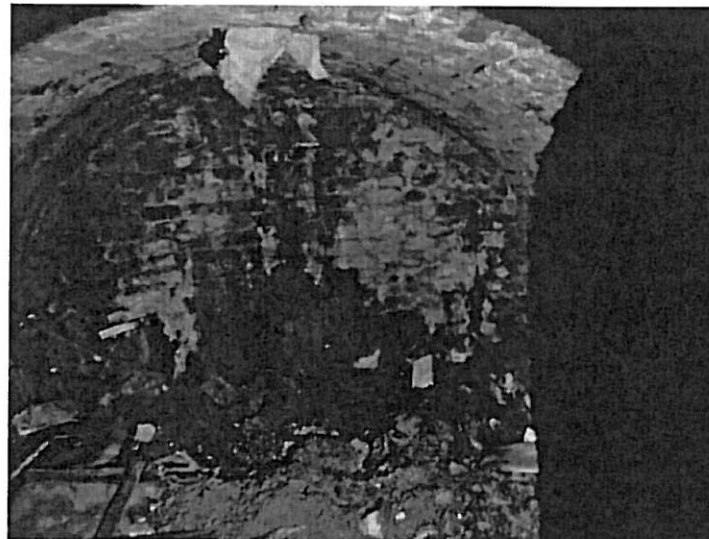
1.8 Existing Vaults:

The vaults have strong historical significance. However, they are in poor condition and cannot be used in their current state. The condition of brickwork in the coal store is poor, and timber doorframes suffer from dry rot.

The existing vaults are to be retained. Non-destructive techniques will eradicate dry rot. New methods of natural ventilation are suggested with minimal works to the existing building. Low-key repairs to bowed or cracked brickwork are proposed to prevent the progressive dismantling of structure.

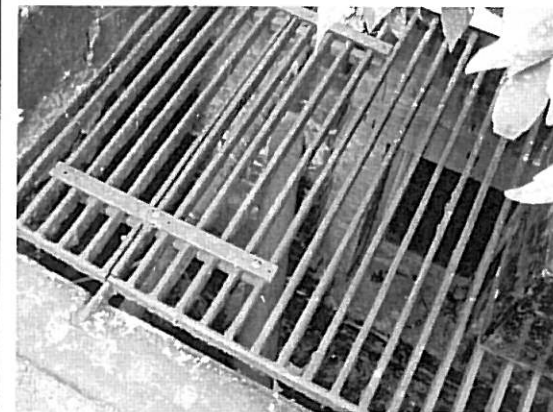
1.9 Existing Grille:

The grille to the external lightwell currently presents a health and safety issue. It is not possible to walk directly in front of the shop window to view goods on offer.

The scheme proposes to remove the grille and replace it with pavement lights. This will address the health and safety issue. Furthermore, it will be in keeping with the many other pavement lights along the street and will encourage people to come closer to the shop front, to view goods on offer and thus improving the use of the building.

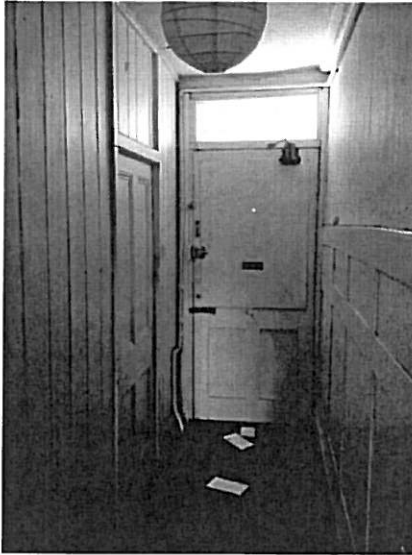
2.1 Existing Entrance

Wainscot and panelling line the entrance hallway. Much of it is in poor condition.

All elements of wainscot and panelling are to be retained and repaired.

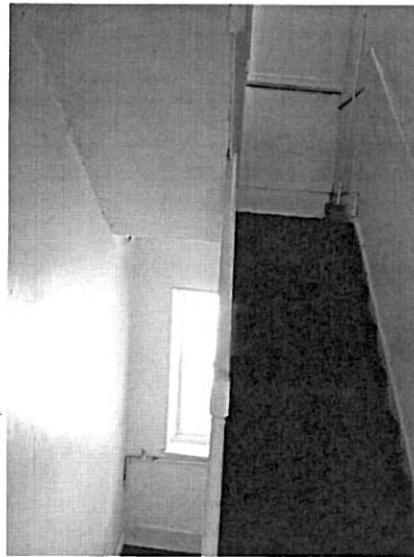
2.2 Existing Staircase

The staircase is currently unsafe, but represents a key historical feature of the existing building.

It is to be retained, repaired and stabilised to ensure it is safe to use. Investigation works will need to be carried out to assess how much stabilization will be required to make the staircase fully usable.

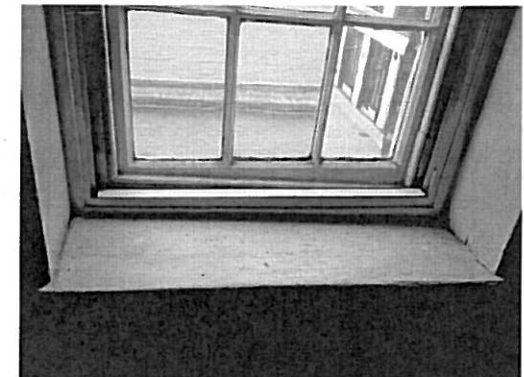
2.4 Existing Staircase Windows

The existing windows to the staircase are in a poor condition.

The existing windows will be retained and repaired, and where appropriate, details will be reinstated to their original pattern.

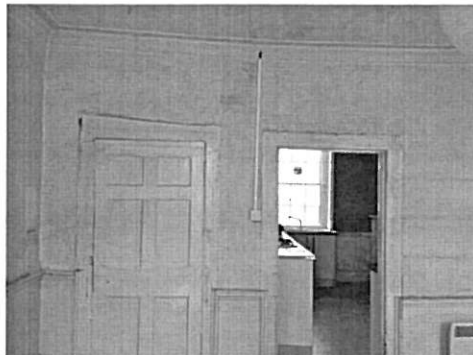
3.1 Existing Doors & Frames

The photograph illustrates a typical doorway and architrave which is badly damaged.

The proposal is to repair and protect these features from future damage as much as possible. Infill pieces of framework will be removed, and the door adjusted to suit the opening.

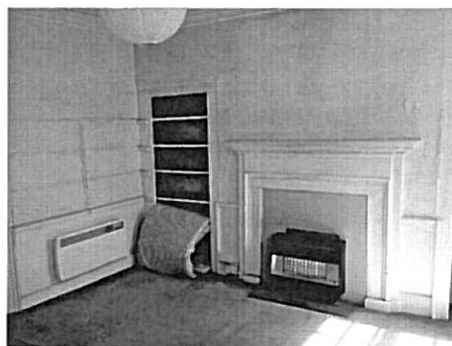
3.2 Existing Storage Heaters & Fireplaces

There are wall mounted storage heaters on the first, second and third floors. These detract from originally panelling and are not original features of the building. The fireplace on the first floor is in slightly better condition than others in the property, however it is still in need of repair.

All storage heaters will be removed. Plasterwork which is then exposed will be repaired. Fireplaces will be repaired on all floors.

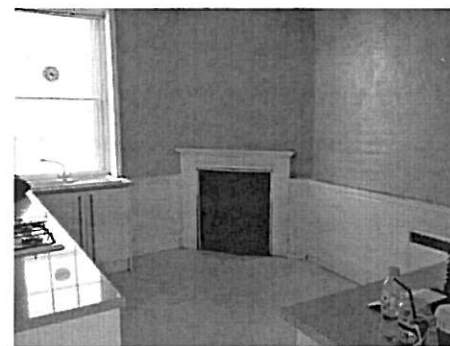
3.3 Existing Kitchen Units

Kitchen units, added recently, do not contribute to the historic value of the building.

The kitchen units are to be removed. The fireplace surround will be removed if not original, and replaced with a simple surround. The provision of modern bathroom/kitchen facilities within the building is necessary to make the property attractive to future residents.

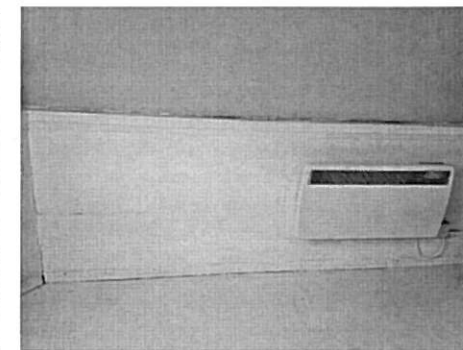
3.4 Existing Wainscot

Most of the wainscot is in place to the first floor rooms (except at the front façade)

Wainscot will be repaired and preserved.

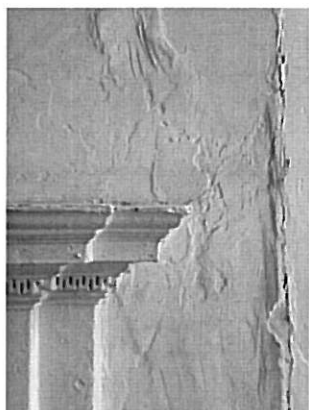
3.5 Existing Plasterwork

The plasterwork contributes strongly to the building's historic significance. However, it has been severely damaged over time.

Disturbed and damaged areas of plasterwork will be repaired to match the original.

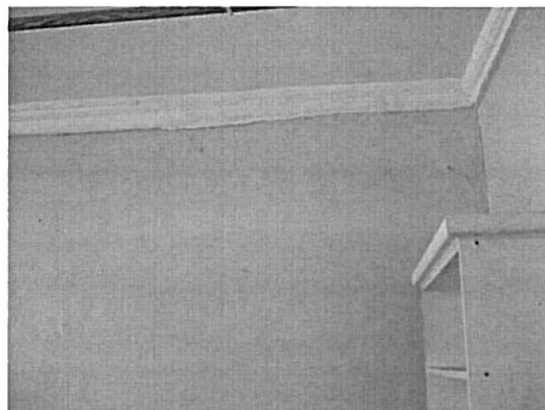
3.6 Existing Cornice

This photo illustrates the poor condition of cornices throughout the property.

The scheme proposes to retain as many existing cornices as possible. New sections of cornice will be introduced where previously located using moulds of the existing, these will retain the current appearance of the cornices i.e they will not be stripped back to reveal crisp and clean features. A new simple cornice will be fitted along the wall at the front façade.

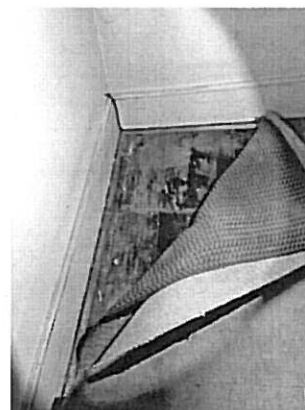
3.7 Existing Floor

There is a major bow in the floor at first floor level, especially to the front reception room.

The floor will be levelled to some extent. This will take the form of packing on top of the existing joints. A method statement will be produced outlining the appropriateness of techniques and sequence of works proposed to re stabilise the floor. Existing floor boards will be retained and re-used where possible. See Heritage Statement 4.7

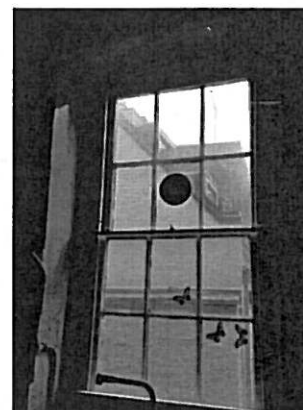
3.8 Existing Windows

The windows on the rear façade of the property are in particularly bad condition. Windows on the front façade still require some repair work.

The windows throughout the first floor will be retained and repaired.

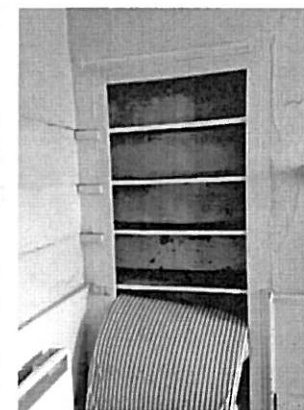
3.9 Existing Shelving

Cupboard doors have been removed from shelves at the rear of the room. Shelving at the front of the room is in poor condition and need of repair.

Cupboard doors will be reinstated and shelving repaired.

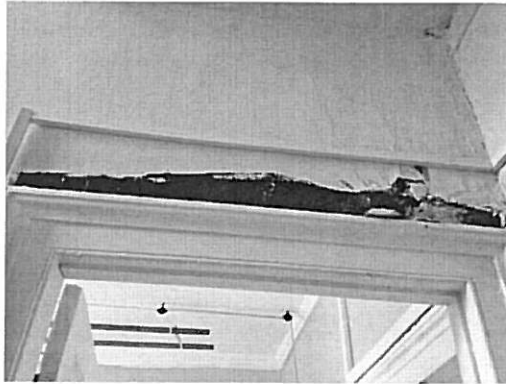
4.1 Existing Door Frames

The door frames are distinctive features of the original building, however, they have become badly damaged. In some cases the frameworks and architraves have been completely destroyed, including the surrounding plasterwork.

Door frames and architraves will be repaired, retained and reinstated. Where they become redundant they will be maintained as dummy doors, where they can still contribute to the architectural or historic interest of the building.

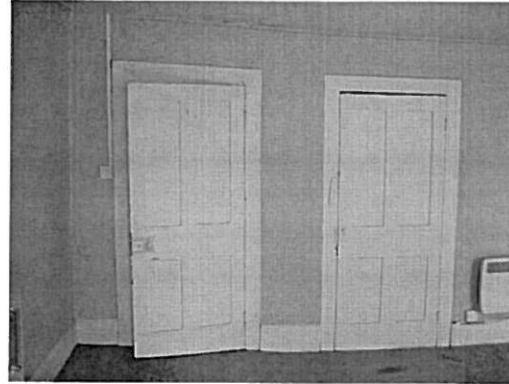
4.2 Existing Doors

This photo illustrates one door (left), which cannot be closed due to the bow in the floor.

To create habitable space, the doors and floors will be repaired with minimal structural alteration. This may include raising the doorway so that it can close properly.

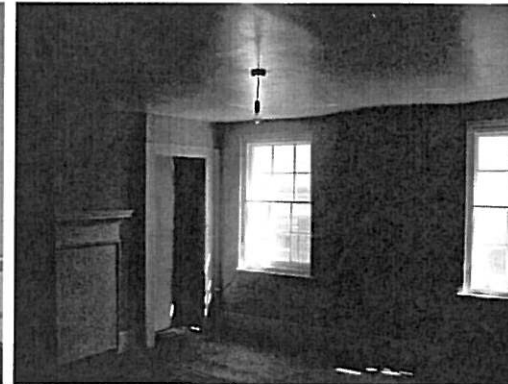
4.3 Existing Floors

Floors are severely bowed and this is particularly severe on the second floor to the front reception room.

The floor will be levelled to some extent. This will take the form of packing on top of the existing joints. A method statement will be produced outlining the appropriateness of techniques and sequence of works proposed to re-stabilise the floor. Existing floor boards will be retained and re-used where possible. See Heritage Statement 4.7

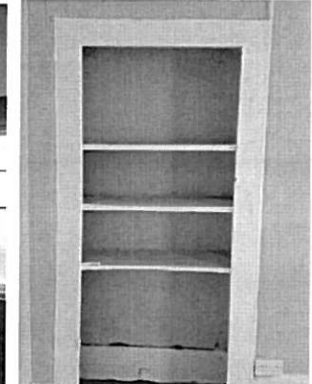
4.4 Existing Shelving

Existing shelving is in poor condition. Originally there would have been a cupboard door to the shelves. As the front of the room, shelving has been removed.

Cupboard doors will be reintroduced. Shelving will be reinstated where it has been removed.

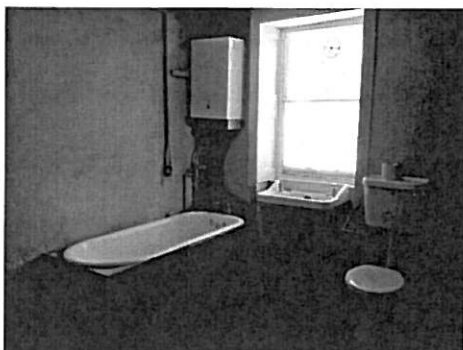
4.5 Existing Sanitaryware

The existing sanitary fittings are in poor condition.

WC and bath will be removed, however, the sink will be retained and used in the new bathroom.

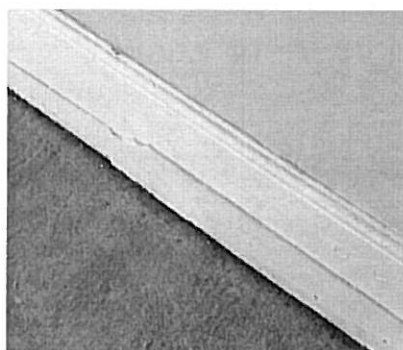
4.6 Existing Walls & Skirtings

The plasterwork is in poor condition and is 'live' in some areas. Skirting boards are in very poor condition, and as illustrated here, poor attempts at repairing them has damaged their original appearance.

Loose & damaged areas of plasterwork will be repaired to match the original. Non-original skirtings will be removed. Damaged portions of existing skirting will be repaired. New skirtings will be provided throughout where necessary, to match existing.

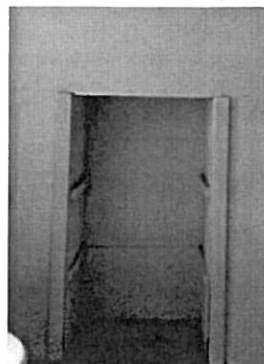
4.7 Existing Fireplaces

The fireplace in the bathroom has been removed. The fireplace in the front room is in better condition but still requires repair work.

The fireplace to the rear will be reinstated in an appropriate manner. The front fireplace will be retained, repaired and preserved as a key historical asset. It is not expected at this stage that either fireplace will be in working condition.

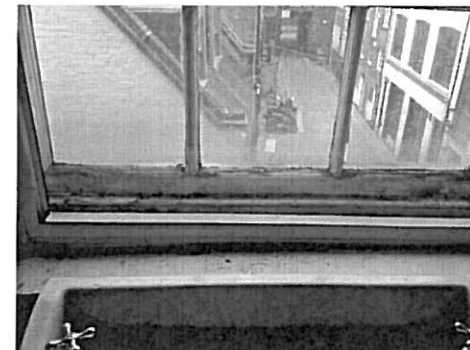
4.8 Existing Windows

The windows on the rear façade of the property are in particularly bad condition. Windows on the front façade still require some repair work.

The bathroom window will be repaired, retaining historic cill and lintel details on the exterior. The windows throughout the second floor will be retained and repaired.

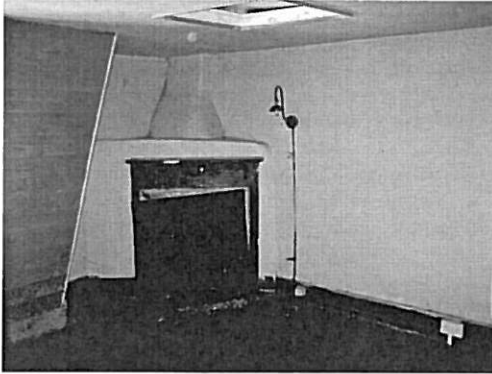
5.1 Existing Fireplaces

Both of the fireplaces and their surrounding plasterwork are in a deteriorated state.

The proposal will repair and retain the fireplaces in position, with minimal alteration. It is not expected at this stage that either fireplace will be in working condition.

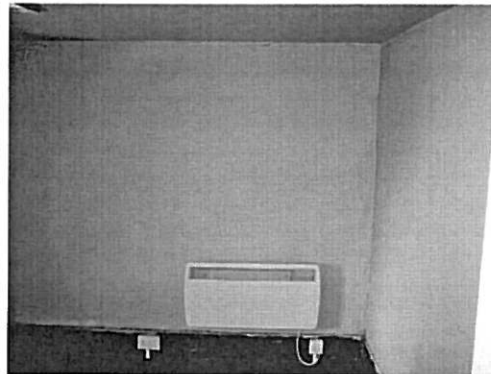
5.2 Existing Skirtings & Cladding

Skirting boards are in very poor condition throughout this level, and as illustrated here, poor attempts at repairing them has damaged their original appearance. 'Modern' timber cladding has been fixed to the rear mansard as shown in item 5.3.

Non-original skirtings will be removed. Damaged portions of existing skirting will be repaired. New skirtings will be provided throughout where necessary, to match existing. Timber cladding will be removed and the plasterwork will be reinstated.

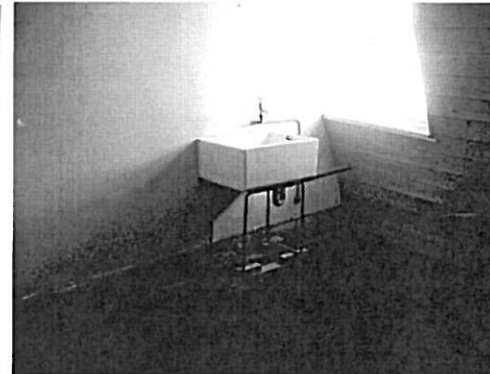
5.3 Existing Sanitaryware

Sanitaryware is in very poor condition. This sink has a base supported by bare bricks.

The sink will be removed, plus all associated pipework. Refer to plan layouts for new sanitary accommodation throughout.

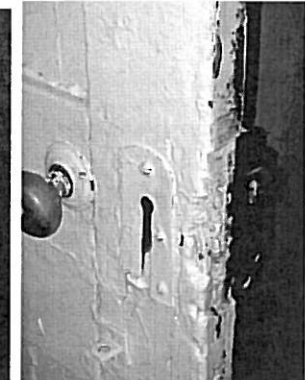
5.4 Existing Doors

This photograph illustrates how the doors have become damaged over time.

Doors will be retained but restored and repainted to an acceptable condition.

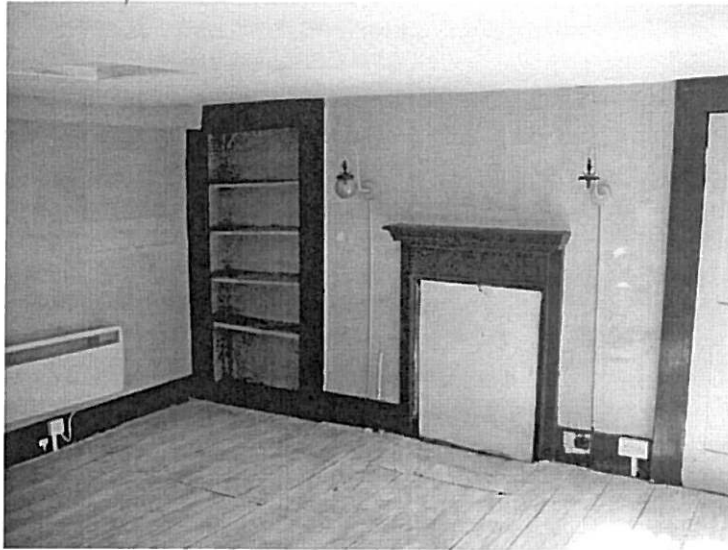
5.5 Existing Joinery

An extensive bow in the floor has affected the adjacent joinery.

Shelving and other joinery will be carefully repaired to match the original, reusing original mouldings and decorative features.

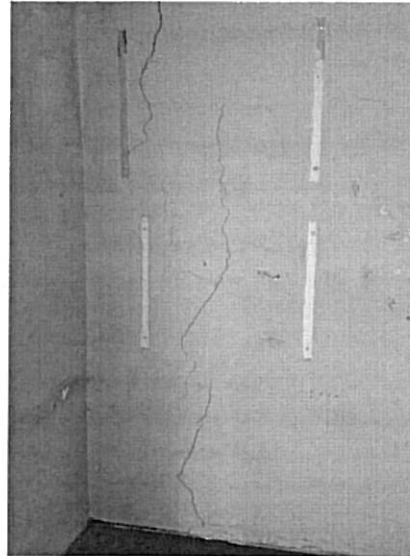
5.6 Existing Plasterwork

This photograph further illustrates the large amounts of cracking to plasterwork.

All plasterwork will be repaired to match the original.

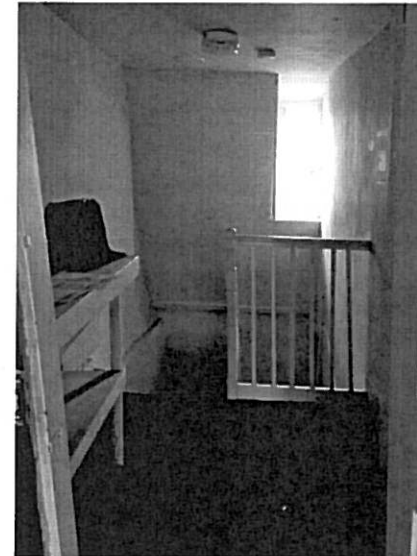
5.7 Staircase Wall

From the outside this is a strange section of wall where the mansard roof runs down, the neighboring property is set well back from this and has a parapet so this section of wall is a little unusual and isolated.

This section of wall will be evened out, in order to lessen the disorientating' effect of the uneven stairs.

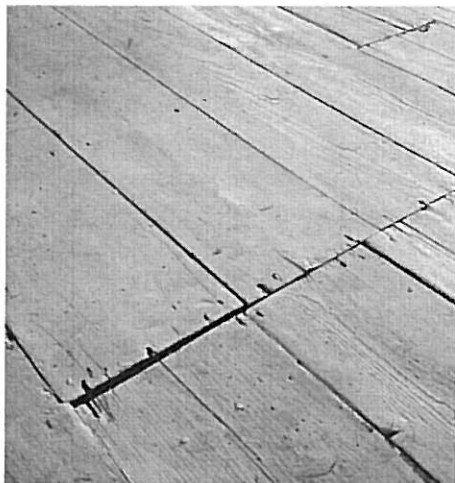
5.8 Existing Floorboards

The original floorboards are a fundamental characteristic of the Georgian Terrace. They are in acceptable condition but require some repair work.

The floorboards will be cleaned and refurbished to bring new life to the listed building. The floor will be levelled to some extent. This will take the form of packing ontop of the existing joints. A method statement will be produced outlining the appropriateness of techniques and sequence of works proposed to re stabilise the floor. Existing floor boards will be retained and re-used where possible. See Heritage Statement 4.7

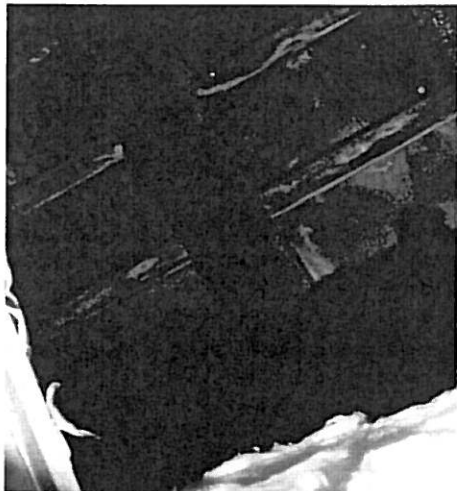
5.9 Existing Roof Timbers

Some of the roof timbers have been badly damaged in a fire.

Burnt roof timbers will be replaced to make the building safe to inhabit and extend its life.

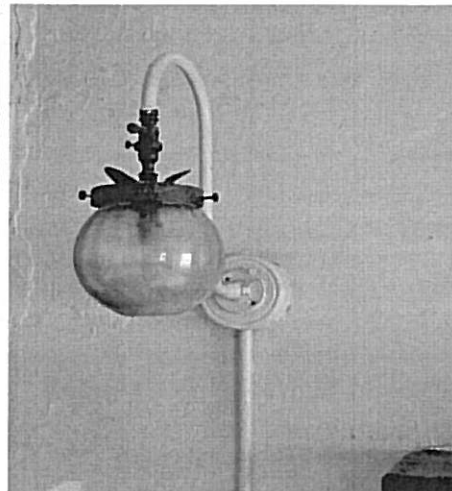
5.10 Existing Gas Lamps

Gas lamps in the third floor front room are some of the most significant historical features of the property to be retained. Only one has its glass shade.

The gas lamps will be carefully protected from surrounding works. They are to be retained, together with any associated details. Gas lamps are some of the most historically important original features of the building. These will be repaired and protected from future damage during the course of works on site. They will be wired to enable use as safe lighting.

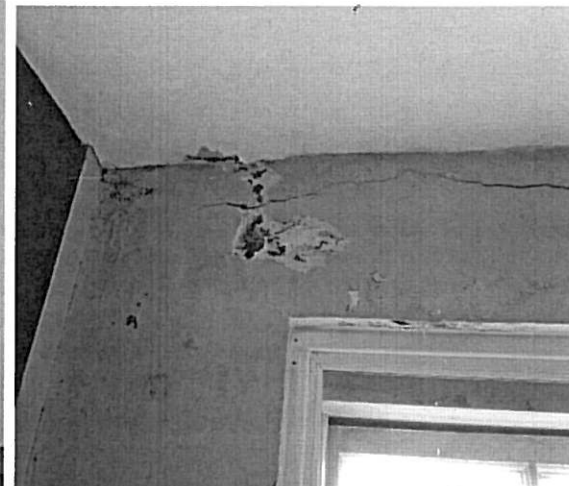
5.11 Existing Windows

The windows and surrounding plasterwork are in poor condition.

Retain and restore all windows to their original state.
