*NHR Joinery Ltd*

**1-2 LINCOLNS INN FIELDS**  
**STAIRCASE CONDITIONS REPORT**  
**(SURVEY DATE 6<sup>th</sup> MAY 2014)**

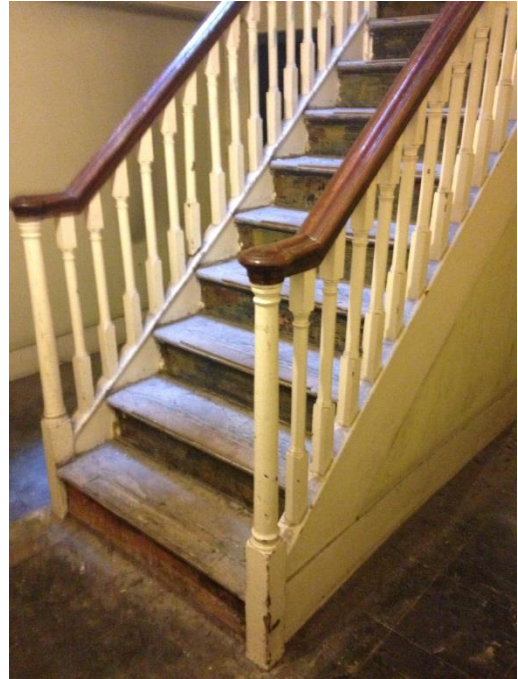
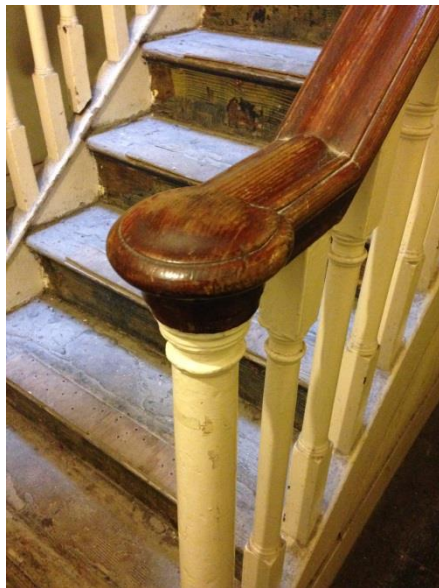
The staircase is complete with no missing components. The staircase shows signs of wear and tear. This would be expected considering the age of the building but these defects are superficial and should not raise concern.

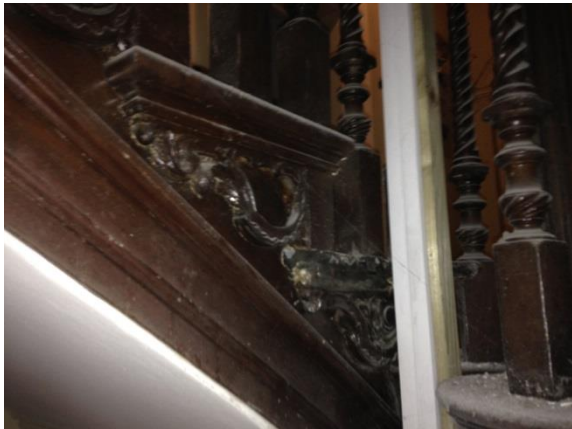
Figure 1

There are 6no carved brackets to the inner cut string including the tread nosing returns. The second bracket up has carved sections missing and would require attention (Figure 1)

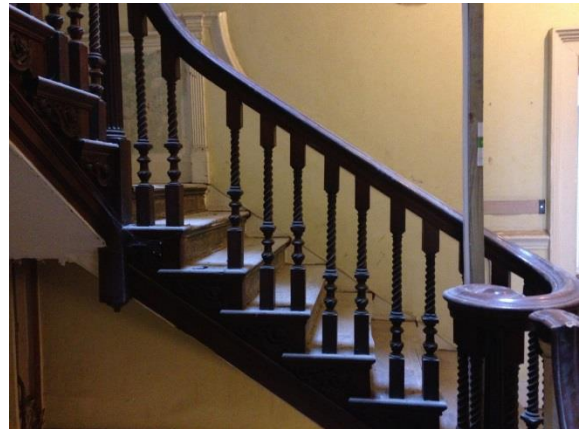
Figure 2

18no existing balusters in position with 1no baluster missing on the 5<sup>th</sup> Tread and would require a replacement (Figure 2)

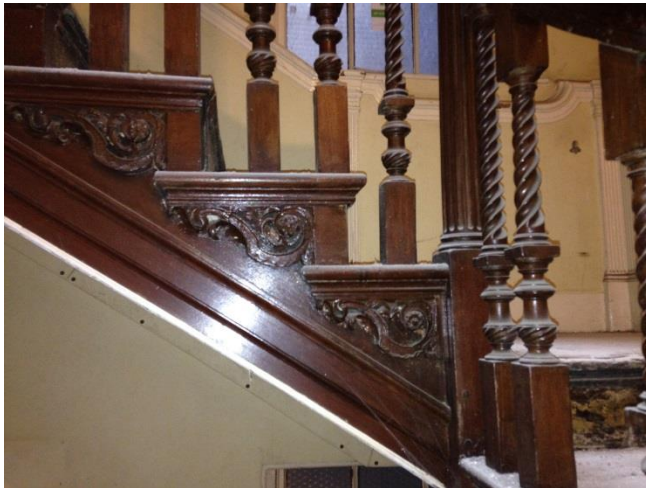
**Figure 3**

There are 6no carved brackets to the inner cut string. The first bracket has sections missing and requires attention (Figure 3)

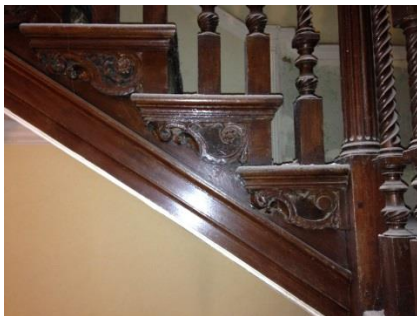
**Figure 4**

There are 4no carved brackets to the inner cut string. The first and second brackets have sections missing and require attention (Figures 4) The carved bracket to the landing also requires attention (Figure 5)

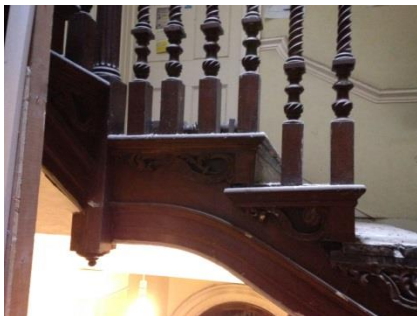
**Figure 6**

There are 2no carved brackets to the inner cut string and 2no landing brackets. The second bracket and both landing brackets require attention. Tread return nosing is missing on first tread and is loose on the second tread (Figure 6 & 7)

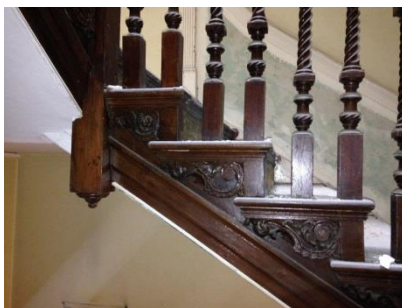
Figure 8

There are 7no carved brackets to the inner cut string with the first, second, fourth, fifth and sixth brackets all having sections missing and all requiring attention (figures 8 & 9)

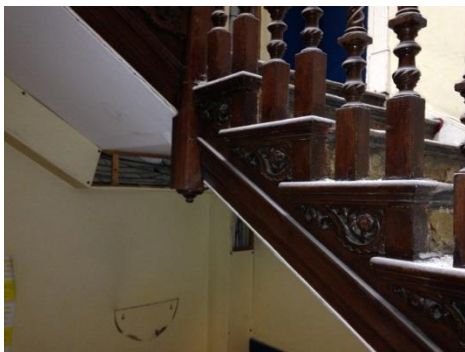
**Figure 9**

There are 6no carved brackets to the inner cut string with the second and third brackets all having sections missing and all requiring attention. Loose nosing return on tread no2 (figures 9& 10)

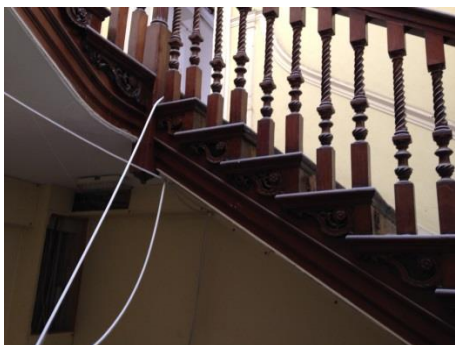
**Figure 11**

There are 7no carved brackets to the inner cut string with the third, sixth and seventh brackets all having sections missing and all requiring attention (figures 11 & 12)

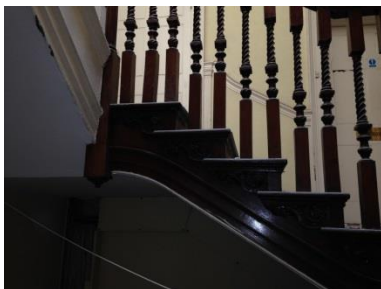
**Figure 13**

There are 3no carved brackets to the inner cut string and 2no landing brackets. The third bracket and both landing brackets having sections missing and all requiring attention (figures 13 & 14)

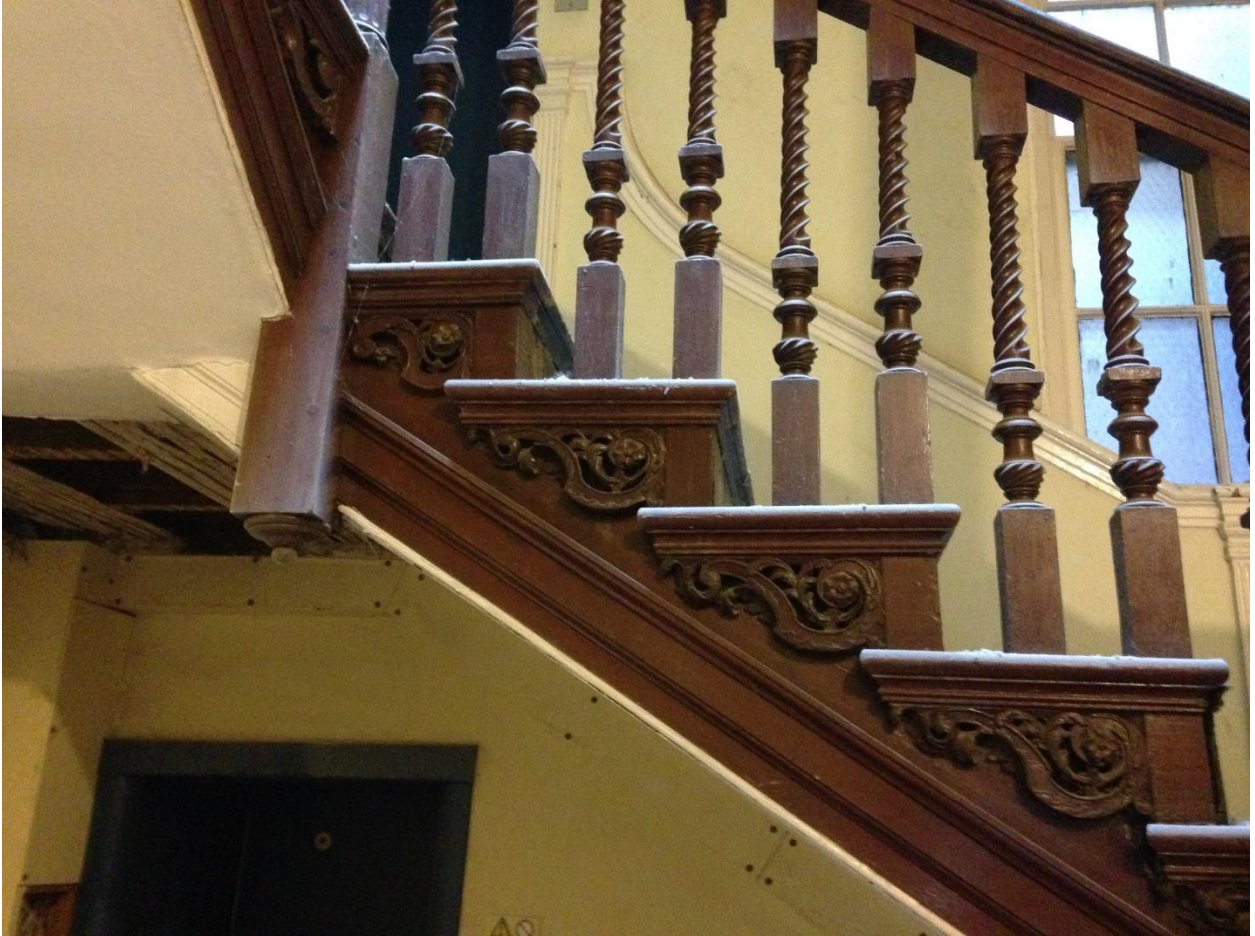
4. Drill out draw dowels to newel post/cut string tenon junction in order to remove flight. As noted in the photograph below the tenon may have to be sacrificed for the flight removal.
