6 Holly Lodge Gardens, London N6 6AA

BS5837:2012 Tree Survey

Elizabeth Greenwood CMLI, F. Arbor A.

September 2012 as amended

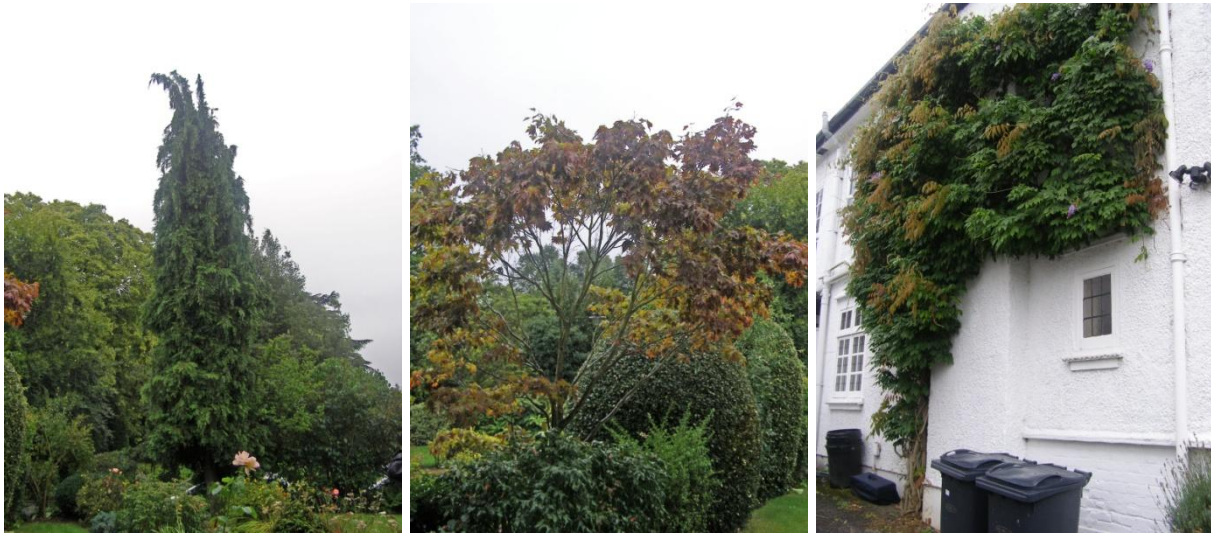
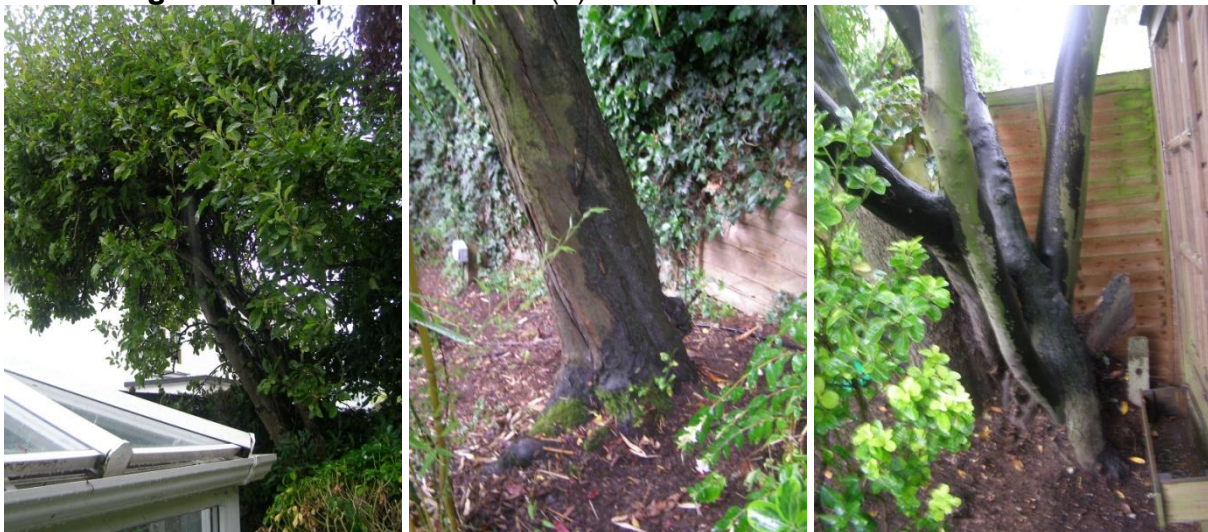
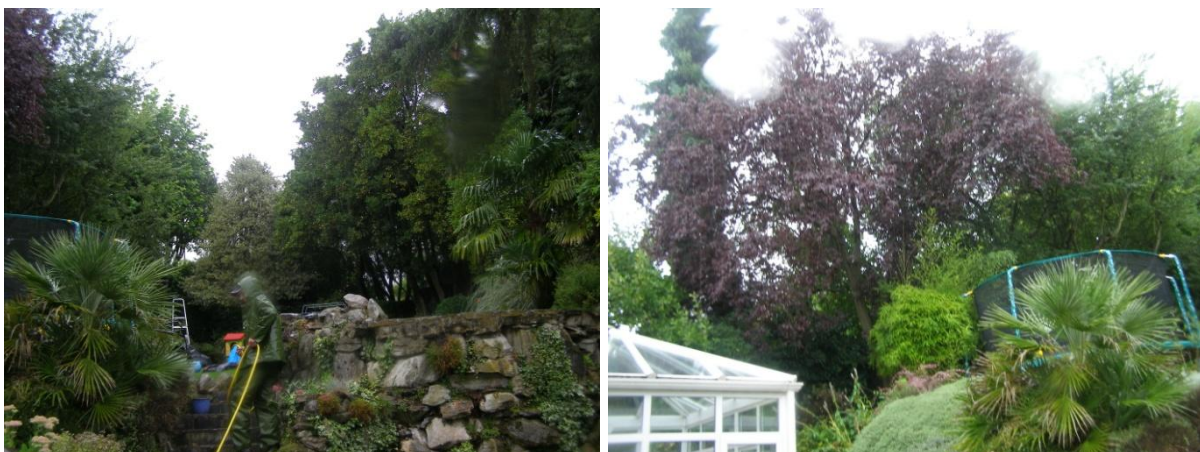
- 5.1 Within the front garden there is a Lawson's cypress (1) planted near the path which has twin stems and has been reduced; re-growth has subsequently occurred within the upper crown. A small multi-stem Japanese maple (2) is growing on the western shrub border- These trees are of no particular value, although retention of trees within the front garden does contribute to the ambiance of these properties.
- 5.2 In a small planted bed close the house a mature wisteria (3) is secured to the western elevation of this building. If removed there may be scope for planting of new climbing plants on this elevation.
- 5.3 Close to the rear of the house and growing on a bank there is an mature apple tree- it leans over the building with a tight fork at the divided trunk at 500mm. Its crown

overhangs the building but at 4.5 metres in height with decay within the trunk and laterals. Its presence is unlikely to be a constraint to development.

- 5.4 Consistent with early twentieth century planting the mature purple leaved plum (5) has a twisted trunk and decayed branch stubs from branch removal. It has a 4.25 metre radius root protection area however it is noted that its prognosis is limited. It is likely it was a grafted tree on the root stock of a cherry plum. The adjacent single and multi-stemmed cherry plums (6 and 7) could have formed from suckers and the root stock of this or another grafted trees. At 10-12 metres in height they form a low level screen between garden, although they contain defects within their branch structure. All three trees would be assessed as of 'C' quality with limited prognosis.

Above left- the cultivar Lawson cypress (1) within the front garden **Above right-** the Japanese maple(2) **Above right** the climbing wisteria notated on this survey(3). **Below left and centre-** the apple (4) leaning over the building with a leaning trunk and enlarge buttress roots. **Below right-** poor structure of the two cherry plans (6 and 7) possibly re-grown from root stock of grafted trees. **Bottom left-** the terraced garden with retaining wall. **Bottom right-** the purple leaved plum (5)

Tree no	. Species	Management recommendations
1	Lawson cypress	Reduce to retain its existing size and control its growth
4	Apple	remove
5	Purple leaved plum	Clean- if removed replace with a small density branched tree or evergreen
6 and 7	Cherry plums	Clean the crown removing dead and defective branches
9 and 10	Portuguese laurels	Clean and remove stubs of trunks and branch stubs

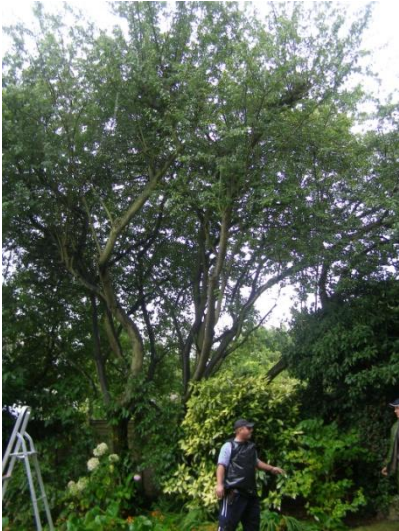
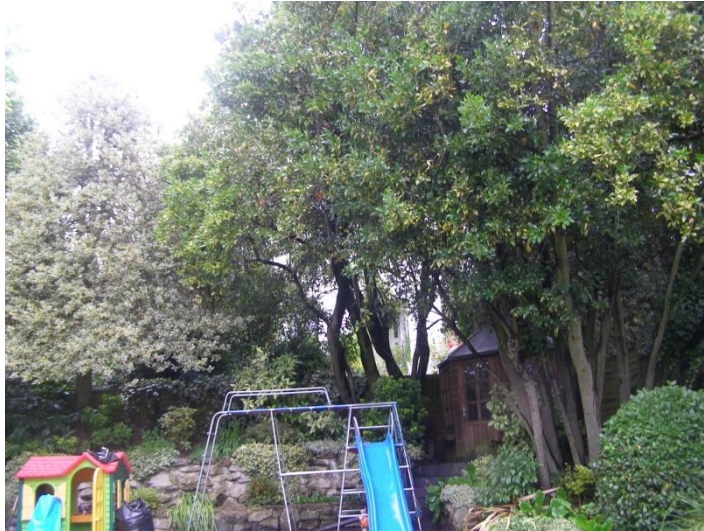
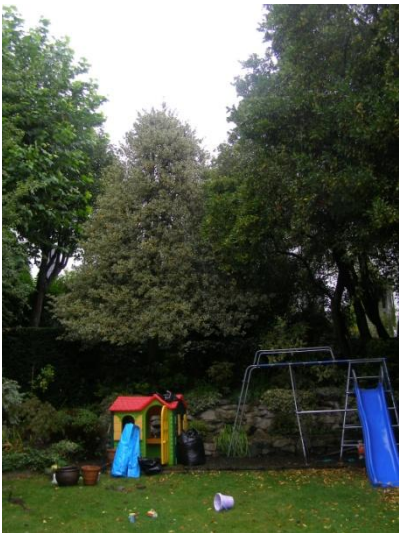
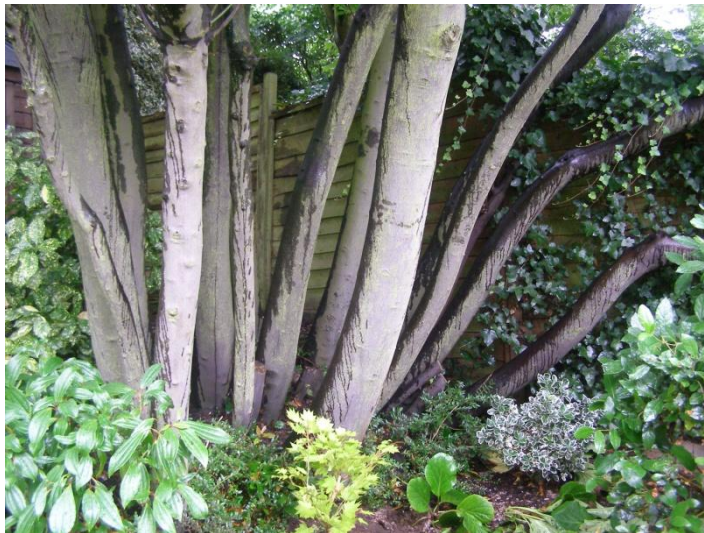
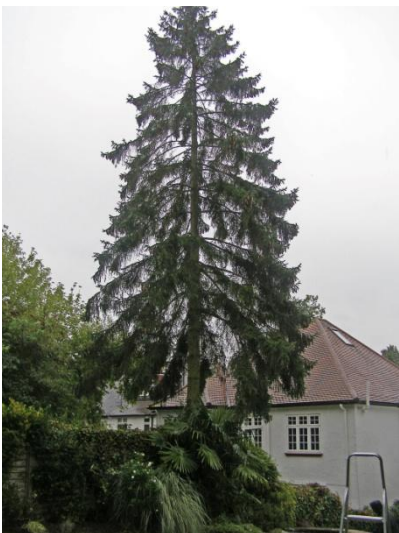
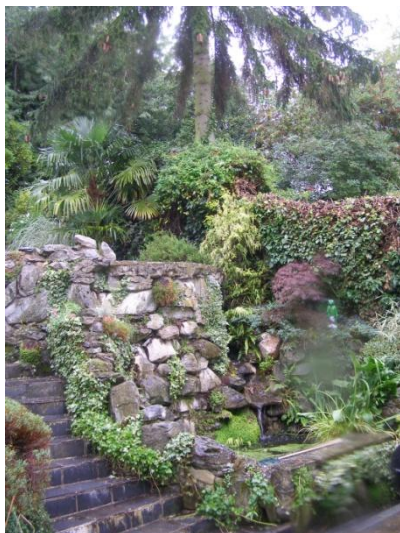
- 5.5 A 10 metres high variegated holly (8) with a slight lean to the south occupies a more central position along the rear boundary. The two Portuguese laurels (9 and 10) growing at the top of this retaining wall, although with some defects within their structure are important visually in screening this garden from the surrounding properties,

Above left- dense foliage of the cherry plums (6 and7) **Above left-** the rear garden dense evergreen planting with the variegated holly (8) and two multistem Portuguese laurels (9 and 10). **Below left-** the variegated holly (8). **Below left -** the multistem with tight fork of the Portuguese laurels- both tree have some s stubs from removed trunk at the base
