## **Appendix B.2 - Arboriculture Survey & Report**

# **Simon Pryce Arboriculture**

**Site:** Three sites at Lambie Street and Barrington Close, Gospel Oak, London, NW5

**Subject:** Trees and proposed building work

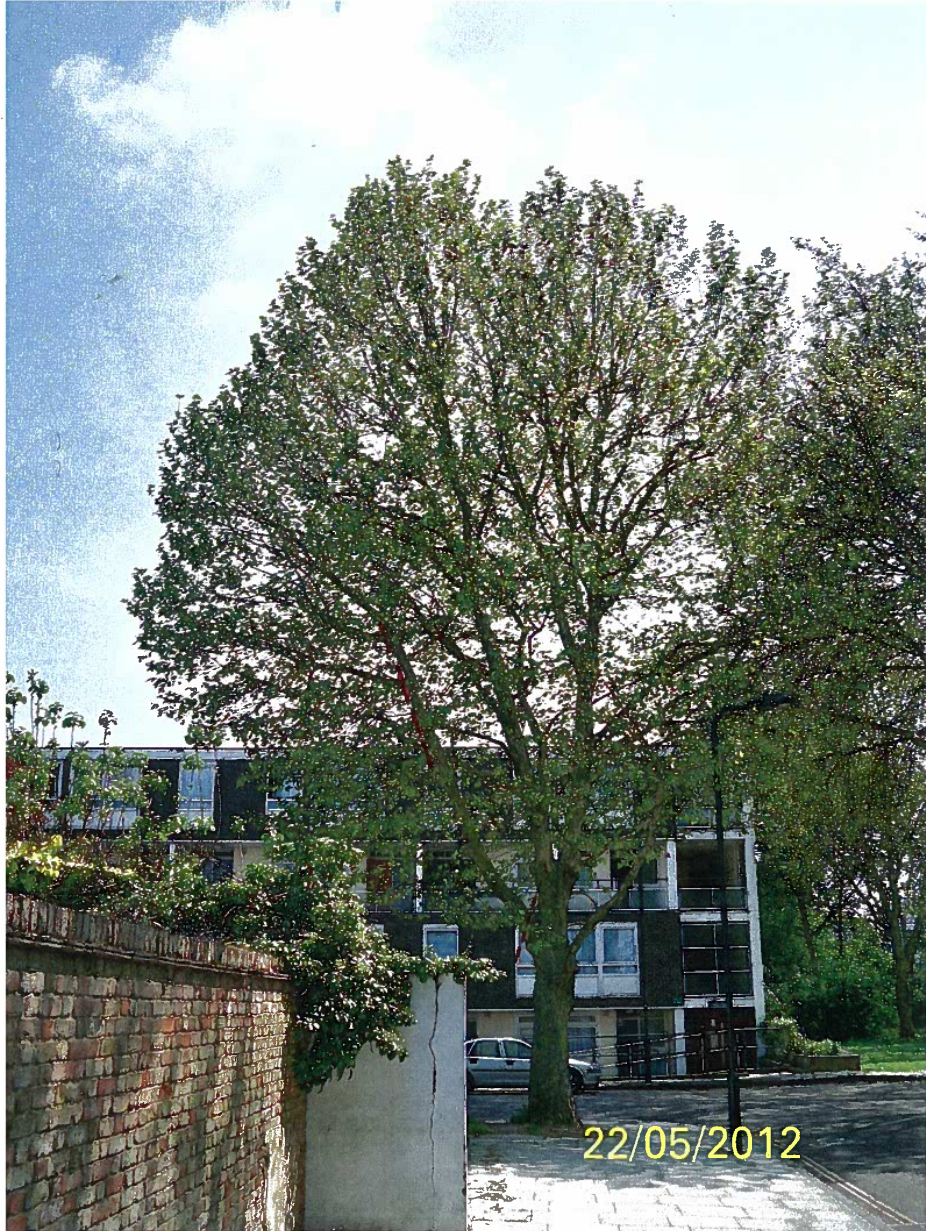
The initial survey work for the Plane tree adjacent to the vacant site on Lamble St has been under taken. An Air spade excavation was carried to a depth of 500mm to determine the extent to which tree roots had grown into the site. No significant root growth was found. The top 500mm was found to be made up ground with dense clay beneath. It seems that the depth of the foundation to the wall is deeper than 500mm. Therefore there are no significant constraints beneath ground level to the redevelopment of the vacant Lamble St site.

In terms of the above ground constraints to the site with the over hanging branches it would be preferable to work within the constraints of the limb removal marked on the attached photo. That is with the removal of the secondary laterals as shown (solid red line) Arboricultural Services have agreed that if the scheme was shown to be unviable as a result of this more limited option then they would be prepared to accept the loss of the more major limb at the trunk (dashed red line). However this would require some rebalancing of the crown shape which would leave a less attractive tree and increase the risk of the wound left by pruning decaying over time and leading to the ultimate loss of the tree.

In either case the built form should aim to be 2m from the tree.

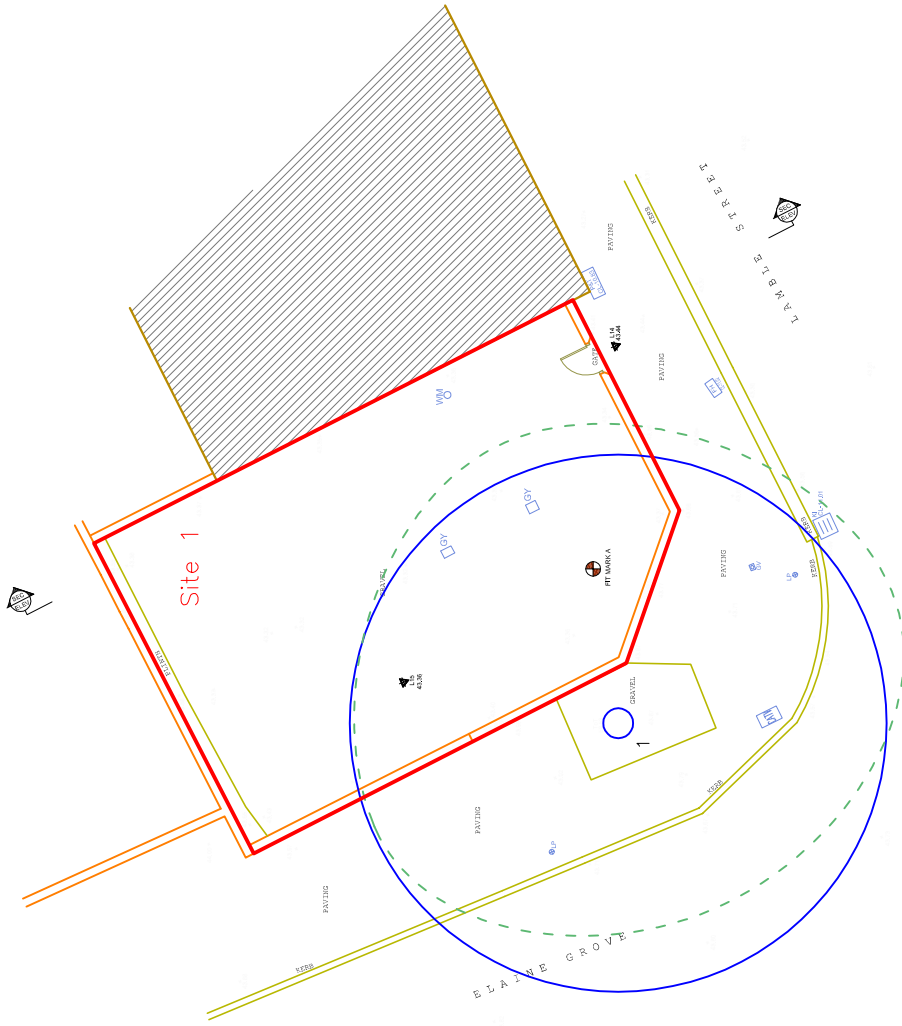
- 4.5 The proposal is for a two storey house continuing the existing terrace on to the Elaine Grove boundary. A significant part of that is within the RPA of the plane tree in the street (tree 1), if treated as circle. The existing boundary wall might inhibit root growth, but is unlikely to prevent it completely, particularly with the carriageway on two sides.

- 4.6 There is therefore some potential for root damage, although there are mitigating factors. As the subsoil is London clay, which is highly shrinkable, the house will need deeper foundations than normal. The exact design is an engineering matter, but it is likely that the most suitable design will be piles and a ground beam or raft. This involves far less excavation than conventional strip footings, although a shallow trench is likely to be needed in order to accommodate a ground beam. This can be addressed by shallow trial excavation to determine whether any roots have grown into the site. If so options would include pruning small ones or adjusting pile locations to miss larger ones.

- 4.7 Planes are naturally highly resilient, and this tree is a healthy middle aged specimen, so will be less vulnerable to adverse effects from nearby work than most other species. It has been reduced recently, which appears to be done on the regular cycle adopted with many street trees. That will also help to compensate for the effects of any root disturbance and might need to be modified slightly in future to maintain clearance from the completed building. As spread on the other side is also restricted slightly by the tree across the road that could help to make it more symmetrical.

- 4.8 The site fence will protect the tree from incidental damage from the work, although it would be advisable to box in the trunk with scaffolding or plywood to reduce the risk of any impact from delivery vehicles or plant.

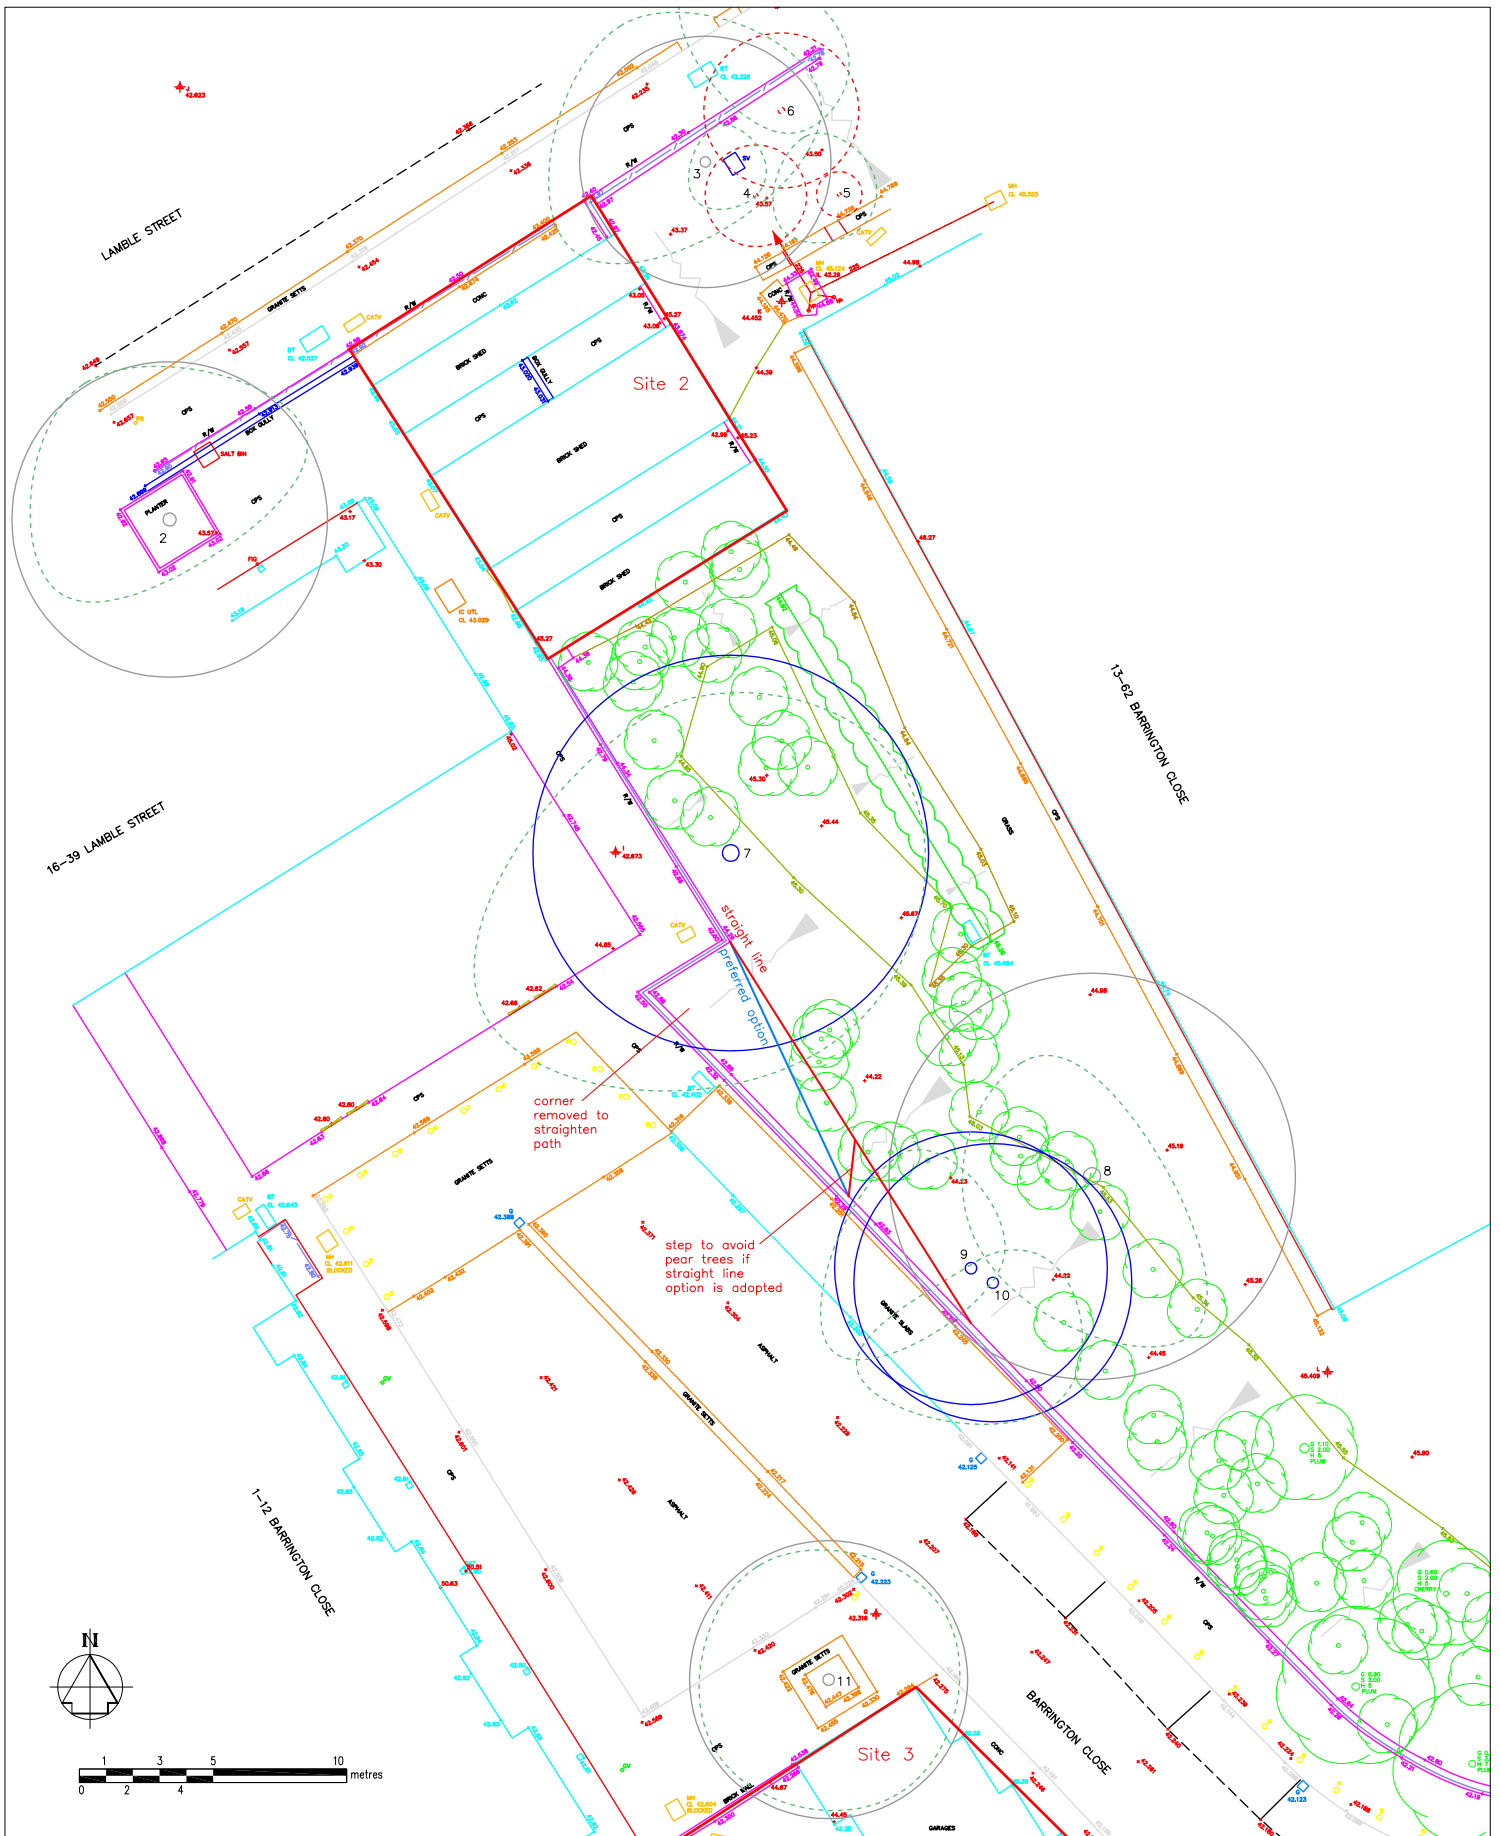
Client:  
London Borough of Camden  
Site:  
Lambie Street and Barrington Close,  
Sites 1 & 2  
Title:  
Tree survey  
Date:  
3 September 2013

- 4.9 The new house replaces existing buildings in what amounts to a rectangular pit, the retaining wall of which will remain in situ. The RPA of tree 3, the nearest birch in front of the tower block, just impinges on this but, while root growth will be restricted by the road to the north, the tree also has ample space elsewhere on the bank. Some roots from the Turkey oak to the south might have grown under the retaining wall but it is well beyond the RPA circle and, as the wall will remain the tree will not be vulnerable to any direct effect.
- 4.10 The site layout also helps to protect the trees from incidental damage during the work, and that would be supplemented by the site safety fence, so specific tree protection fencing is not likely to be needed. This also applies to tree 2, the Norway maple in the street to the west and trees farther south along the bank.

- 4.11 The original proposal is to take off the corner of the bank to continue a straight line from the SW side of Site 2. At the southern end that would involve some ground work to form a new retaining structure near the bases of trees 9 and 10, two pears which are among the older and more interesting specimens. The drawing shows a preferred option which stops before the pear trees. It creates a bend of about 8 degrees, which will not create any visibility or security issues. Another option would be to make the new wall straight with a short side step to avoid the pear trees, as shown on the drawing.

- 4.12 The modification also involves working close to the Turkey oak, although the overall loss of soft ground is 18m<sup>2</sup> for the preferred line, of which about 11m<sup>2</sup> is within the RPA circle. Although the circle is not necessarily an accurate indication of actual root spread these areas involved are a small proportion of the RPA as whole, which is 174m<sup>2</sup>. The tree has ample rooting space on the rest of the bank and, as it leans and has most of its weight on the SW, the most important structural roots will be on the other side. There are also work methods that would minimise root disturbance. The preferred option in arboricultural terms would be to sheet pile along the line of the new wall in order to cut any roots cleanly and avoid leaving them exposed to air. If clearance under the tree is inadequate for the piling rig an alternative would be to hand excavate and cut any roots cleanly.

- 5.4 Where the footpath is straightened it would be preferable to adjust the line in order to avoid the two pear trees, either with a slight angle where it will meet the existing wall or a short side step to avoid the pear trees.
