Arboricultural Implication Assessment

Preliminary Report on Trees

For:	Client:	Richard F Gill & Associates
	Insurer:	Aviva
Site:	Policyholder:	Miss Osband
	Risk Address:	26a Frognal, London, NW3 6AG
Refs:	OCA Ref:	55638
	Client Ref:	13307

Survey By:	Adele Devonshire		
Title:	Arboricultural Technician	Date:	06 February 2014
Report By:	Sue Lawson		
Title:	Consulting Arborist	Date:	15 February 2014

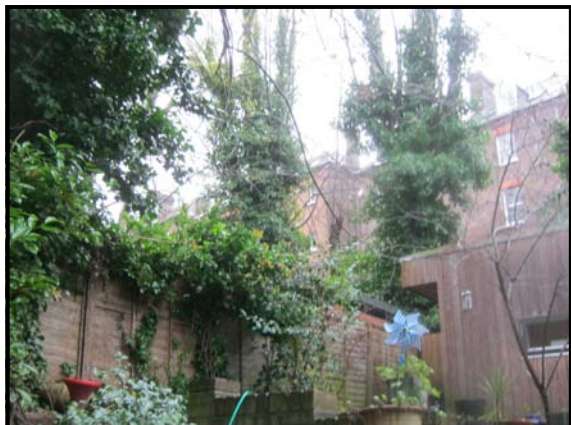
1. Lime tree T6.

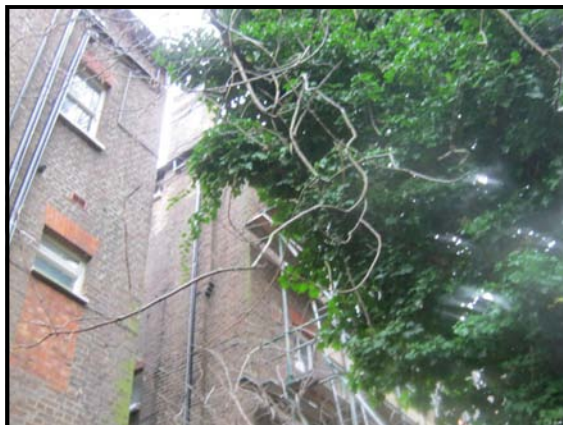
Roots have been noted to a maximum depth of 1.6m in TPBH1. Samples of these roots have been tested using light microscopy techniques and have been formally identified as from the botanical genus *Fraxinus* (Ash).

Given its size, species and proximity to the location of the trial pit/borehole we consider that these roots have emanated from T1 (Ash).

The area of damage as described by the Engineer is entirely consistent with the location of T1 (Ash).

Therefore it is our opinion that sufficient information has been provided to demonstrate that, on the balance of probabilities, T1 is the material cause of the current subsidence damage.

2. View of Ash T1 from beneath the crown.

We do not consider that pruning will offer an effective or sustainable means of controlling the water use of T1 (Ash). Therefore and in order to provide a long-term solution to the current subsidence damage we recommend that this tree be removed.

Tree No:	Species	Works Required	Ownership
T1	Ash	Fell as close as possible to ground level and treat stump with appropriate herbicide to prevent future growth.	PH

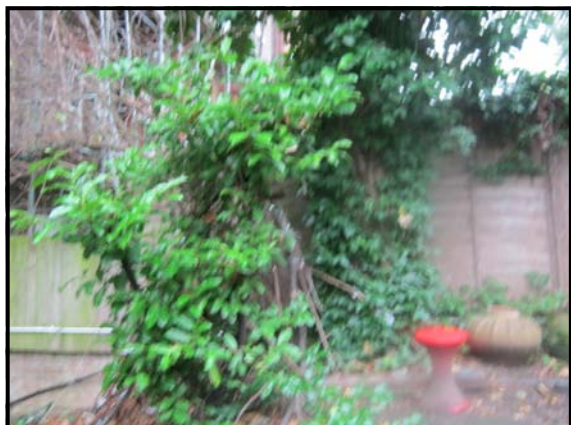
3. Cherry Laurel T2, Elder T8 and Ash T1.

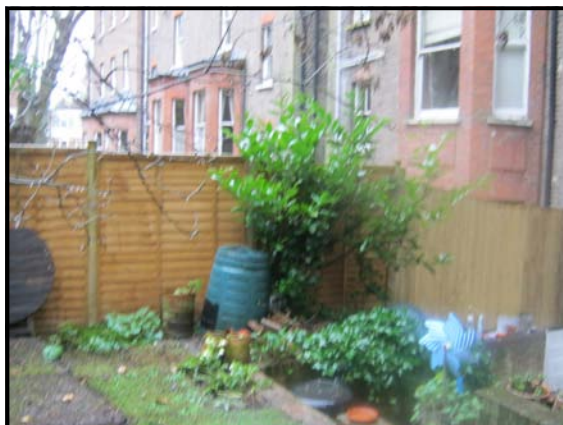
4. Cherry Laurel T4.

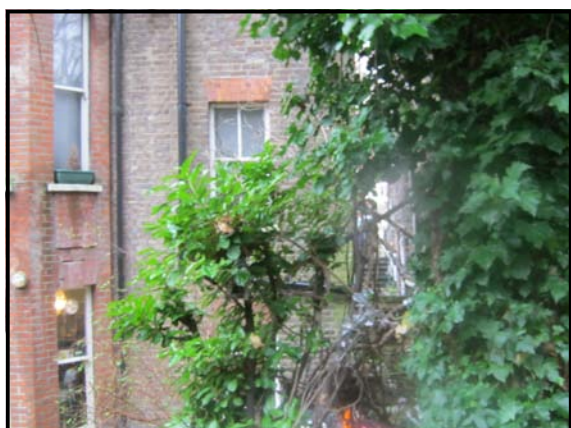
5. Cherry Laurel T2.

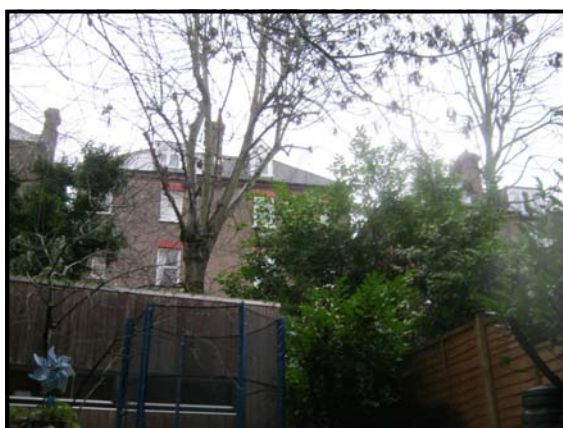
6. Lime T5.
