24 PARK VILLAGE EAST

Our Ref: EW/VP/UKDN294231/Rpt001.

RE: 24 Park Village East, London, NW1 7PZ

Drainage surveyed: Foul

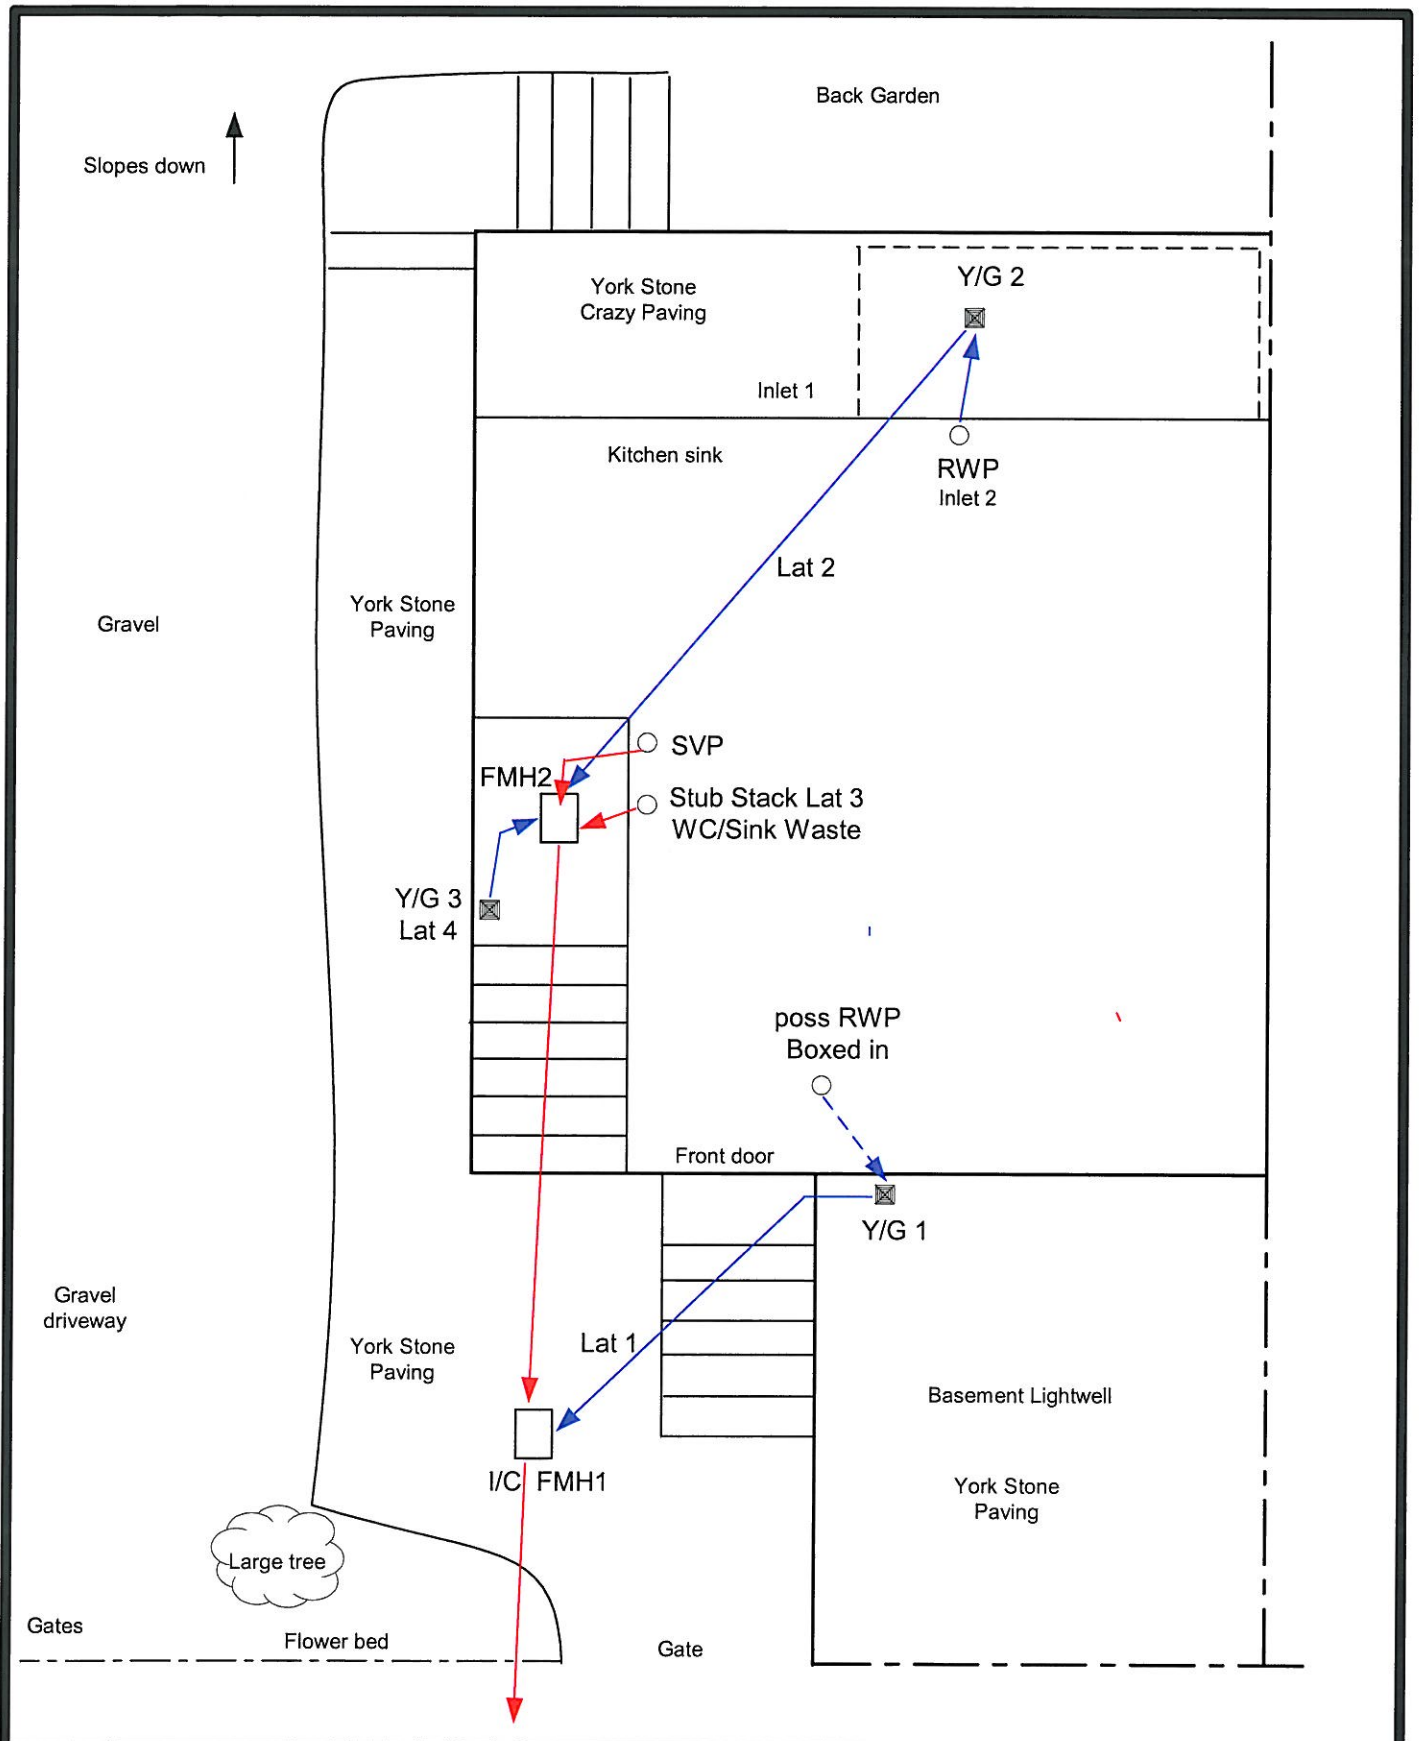
MANHOLE DEPTHS AND CONDITIONS

Foul Manhole 1 – 3.39m

Foul Manhole 2 – 0.58m

FMH 1 - 3.39m
FMH 2 - 0.58m
