Heritage Surveys Limited

Conservation Plan & Statement of Heritage Significance Report

1-28 Levita House
Ossulston Estate
Chalton Street
London
NW1 1JJ

Report date: 9 May 2014

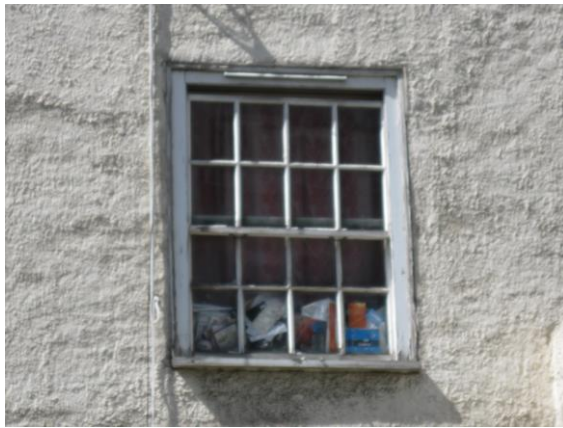
All windows are single glazed timber and are in a poor state of repair. They have reached the end of their serviceable life with evidence of timber decay, extremely poor decorations, glazing defects, draughts and poor levels of thermal insulation.

Existing sash window in 1 -21 Levita House

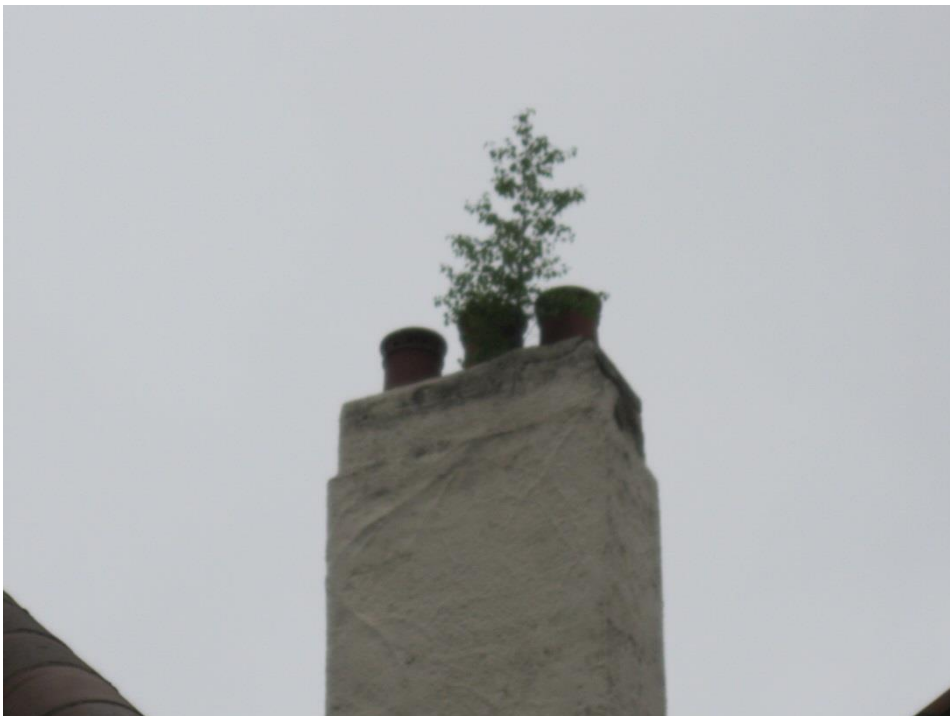
The render is showing signs of significant defects, particularly to the chimneys where areas are spalling and the brickwork is exposed and vegetation growth is apparent (photos 5 and 6). Similarly on the courtyard elevation, render is “live” and in need of extensive repair (e.g. photo 14).

Photograph 6 **Chimney – vegetation growth**

The proposal is to sample the render to analyse the mix, remove existing and re-render the entire courtyard elevation in a rough cast finish to match the original, with the application of masonry paint in an agreed colour.

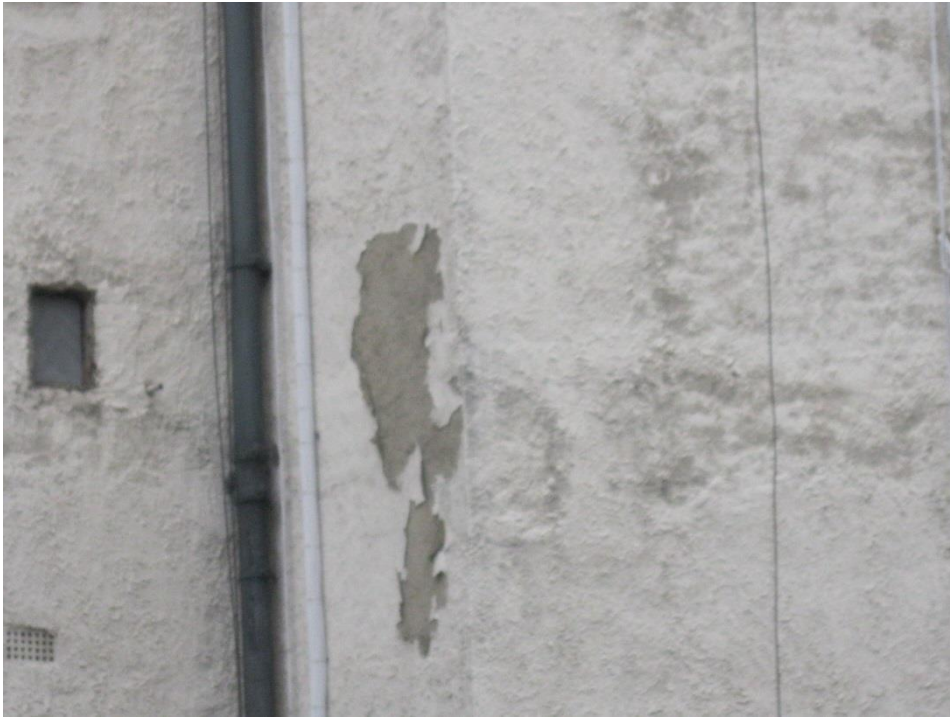
Photograph 7 **Render – defective coatings**

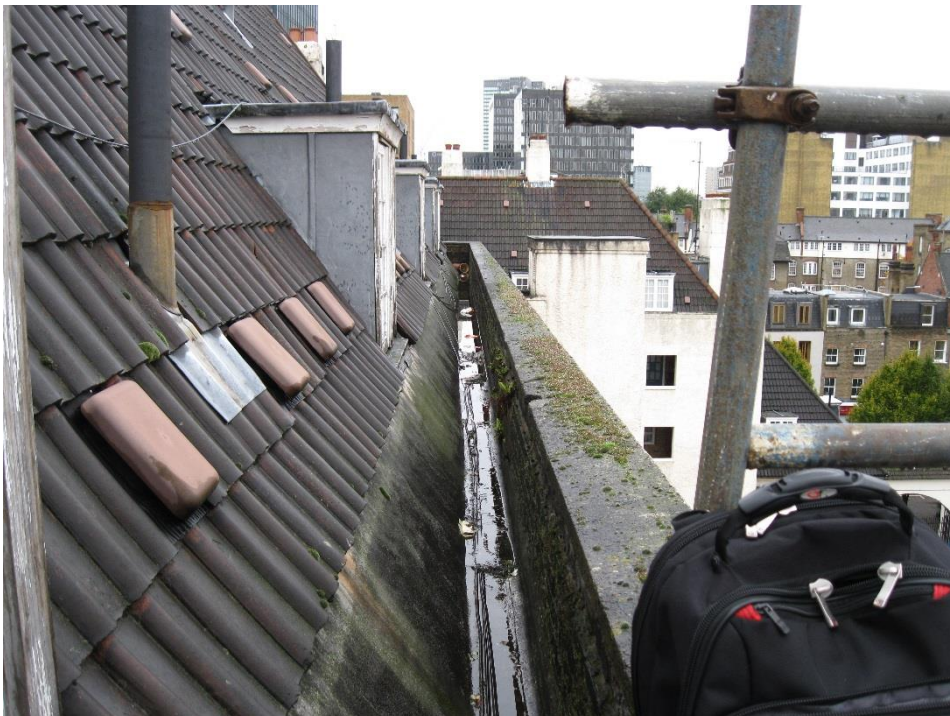
These are lined with asphalt and are in a poor state of repair. (Photos 8 and 9). It is proposed to repair these and coat them with a liquid membrane solution, replacing lead flashings and taking the opportunity to increase the depth of the gutter to prevent potential overflowing damaging the fabric and internal finishes. This proposal will not have any external visual impact as the works will be entirely concealed behind the high parapet walls.

Photograph 8 **Parapet Gutter**

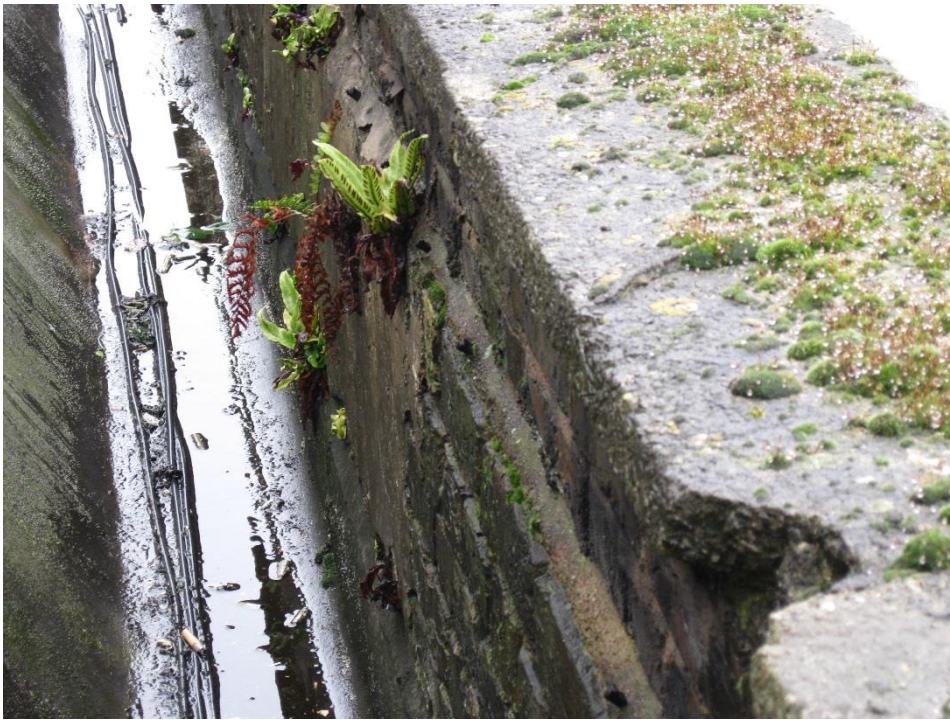
Photograph 9 **Parapet wall and gutter vegetation growth**

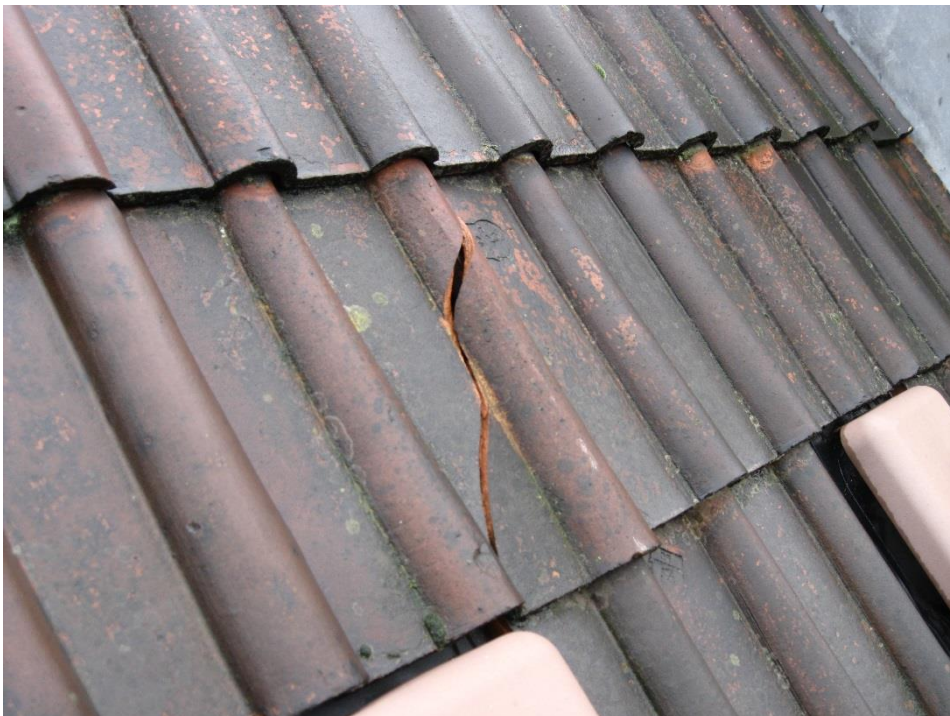
Based on a visual non-intrusive inspection, the roof structure appears to be in reasonable condition with no major deflection evident. A large number of tiles are cracked, some of which will be mechanical damage, with some evidence of weathering. There is no sarking felt under the tiling. The property is prone to leaks, particularly in wind driven rain or in the event that tiles are damaged. (Photos 10, 11 and 12).

Photograph 10 **Roof tiling**

The proposal is to strip all of the pitched roof coverings and set aside existing tiles for re-use. The intention would be to partially re-cover with new Sandtoft matching profile tiles (please refer to Appendix 2), re-use the existing tiles on the key elevations, assumed to be the courtyard facing north elevations.

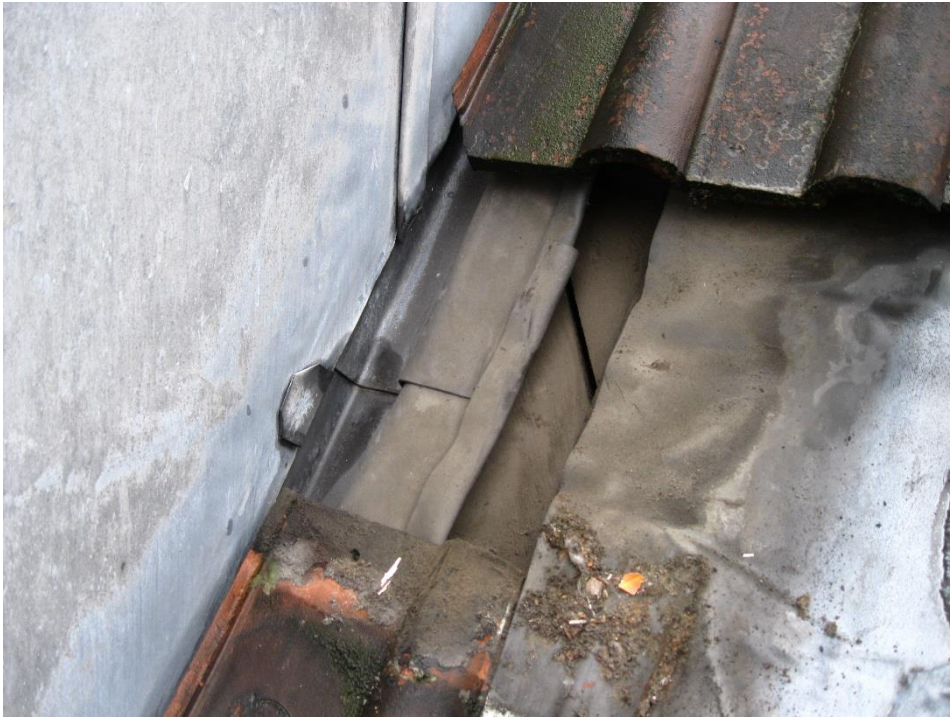
Photograph 11 **Secret gutter and dormer detail**

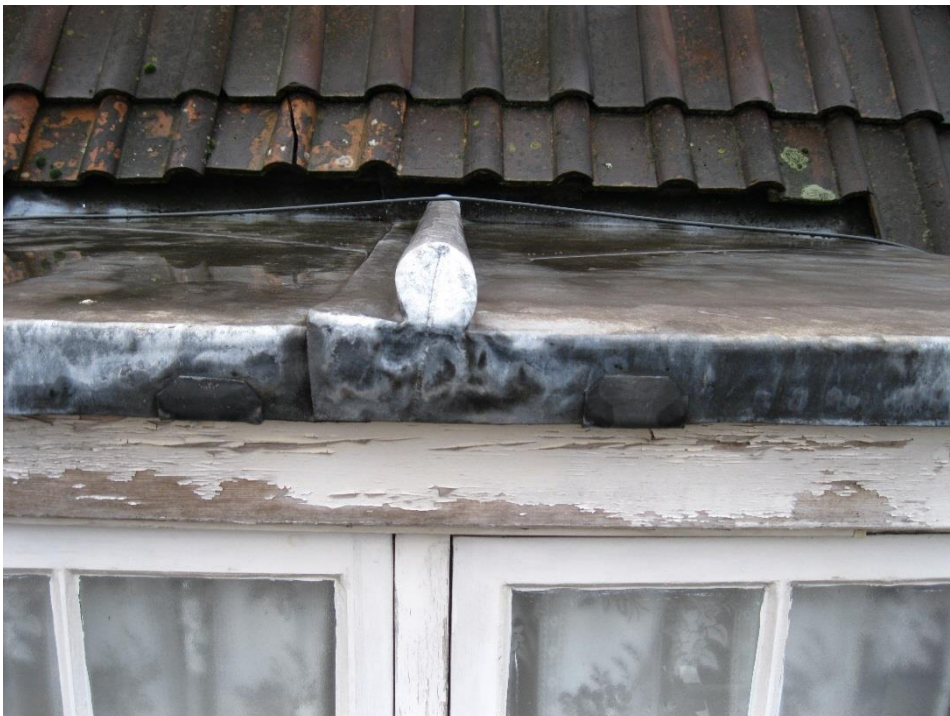
Photograph 12 **Dormer roof and window**

The recommendation is that the lead cladding to the dormers and all other lead weatherings are replaced, with lead to match the original but in accordance with current best practice. (Photos 12 and 13). Again the opportunity will be taken to install thermal insulation without impacting on the appearance of the dormers.

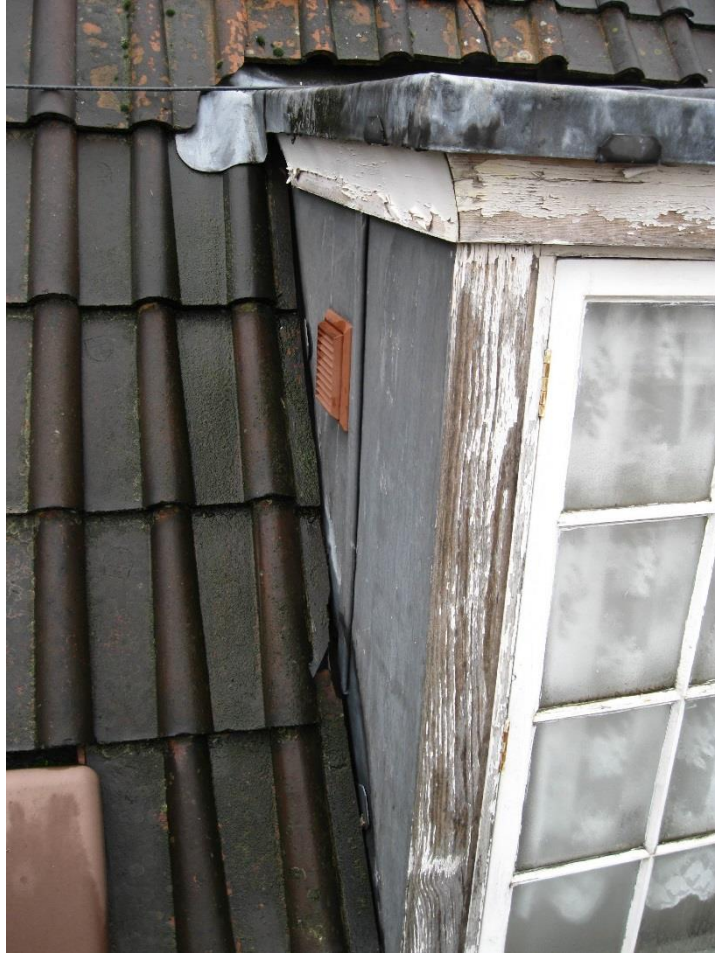
Photograph 13 **Dormer window cheek**

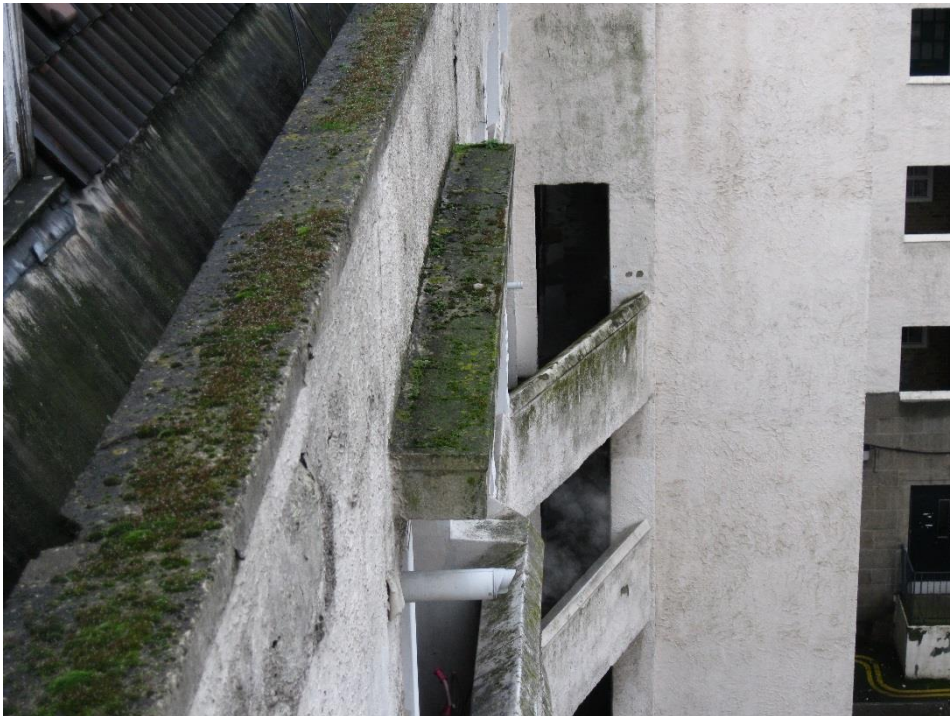
Photograph 14 **Render North west side, blown**

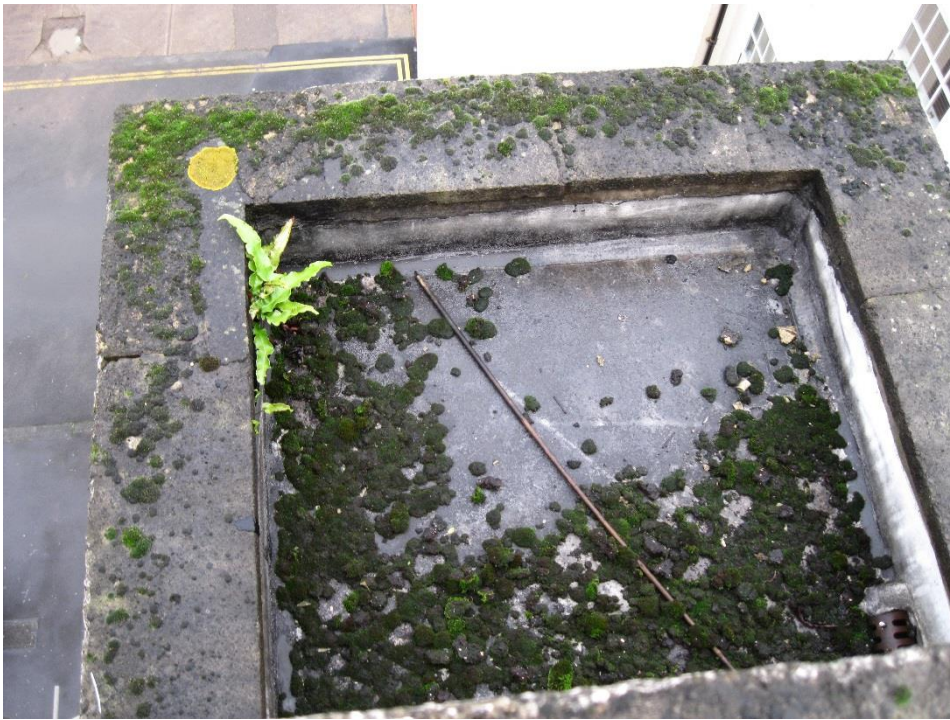
A number of small flat roofs are provided over the lift shaft, refuse store etc. These are in poor condition (Photos 15 and 19) and it is proposed to recover with a liquid membrane or similar high performance coating.

Photograph 15 **Flat roof, north end**

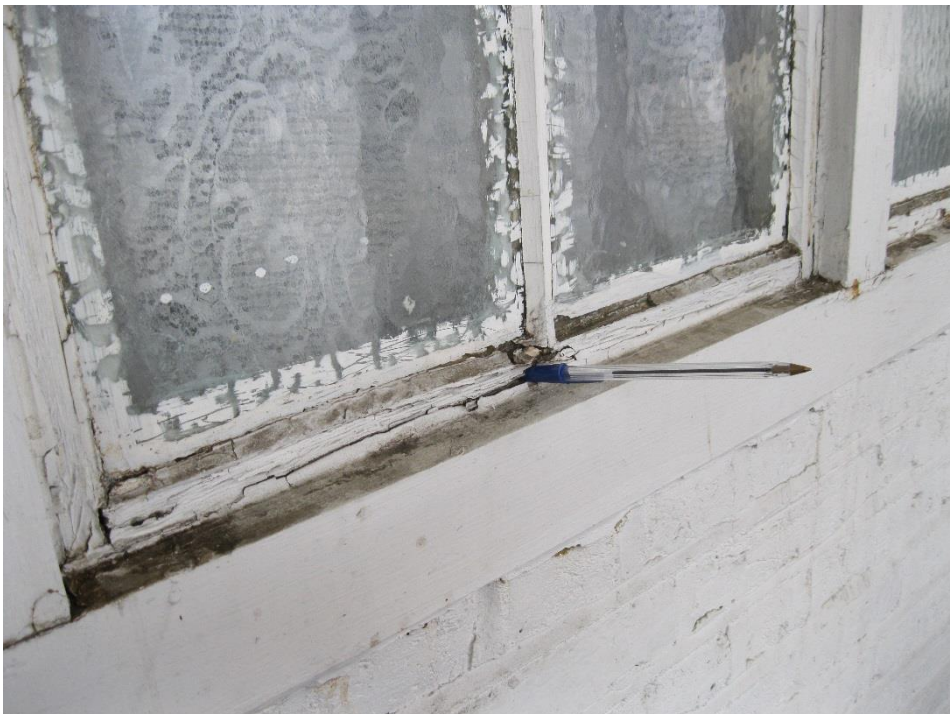
Photograph 16 **Access balcony window – flat 21**

To comply with modern standards, it is proposed to replace all of the windows. The principle of installing double glazing has been established elsewhere in the listed estate (plasesee1.8 earlier).

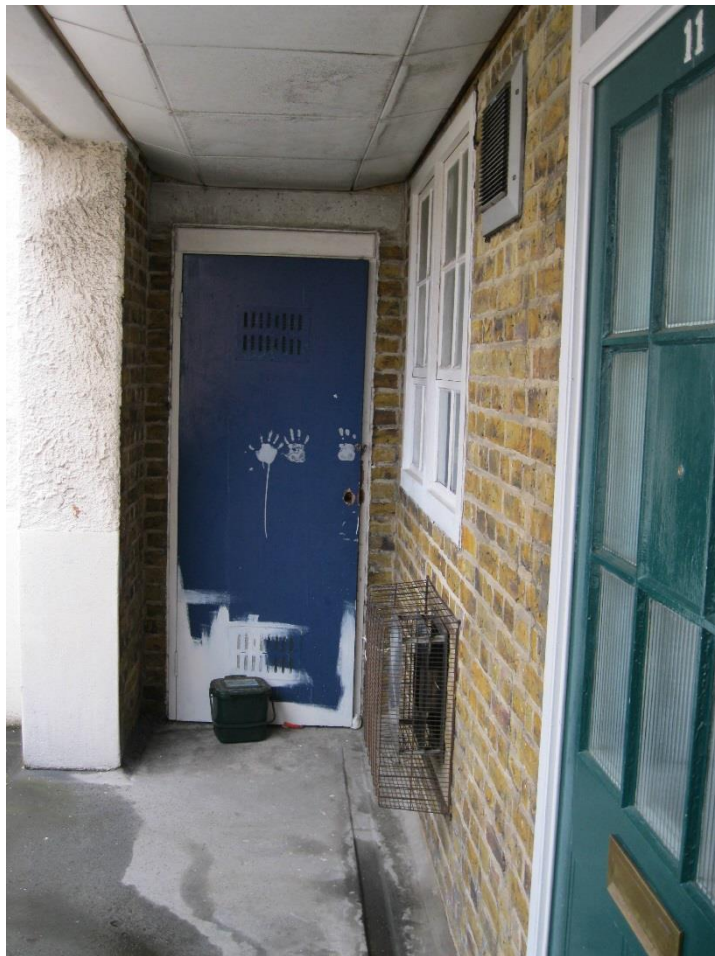
Flat entrance doors are timber with glazed upper panels. (Photo 17). Existing timber doors and frames are also in poor condition. A number of doors have been replaced from what is believed to be the original multi glazed doors.

Photograph 17 Access balcony flat entrance door No 11 and store door

The proposal is to replace the doors to achieve a Secured by Design standard in terms of locking mechanisms and also to the current recommendations in relation to fire precautions.

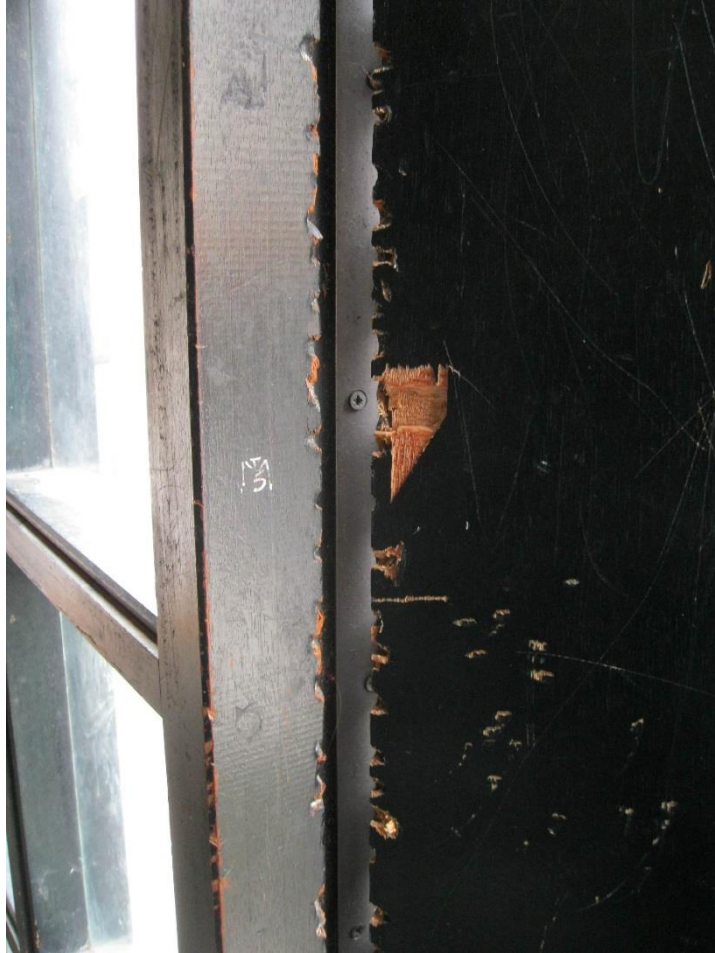
Photograph 18 **Damage to communal door leaf**

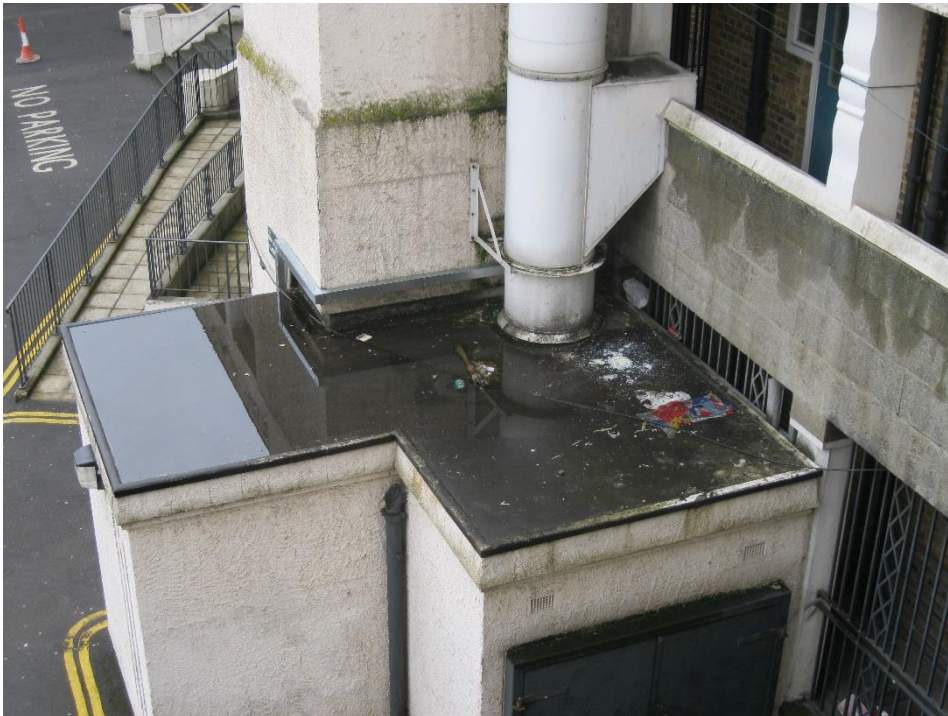
Photograph 19 **Low level flat roof**

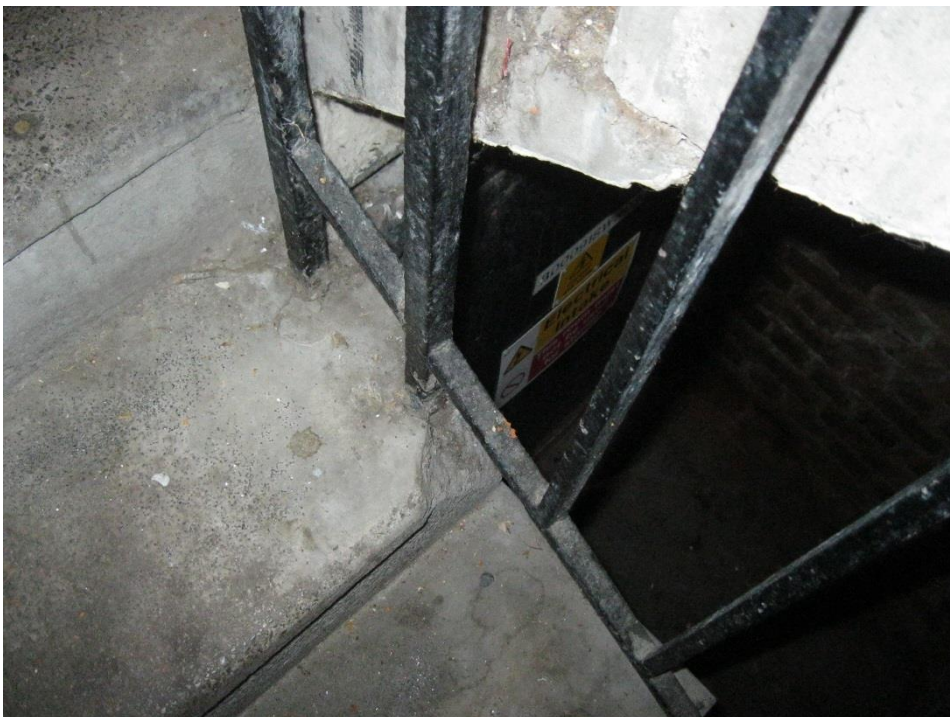
Concrete balconies and other services appear to be in fair condition but the proposal is to carry out all the necessary pre-decoration repairs e.g. to the access balcony soffits etc. The communal staircases show evidence of corrosion of steel, which is causing spalling of the concrete, and other mechanical damage.

Photograph 21 **Stair damage**

The proposal will be to remove defective concrete, suitably prepare exposed steel and repair with a specialist concrete repair compound such as the Fosroc Renderoc system of repair mortars with appropriate priming of exposed steel work. Repair profiles will match the original profiles of the repaired element.

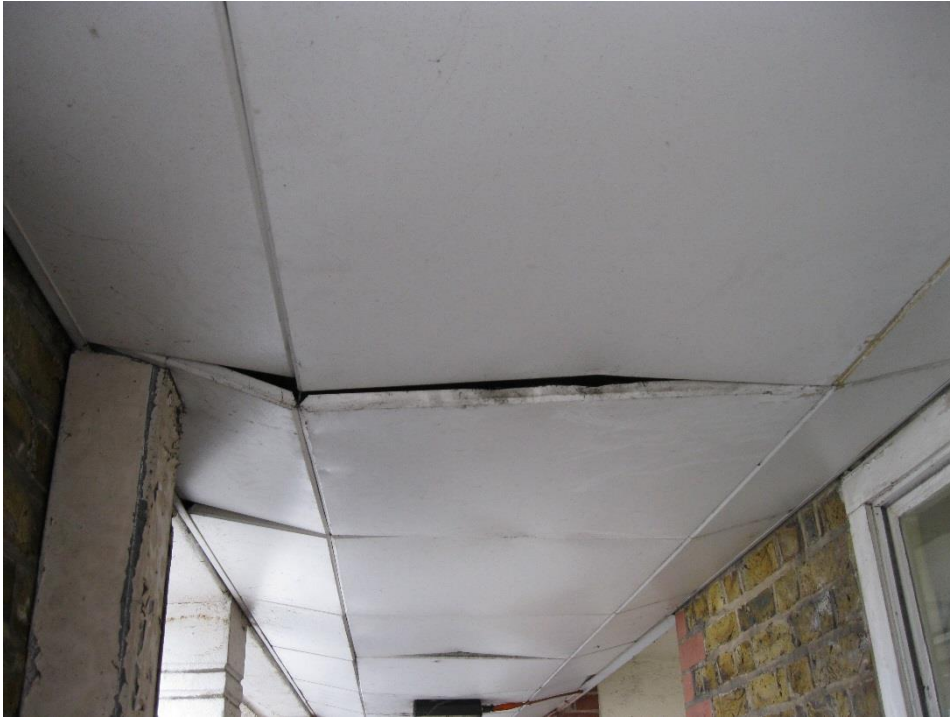
Photograph 22 **Access balcony suspended ceiling**

The suspended ceiling system will be retained and repaired, and sections replaced as required.

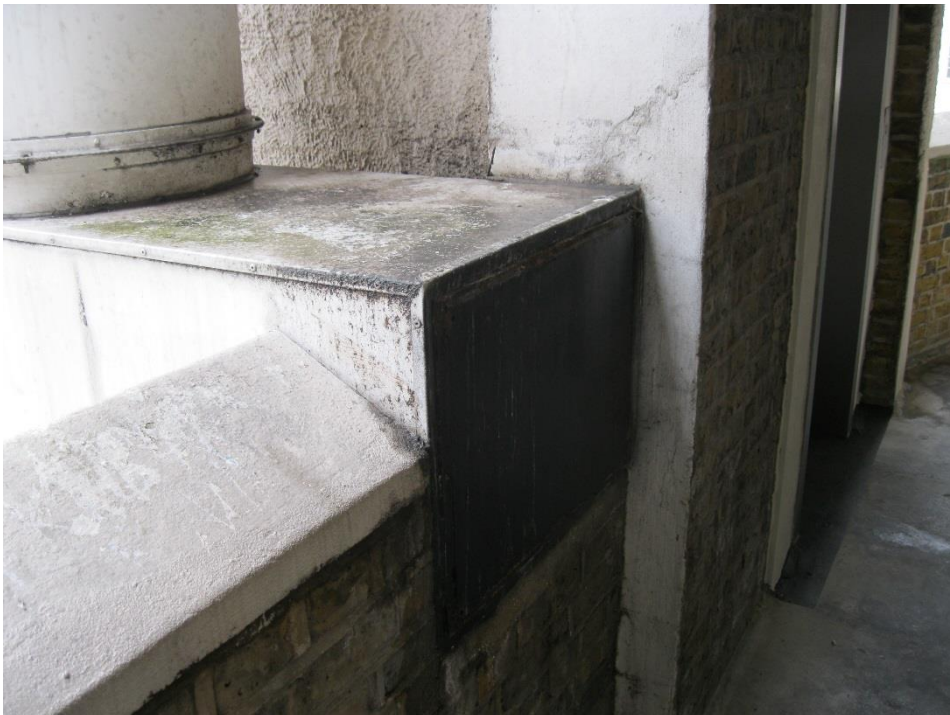
Photograph 23 **Access balcony refuse chute**

The proposal is to remove this and reinstate communal access balcony walls to match the adjacent original design.
