59 Birkenhead Street Camden London WC1 Heritage Statement

14 April 2014

1.0 Introduction

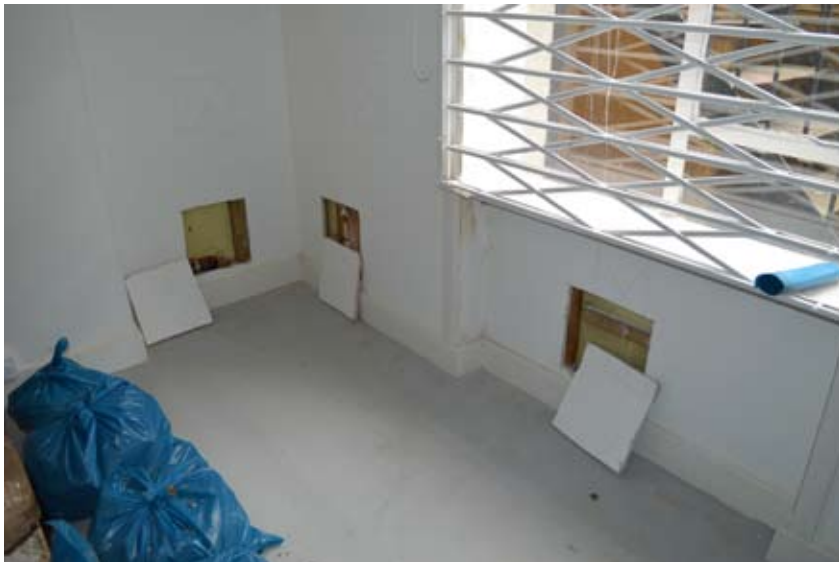
The front basement room showing the dry-lining cut away to show the original walls. (The dry-lining has since been removed.)

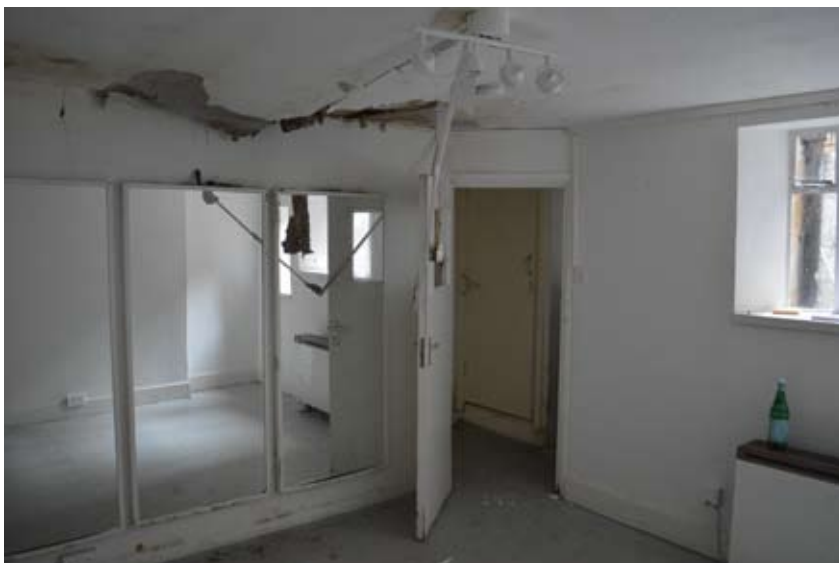
The rear basement room showing the damaged ceiling, metal window and modern door.

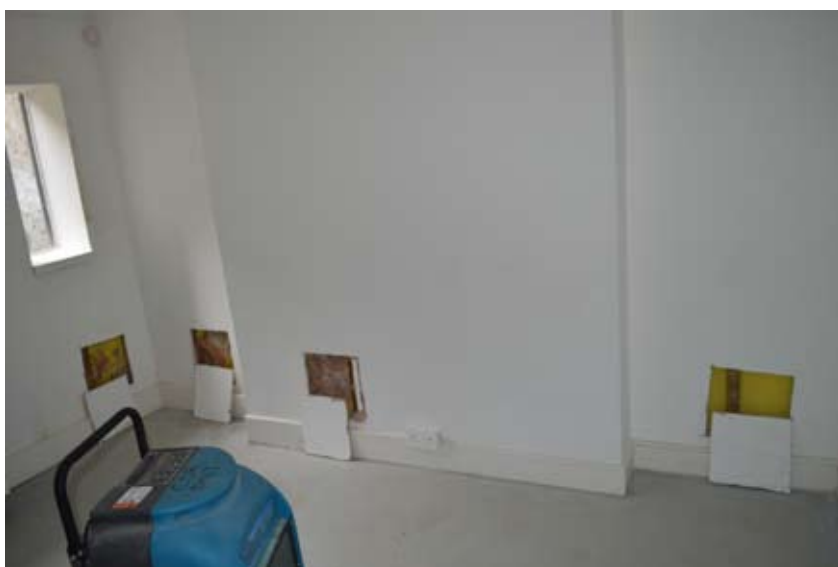
The rear basement room with the dry lining cut away to show the original wall behind. (The dry-lining has since been removed.)

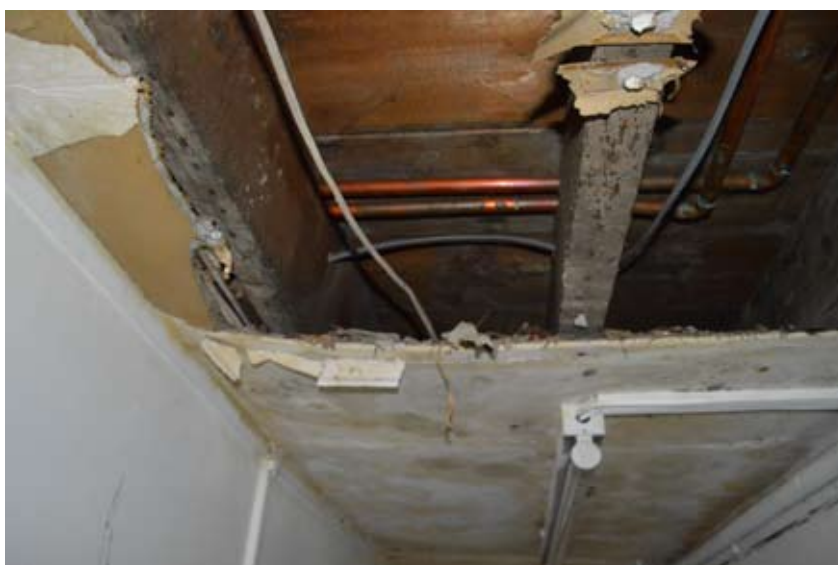
The basement corridor ceiling, now damaged, is modern plasterboard.

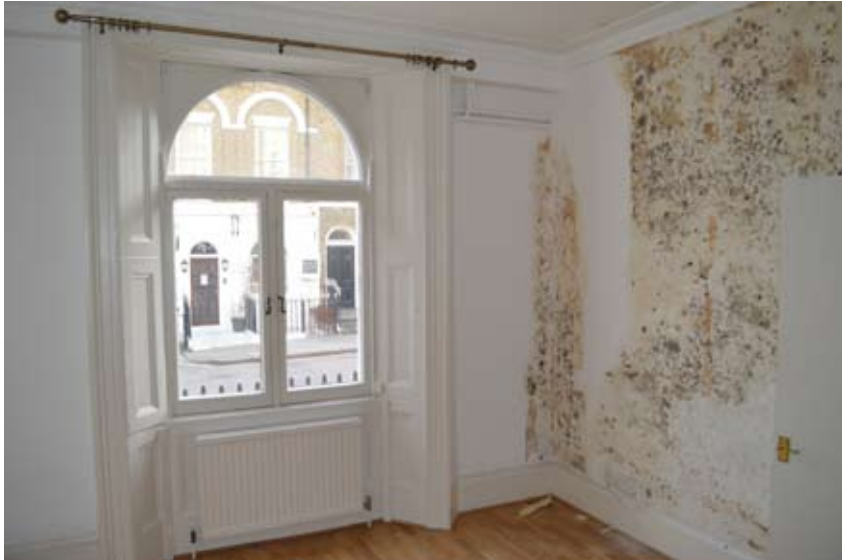
The recent flooding has caused damage to the lath and plaster ceilings in the entrance hall and front room: some of the ceilings have fallen or had to be cut away, while nearby areas of the ceilings and also the walls appear in need of repair and/or replacement. The water has

The front room showing the later shutters and modern window, as well as flood damage to the south wall (right).

In some cases, where large sections of ceiling plaster have already collapsed, it is proposed to remove and replace what remains, essentially because, although still in place, the ceilings have become de-bonded and there is the strong likelihood of further collapse. In such cases, the removal of extant plaster would allow for full inspection (and repair as necessary) of the ceiling joists. Ceilings would be replaced with lath and plaster, using a lime-based plaster reinforced with horsehair. It is also proposed to replace some badly-damaged cornices considered to be at risk of further collapse. Moulds of the existing cornices would be taken to ensure that the replacement cornices exactly match. The new cornices would be constructed of lath and plaster, using a lime mix reinforced with horsehair.

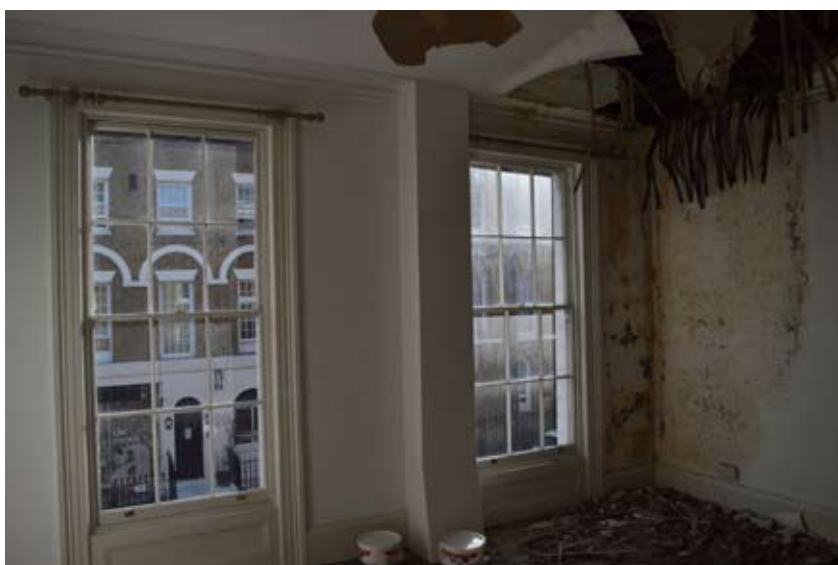
The front room showing the damaged ceiling; this has worsened since this photograph was taken. See detail photograph on p. 22.

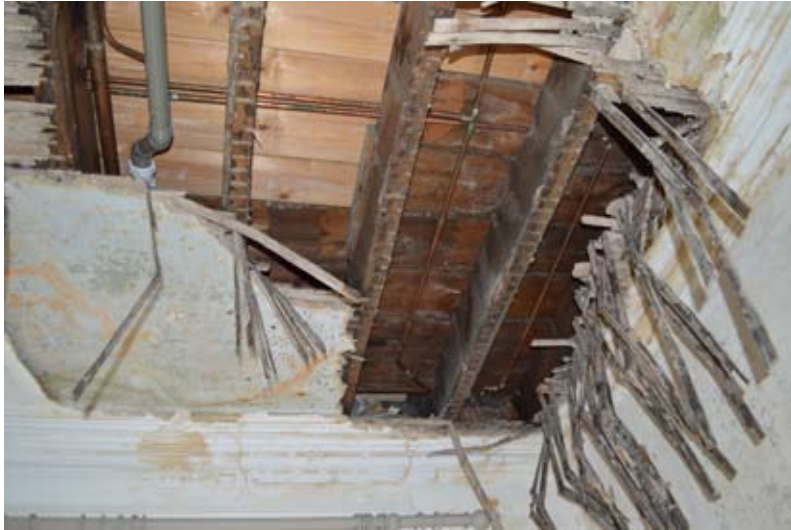
The damaged ceiling in the front room in detail.

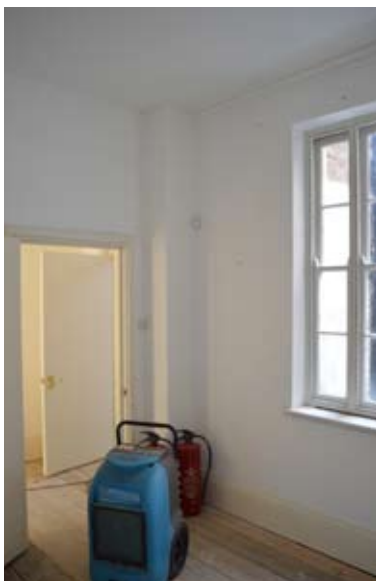
The rear room showing the damaged coving and modern service riser.
