## 5 – 6 Cliff Villas

### Structural Engineer's Report (Demolition)

Prepared by: Linda Chan  
March 2014  
22416

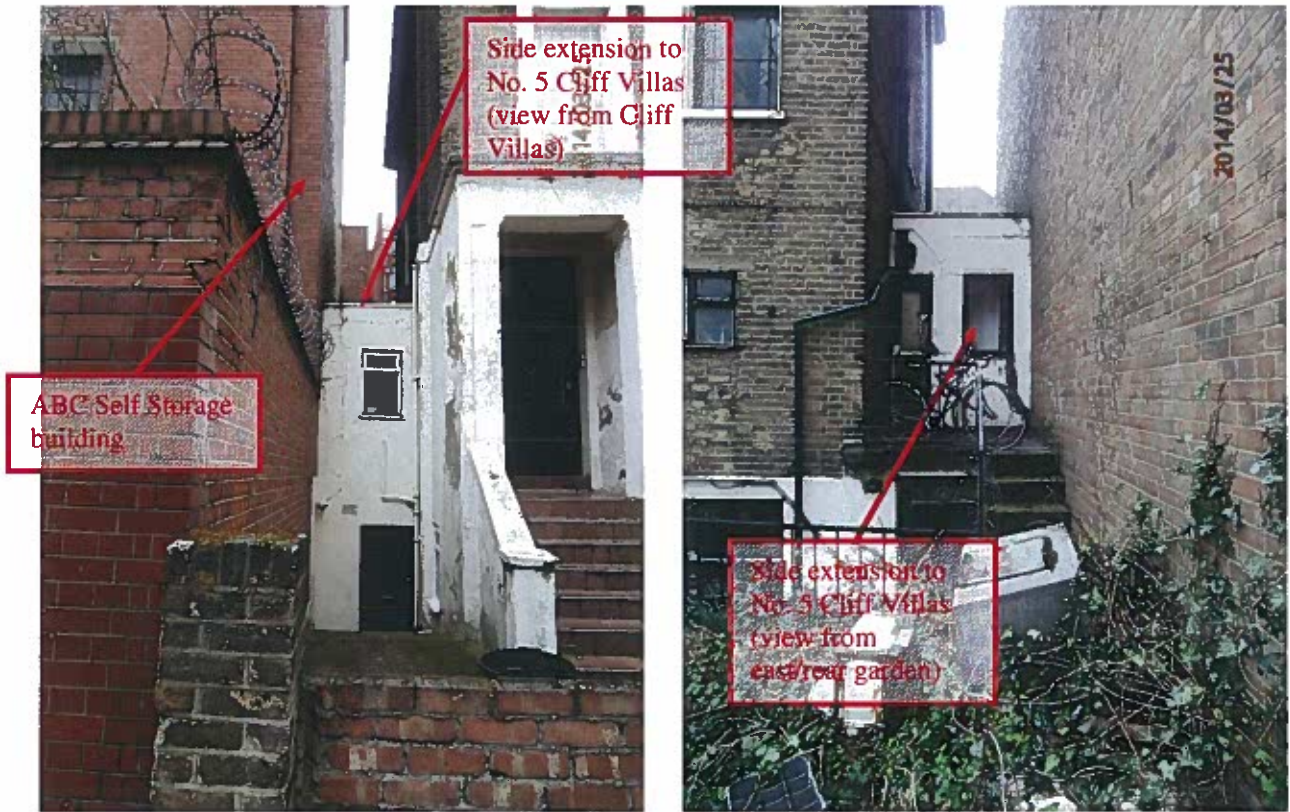
On the north side, the extension to No. 5 Cliff Villas abuts the flank wall of the storage building. The boundary line has been assumed to be between the two and it is assumed the extension encloses against the flank wall (see Figures 2 and 3). The storage building appears to be in good

structural condition. An external visual inspection indicates that the storage building does not have a basement.

Figure 2 - North boundary of property where side extension of No. 5 Cliff Villas adjoins storage building

Figure 3 - View of north boundary of the property from the east (rear garden side)

Temporary props will be required along the north and south boundaries at existing ground floor level, where the side extensions to No. 5 – 6 Cliff Villas meet the adjacent walls. These could be in the form of raking props, positioned to stabilise the adjacent walls that are retaining ground on the adjoining owner's side. These props must be installed prior to demolition of the existing ground floor.

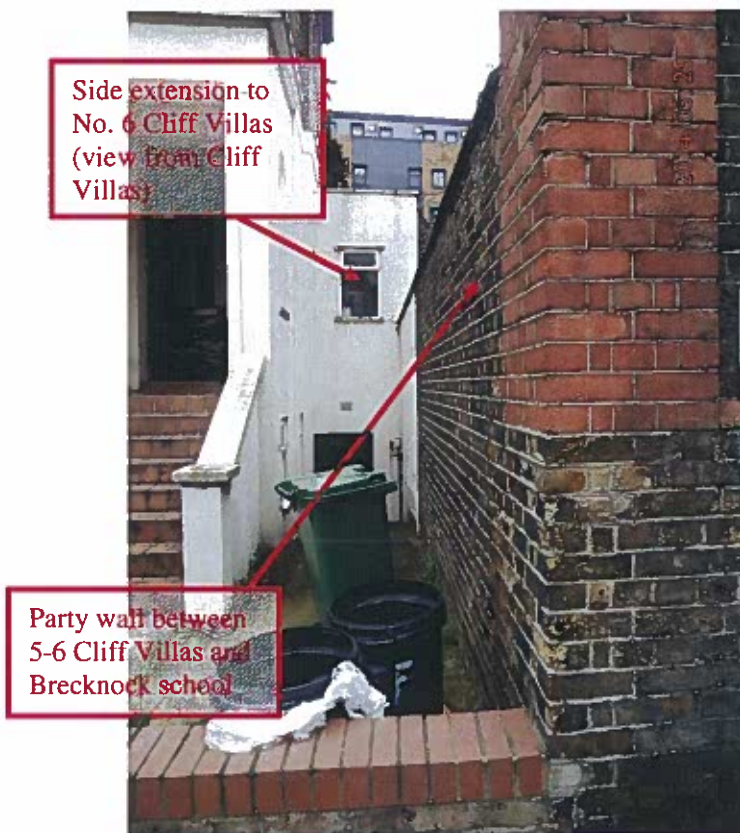
On the south side, the side extension to No. 6 Cliff Villas abuts the boundary wall to the school and extends over the wall, with the adjacent piers extended to match the additional height of the wall (see Figures 4 and 5).

It is thought that both side extensions are later additions to No. 5 and 6 Cliff Villas and certainly constructed after the adjacent properties. In constructing the extensions, the ground has been locally lowered to lower ground floor level, and therefore the adjacent walls (flank wall of storage building and boundary wall of school) may have been underpinned. In any event, the adjacent walls will be retaining ground due to the level difference. Hence, care must be taken to stabilise these adjacent walls during demolition of the existing buildings.

Figure 4 - South boundary of property where flank wall of No. 6 side extension appears to be on school land

The flank wall of the side extension to No. 6 Cliff Villas should be reduced in height to the original level and thus match in with the remainder of the wall. Whilst doing this, we would recommend that the top three courses of the remaining wall are re-built. This should repair the cracked section of wall in this area. New coping stones should be installed to match the existing.

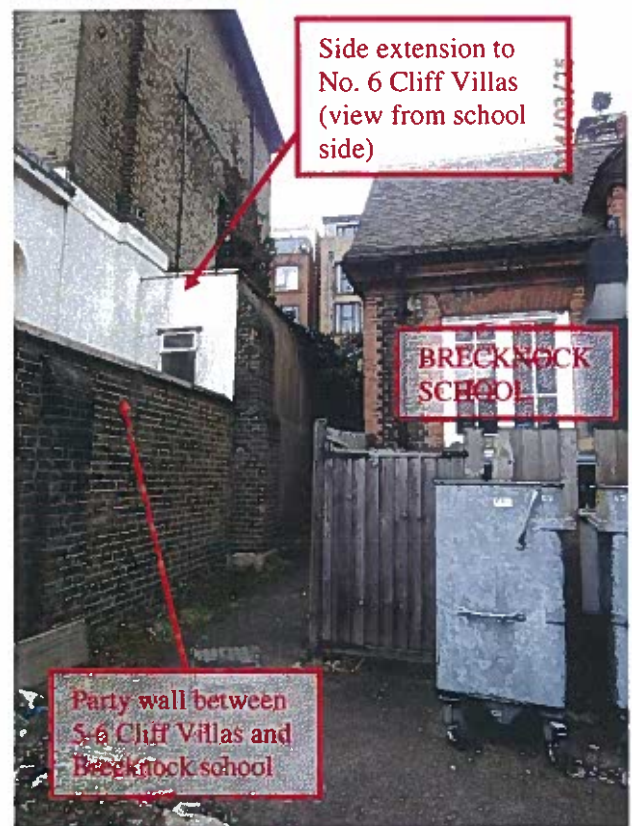
Figure 5 - View of No. 6 side extension from the school side
