18 BEDFORD SQUARE: SUMMARY OF PROPOSED STRUCTURAL WORKS

Project: 18 Bedford Square

Title: Survey Photographs

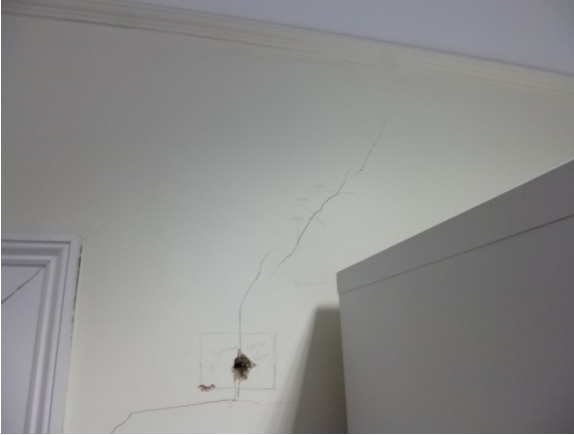
4. There was evidence of movement and cracking in the internal partition walls towards the middle of the building (see photographs 1 & 2).
5. At second floor level the dividing wall between the front rooms had clearly settled and the plaster had cracked at each end and over the doorway. The plaster was locally investigated and was clearly a hard, sand cement mortar applied over metal lath.

1. Movement and cracking of timber stud wall at 2nd floor level.

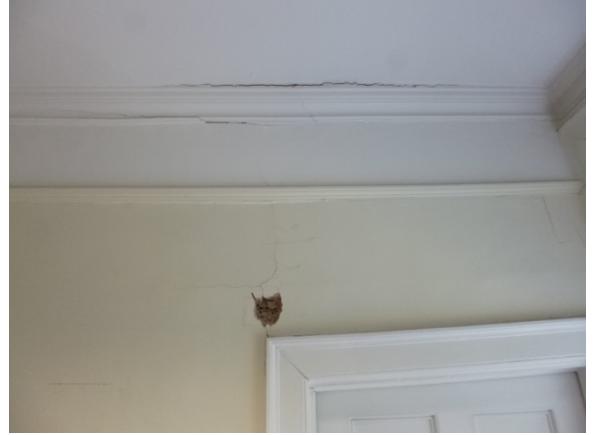
2. Movement and cracking of timber stud walls at 2nd floor level.

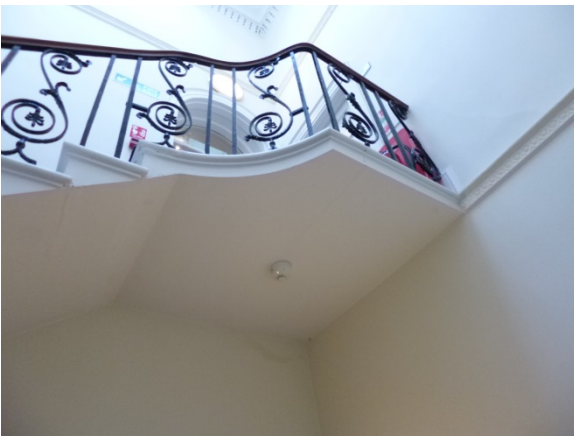
1. The main building was inspected on Tuesday 25th March after the building had been vacated by the current tenant. Reference should be made to the attached survey photographs and drawings.
2. There was evidence of minor cracking between some of the treads on the cantilever stone stair (see photographs 3 & 4).

3. Hairline cracking of stone stair.

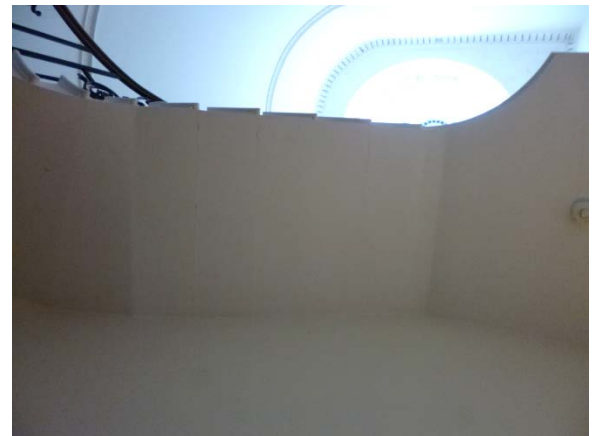
4. Hairline cracking of stone stair treads.

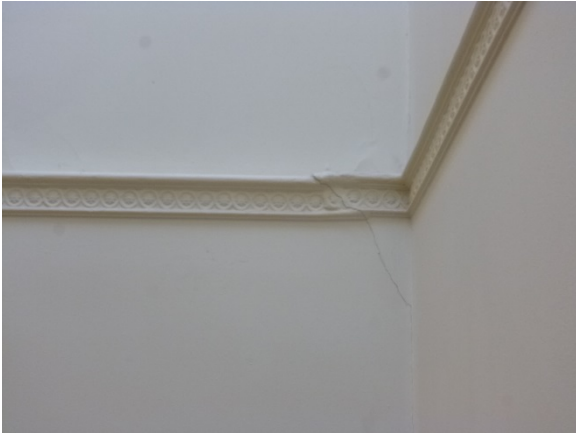
3. The spine wall appears to have settled slightly causing cracking of the plaster string, and there is evidence of minor differential movement between the spine wall and party walls (see photograph 5).

5. Cracking and differential movement between internal spine wall and party wall.

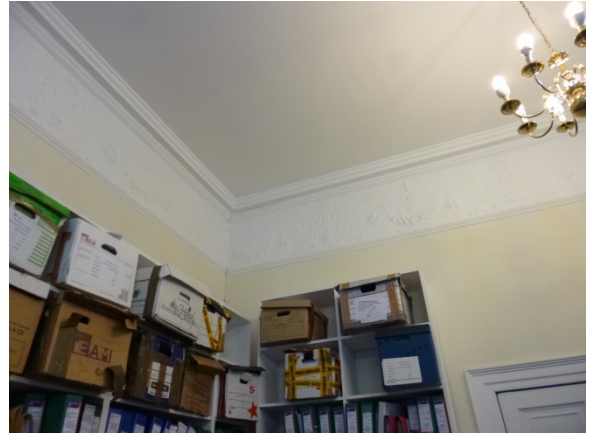
6. At first floor level there was further evidence of minor differential movement between the spine partition and party walls. There was also evidence of cracking to the sides and over the double door opening into the front room indicating minor settlement (see photographs 6, 7 & 8).

6. Differential movement between spine wall and party wall at first floor level.

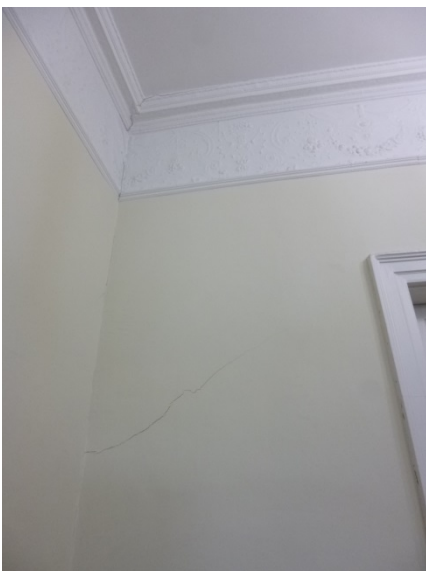
7. Differential movement between spine wall and party wall.

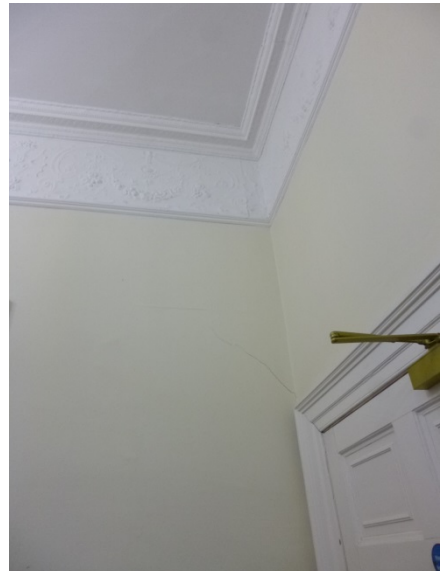
8. Movement of timber stud walls/floor.

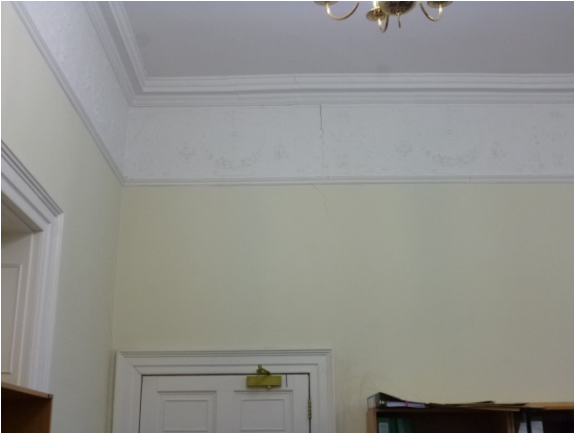
9. Differential movement and cracking between stair and timber stud wall.

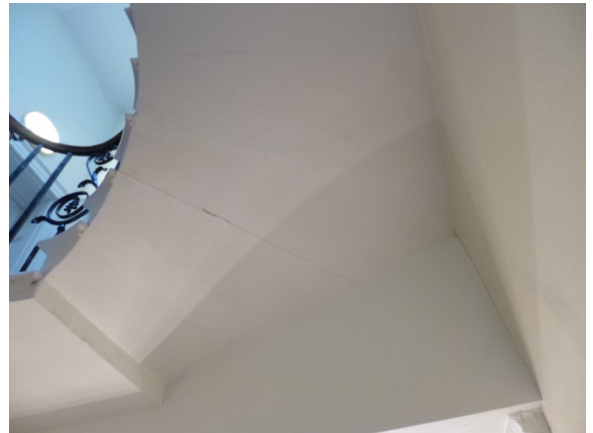
10. Hairline cracking to underside of stair.

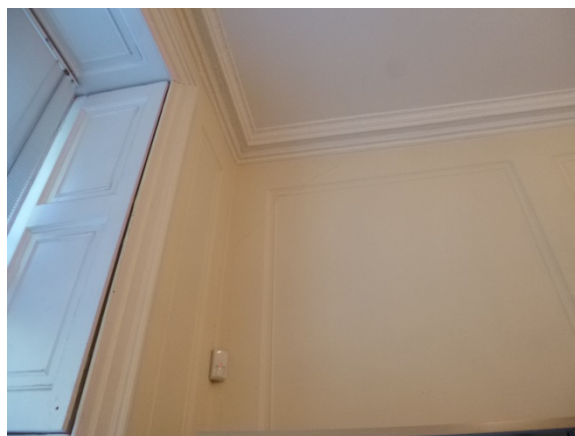
7. At ground floor level there was evidence of minor differential movement and cracking between the hall wall and the front wall of the property (see photograph 11).

11. Differential movement between hall wall and front wall at ground floor level.

1. Strengthen the support to the hall wall.
2. Add steel plate strengthening to adjacent the main beam.
3. Strengthen joists below partition wall (accessed from basement below).
4. Make good ceiling in basement below.
5. Leaving the plaster cornice in place, locally remove the plaster from the ceiling and investigate the beam/floor construction below the spine wall at 1st floor level. Strengthen and make good.
