**DAMAGE ASSESSMENT REPORT  
OF  
NEIGHBOURING STRUCTURES  
DUE TO EXCAVATION AT**

**99A FROGNAL, HAMPSTEAD,  
LONDON, NW3 6XR**

**REF: 214073 - MARCH 2014**

RIBA Stage C - Damage Assessment Report

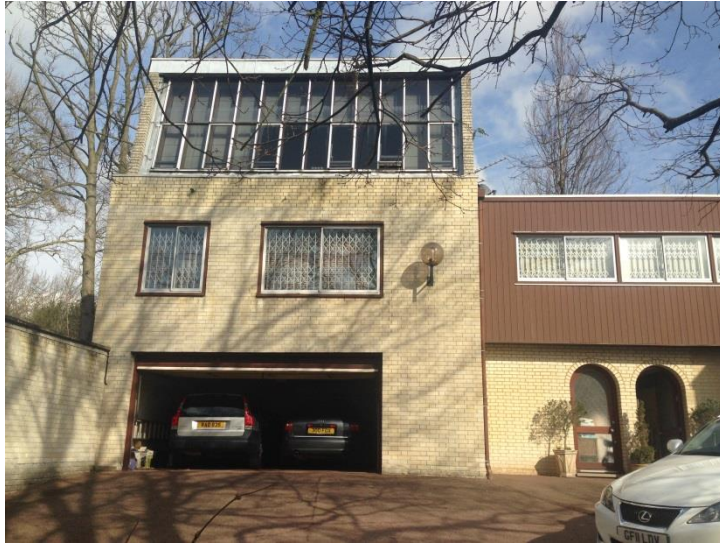
- 5.3 The front and side elevations to no.4a were robust in construction comprising stretcher bond brickwork in sand/cement mortar. There was no evidence of defect or signs of movement. See photograph 1. The building had solid flank walls at 90 degrees to the back wall providing good buttresses. The walls were bonded at the corners. The top mansard construction was an extension to the original building.

1. 4a Oak Hill Park - front.

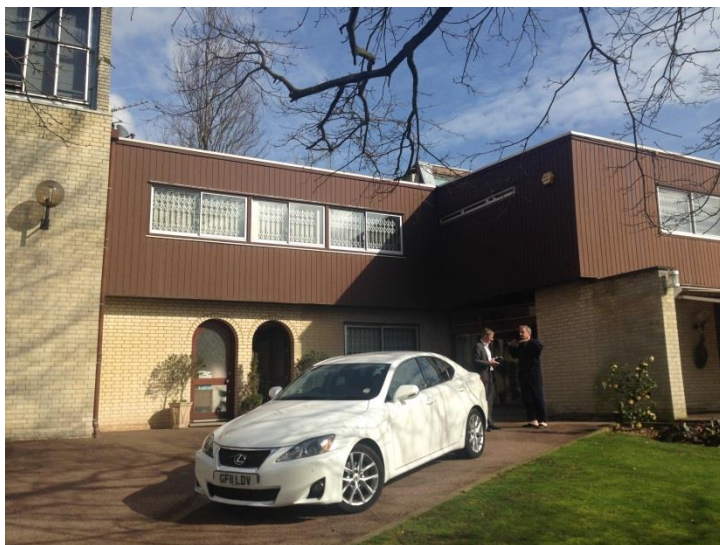
- 5.4 No.4 Oak Hill Park was set on 2 storeys with the ground floor similar in construction to 4a with the first floor covered in a cladding system. See photograph 2 and 3.

2. 4 Oak Hill Park - front.

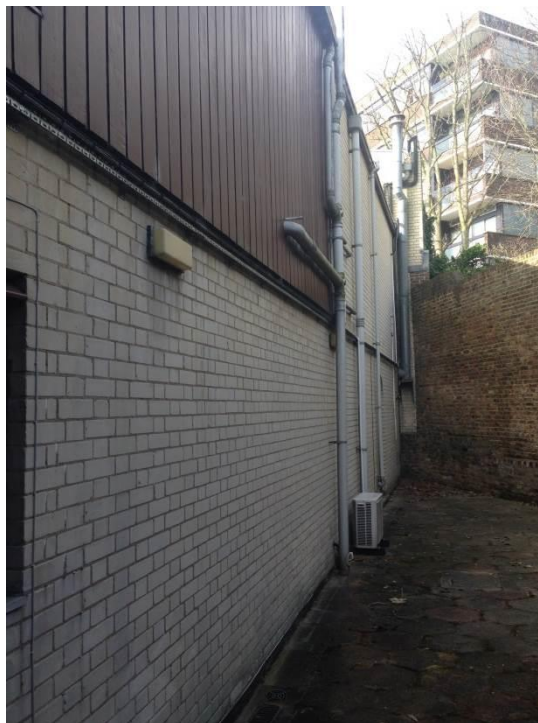
- 5.5 The rear wall of no.4 was similar in construction type to the front and was also generally free from defect. See photograph 4.
- 5.6 The rear extension seen in photograph 5 had doors and a side window exiting on to the rear yard. The rearmost wall lacked a return buttress and some minor movement was noted where the lintol met the original rear wall. Some monitoring of this existing crack should be undertaken before and during the basement excavation. It was a localised issue.

4. Rear.

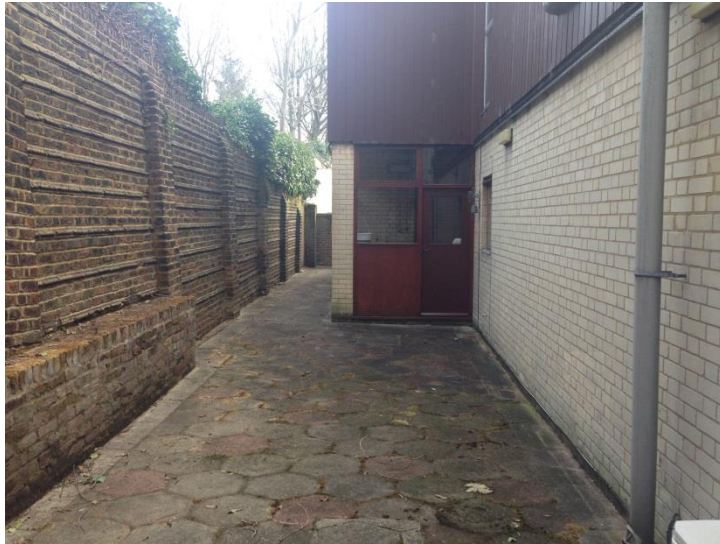
5.

- 5.7 A wall separated no.4 from the development site. See photographs 5 and 6. The wall was approximately 2.5m tall with a wider low plinth and frequent buttress piers. The wall had an outward lean of approximately 70mm at the head. This was longstanding with no evidence of progression. Level monitoring will be required at the head of the wall and we recommend flying shores are adopted to prevent any progression.

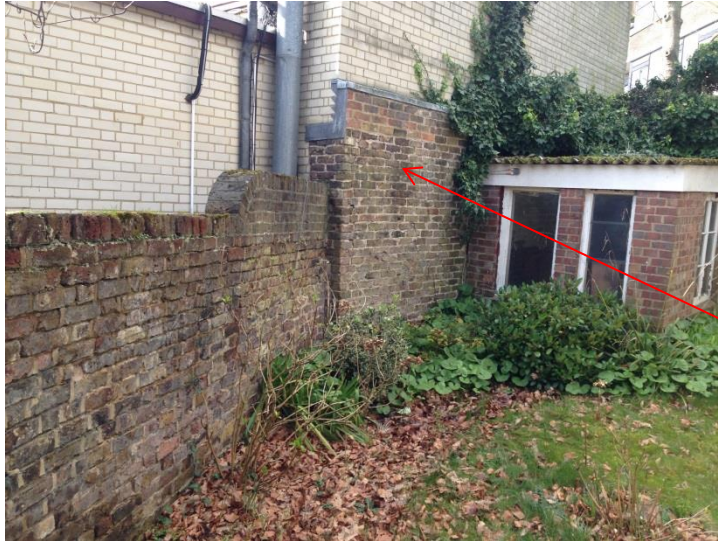
7.

- 5.8 Photographs 7 and 8 highlight the building was extended off the head of the original retaining wall. The wall was at least 2 bricks thick (440mm) formed in stock bricks consistent with the Hampstead area.

Note 4a built off original wall.

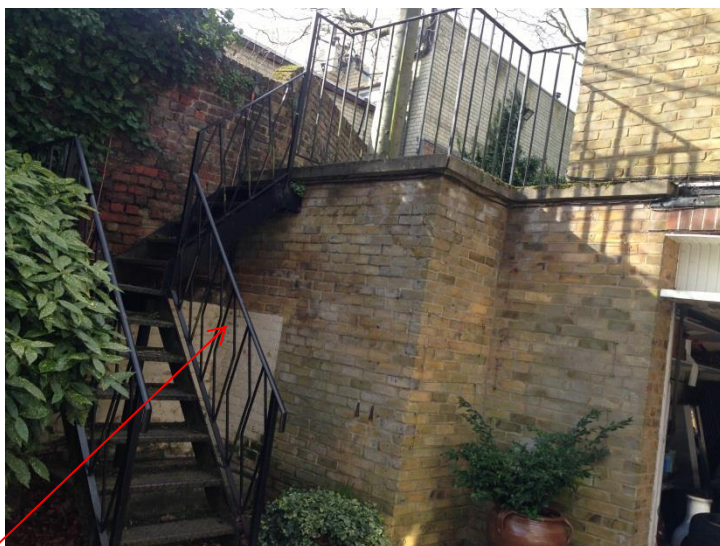
10.

- 5.9 Photographs 10 and 11 highlight the original boundary wall was constructed prior to the elevated garden being constructed on the side of 99A Frogna. There were no defects that could affect development. We recommend level monitoring of the wall is undertaken.

Photo 11 is of this  
junction

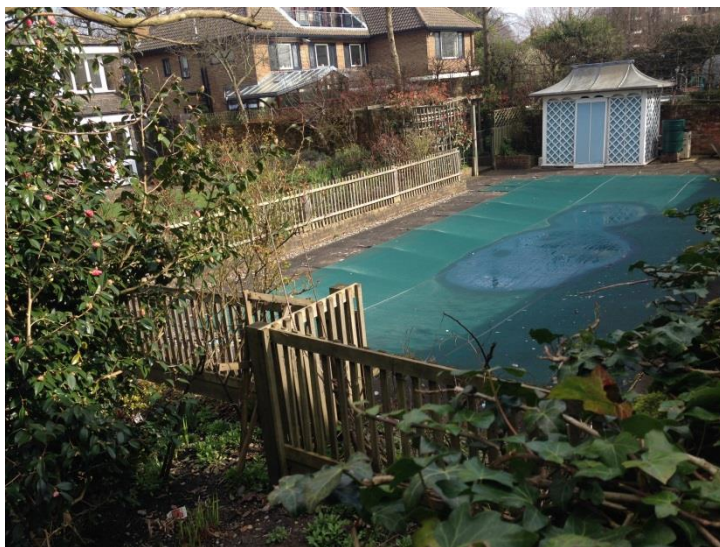
- 5.10 To the opposite boundary, a wall separates the gardens to no.5 Oak Hill Park. Beyond the wall a swimming pool had been constructed. The pool was covered but appeared

to date back approximately 20 years or so. There were no visible defects although close inspection was not feasible. See photographs 12-14.

12. Swimming pool to No. 5
