# Engineers Report

**OUR REFERENCE** .....: B1201463  
**CLAIM REFERENCE**.....: AB72CH-PUC10A  
**PREPARED FOR**.....: QBE UK Property Claims

**NAME OF INSURED** .....: Brookfield Park Surgery [Dr Sinha]  
**RISK ADDRESS** .....: 2 Brookfield Park  
London  
NW5 1ER  
**ENGINEER** .....: Stephen Reynolds  
**DATED** .....: 19/02/2014

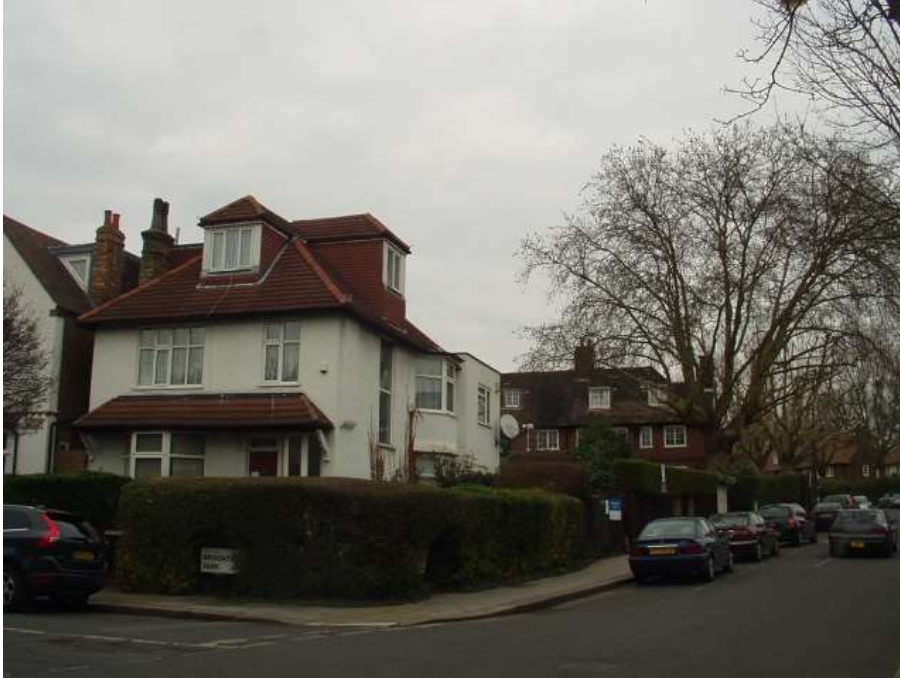
PHOTO 1 : Front and Side View of the Property

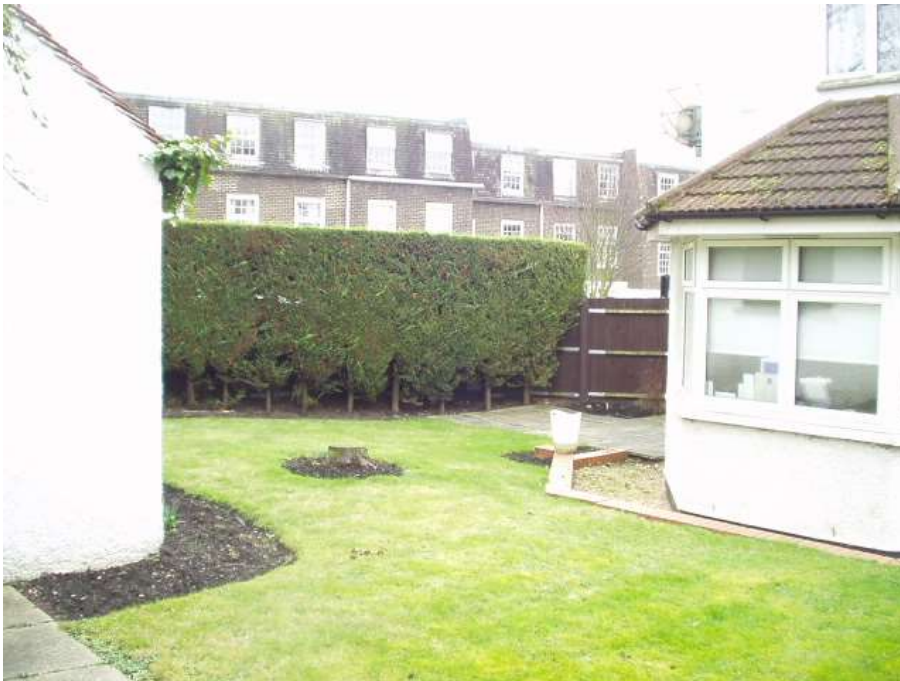
PHOTO 2 : Rear Garden – showing large tree stump and rear of detached garage

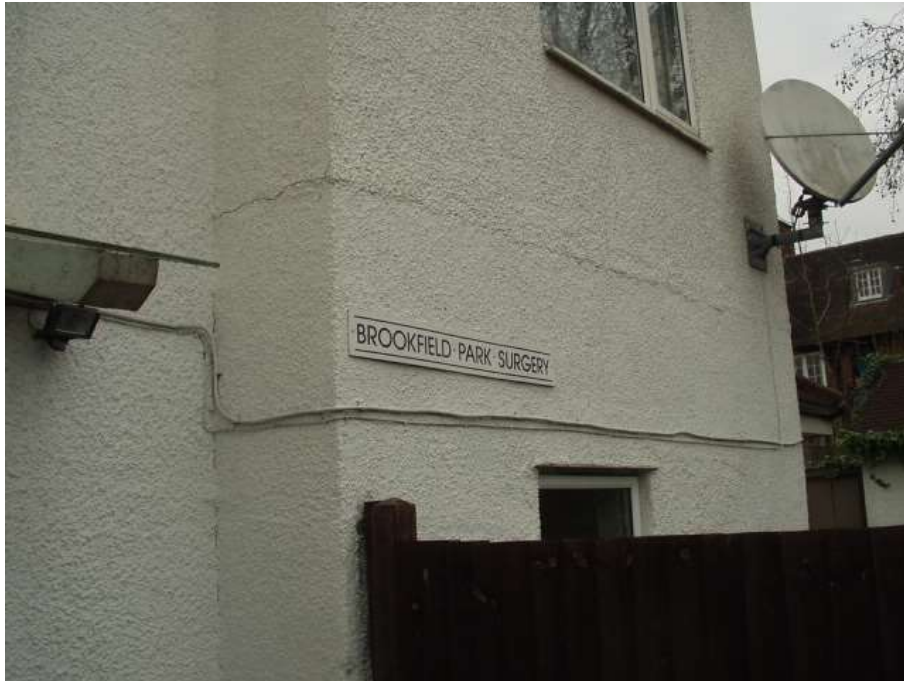
In accordance with the BRE Digest 251. The damage can be classified as Category 3 (Moderate) 5 mm up to 15 mm.

Fracture damages to both external rendered elevation and internal areas are principally to the rear right section of the property, mainly related to the rear flat roofed extension and the later single bay addition, although some associated damage were observed to the original main house.

In accordance with the site investigation results we conclude that the material cause is clay shrinkage subsidence induced by moisture extraction from roots emanating from the neighbouring London Plane tree situated within the boundary of No 1 Kingsware Road

PHOTO 3 : Typical External Damages

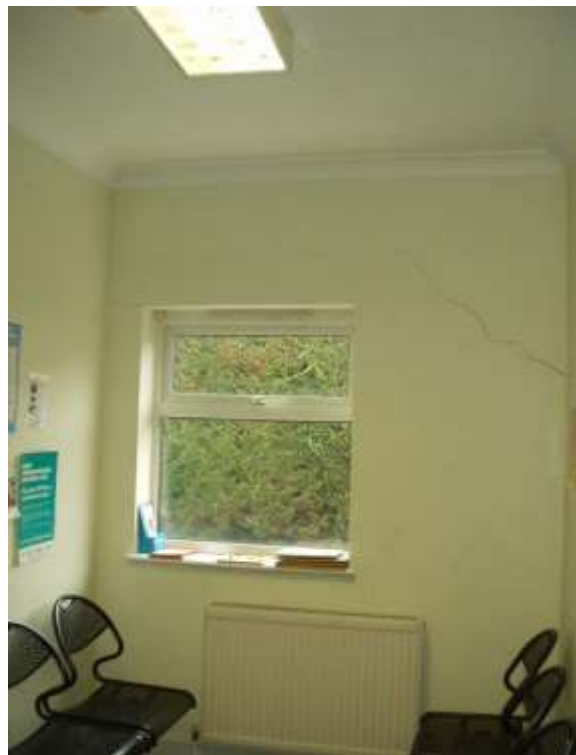
PHOTO 4 : Typical Internal Fracture Damages
