Case Ref: 2014/0150/P

EXPERT REPORT ON DAMPNES

**REPORT # RF/10/605
THERMAL IMAGING SURVEY
45 NEW COMPTON STREET
LONDON WC2**

REPORT # RF/10/633
CAVITY INSPECTION / BRICK REMOVAL
14859/PBR - 45 NEW COMPTON ST.
LONDON WC2

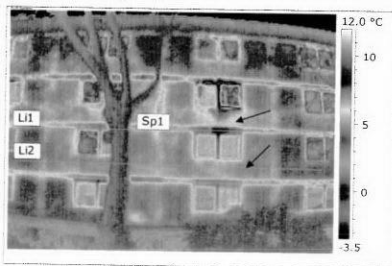
Infrared Image 1 – Centre of image is flat 18.

This section of cavity, upper arrow, (Yellow) had NO Insulation.

Red and Yellow are high heat loss areas. Endoscopic and brick removal inspections determined that there are significant insulation voids. It is very possible that these are the areas where there is little or no insulation.

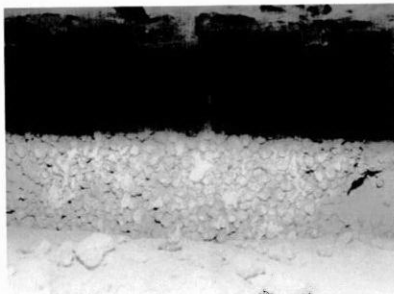
Photograph 2 – Flat 18

Close view of cavity where outer brick was removed. The inner block is the background. A small infrared camera was inserted and the 360 deg view showed an empty cavity. This section of cavity, within the range of the camera, had no insulation. Mortar filled holes were visible where insulation was supposedly blown in. The cavity width was 65mm.

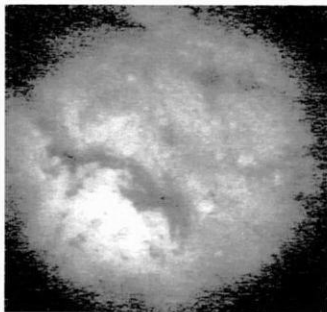
A small infrared camera was inserted in the cavity where the brick had been removed. This image is looking up to the base of the window sill DPC. (block work on left)

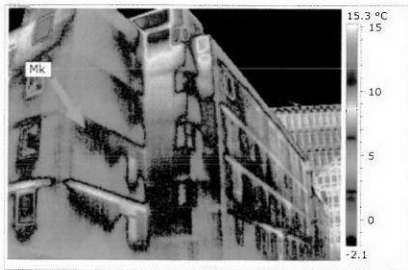
Infrared Image 6

All occupiers of the flats inspected complained of damp walls and decoration damage. The damp was confirmed on external elevations with a conventional damp meter. The image below, extracted from the February 2010 thermographic survey, clearly shows moisture spread inside the cavity down from each floor slab. (arrow)

The Endoscopic images taken for this report showed mortar rubble at the base of the cavity. No cavity tray was visible and no weep holes for water to escape were visible externally. Thermal image 6 suggests water entry is above and below the floor slabs.

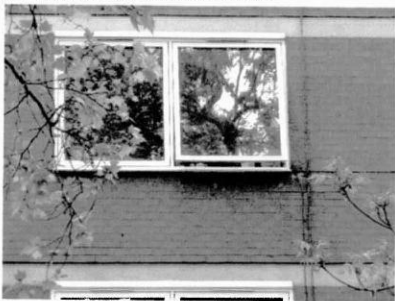
Photograph 3 – Close view of Flat 18 – No weeps holes visible.

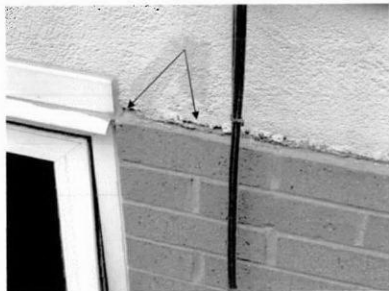
Photograph 9

The arrow points to the typical condition of the render / brick interface. A large cavity next to the window will allow wind driven rain in and past the bricks with the open holes. A waterproof filet along this step would prevent water ingress.

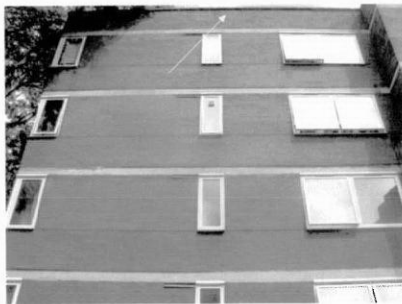
Photograph 10

The parapet coping slabs should be checked. Typically when old they allow water to enter the cavity.

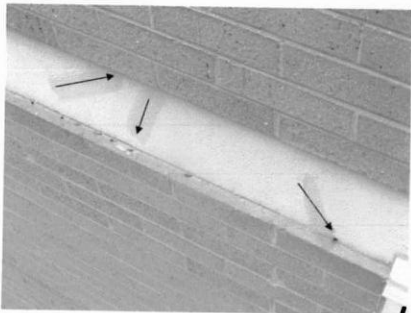
Photograph 7 – Brick Holes partly exposed where the bricks are stepped out from the slab render. Water will enter the bricks.

Photograph 7- the top arrow points to the base of the bricks. This is also a weak area as there is no drip groove and rain water can travel back and under the bricks where mortar has failed. Repaired areas were noticed in a number of places. A similar fillet should be considered here also.

A water proof fillet along the top of all brick sections or flashing is suggested.

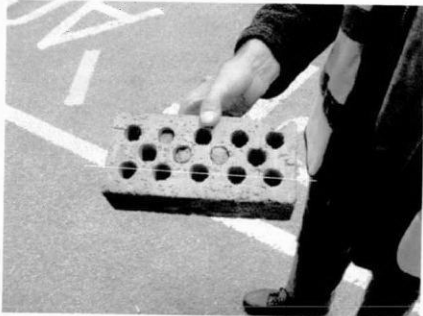
Photograph 8 – Cored Bricks.

The bricks that were removed have holes (cored bricks), shown in the above photograph. In this case, only two of the ten holes had mortar fill. The yellow line annotated along the brick is to illustrate that the uncovered projection can allow water entry.

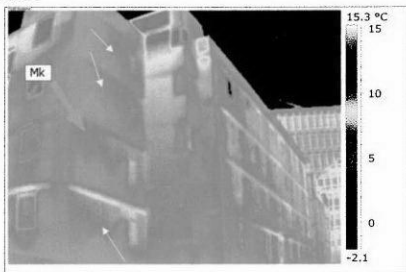
Infrared Image 2

This latest inspection confirmed that water entry is originating at each floor level brick / slab interface. The thermal image below also supports this and shows the spread from the slabs.

With no means of escape, the rain water is soaking into the inner wall blocks causing internal damp.

1. Run a waterproof file at the top and bottom interface with the floor slab band and the bricks walls.
2. Fit weep hole inserts at the base of each brick wall section.
3. Check the parapet coping slabs for mortar condition and drip off provision.
4. Insulation was only found in one of six locations inspected. It is clear from this that there must be large areas that have no insulation despite the capped filler holes. An Endoscopic image at each filler borehole location would determine the extent of missing insulation and provide information for an insulation company to fill the void areas only.

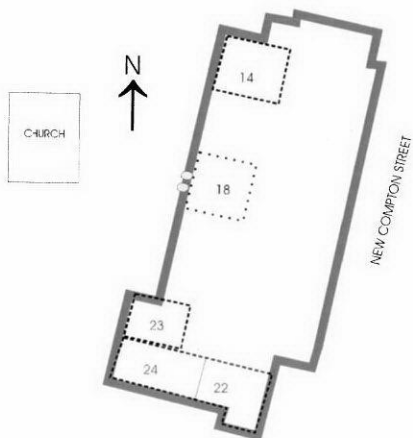
Figure 1 – Plan sketch, not to scale or accuracy, for survey reference only.

Dotted boxes are approximate locations of flats previously inspected.

Yellow circles indicate horizontal positions where bricks were removed.

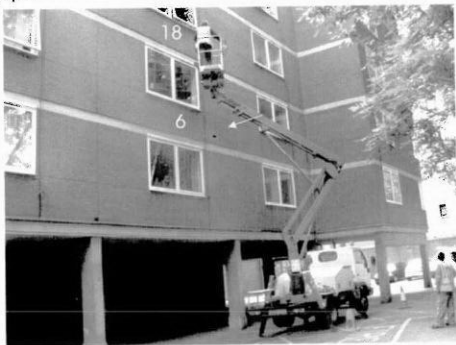
Photograph 1

Measured wall cavity width was 65mm in both locations.
