# Arboricultural Assessment Report

## Summary Report on Trees

<b>For:</b>	<b>Client:</b>	Oriel Services Limited
	<b>Insurer:</b>	Zurich - UK Commercial
<b>Site:</b>	<b>Policyholder:</b>	36 Frognal Ltd.
	<b>Risk Address:</b>	36 Frognal, London, NW3 6AG
<b>Refs:</b>	<b>OCA Ref:</b>	56161
	<b>Client Ref:</b>	7711629
	<b>Insurer Ref:</b>	CRF4031569

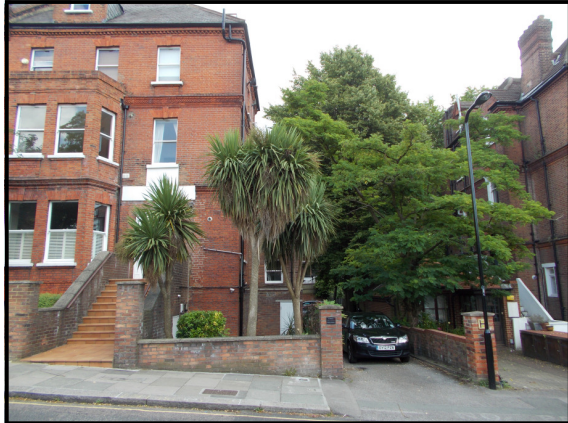
**1.** Front right of the property, G1 to left with T1, T2, T3, and T4 on the right.

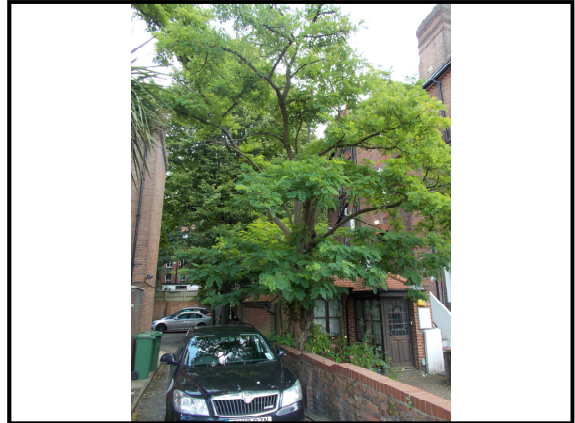
Tree No	Common Name	Age Class	Condition	Height (m)	Crown Spread (m)	Stem diam. (mm)	Dist to bldg (m)	Pruning history	Recommendation	Tree work constraints	Notes	Owner address	Owner
T1	False Acacia	MA	P	10.6	10	550	4.2	2X Main vertical limbs have been topped heavily	Fell and grind stump	None	Tree is in poor form due to previous works. Evidence of limb failure	34/34A Frognal, London, NW3 6AG	PTP
T2	Lime	MA	F	18.2	11.8	430	4.7	No significant past tree works	Fell and grind stump	None		36 Frognal, London, NW3 6AG	PH
T3	Lime	MA	F	18.5	13.8	520	6.7	No significant past tree works	Fell and grind stump	None		36 Frognal, London, NW3 6AG	PH
T4	Holly	MA	F	9.2	6	255	8.9	No significant past tree works	No work required.	N/A		36 Frognal, London, NW3 6AG	PH
G1	Yukka	MA	G	5.4	2.8	190	5	No significant past tree works	No work required.	N/A		36 Frognal, London, NW3 6AG	PH

**2.** Close up of the trees to the right from the front, T1 at front.

Tree No:	Species	Works Required
T1	False Acacia	Fell and grind stump
T2	Lime	Fell and grind stump
T3	Lime	Fell and grind stump

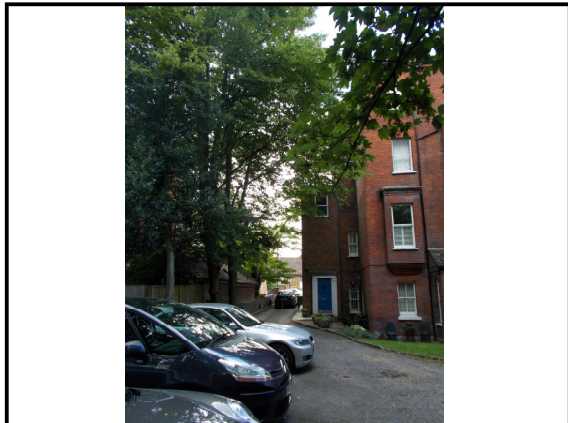
**3.** View of trees from the rear of the property
