Conservation Plan & Statement of Heritage Significance Report

**1-28 Levita House
Ossulston Estate
Chalton Street
London
NW1 1JJ**

Ref: SEB/181

Report date: 9 May 2014

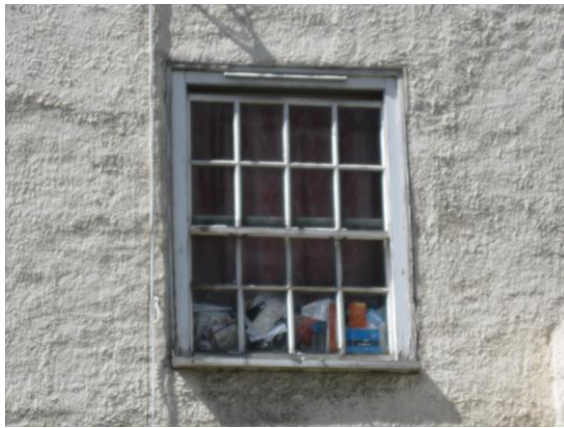
Existing sash window in 1 -21 Levita House

All windows are single glazed timber and are in a poor state of repair. They have reached the end of their serviceable life with evidence of timber decay, extremely poor decorations, glazing defects, draughts and poor levels of thermal insulation.

A similar replacement window scheme has been carried out on the immediately adjacent part of Levita House. The proposal is to use windows similar to those previously approved, i.e.; new timber double glazed windows, factory painted in white with sight lines, glazing beads etc. to replicate the existing as far as reasonably practical. The vertical sliding sashes will tilt to facilitate cleaning from inside. This will preserve the visual appearance of the building but at the same time offer residents much improved thermal and acoustic insulation. The double glazing will be provided with glazing bars very similar to the existing with white integral space bars to give the appearance of a through,

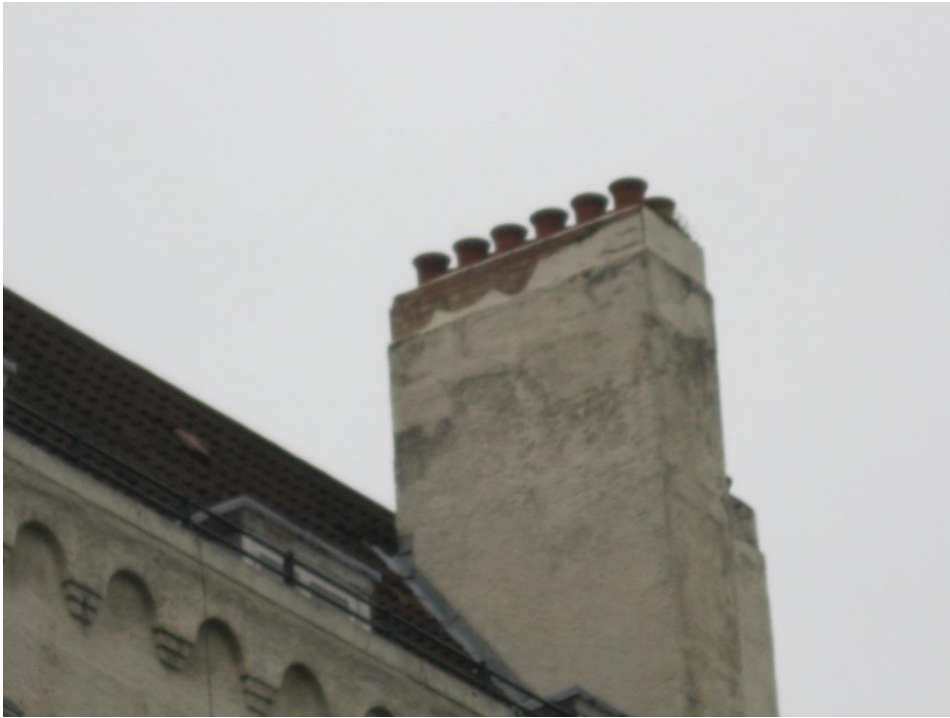
Photograph 5 Chimney defective render - rear

The render is showing signs of significant defects, particularly to the chimneys where areas are spalling and the brickwork is exposed and vegetation growth is apparent (photos 5 and 6). Similarly on the courtyard elevation, render is “live” and in need of extensive repair (e.g. photo 14).

The proposal is to sample the render to analyse the mix, remove existing and re-render the entire courtyard elevation in a rough cast finish to match the original, with the application of masonry paint in an agreed colour.

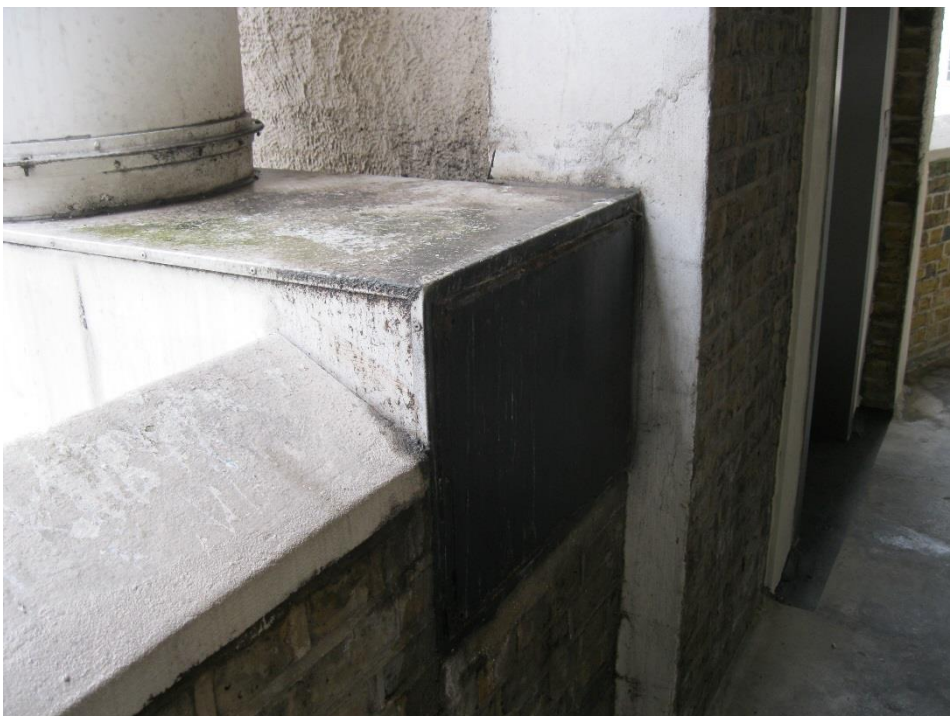
Photograph 23 Access balcony refuse chute

The main building is provided with an external steel refuse chute which does not appear to be original. It is disused and welded shut.

The proposal is to remove this and reinstate communal access balcony walls to match the adjacent original design.
