Arboricultural Consultancy for Aviva

1. Case Details

Insured	Mr Anthony Dworkin	Address	62 Albert Street, London, NW1 7NR		
Client	Infront Innovation	Contact	Arif Khalifa	Claim No.	IFS-AVI-SUB-14-0048840
MT Ref	NL/2301141643/TP	Consultant	Thomas Peppiatt	Contact No.	08702 416 180
Report Date	13/02/2014

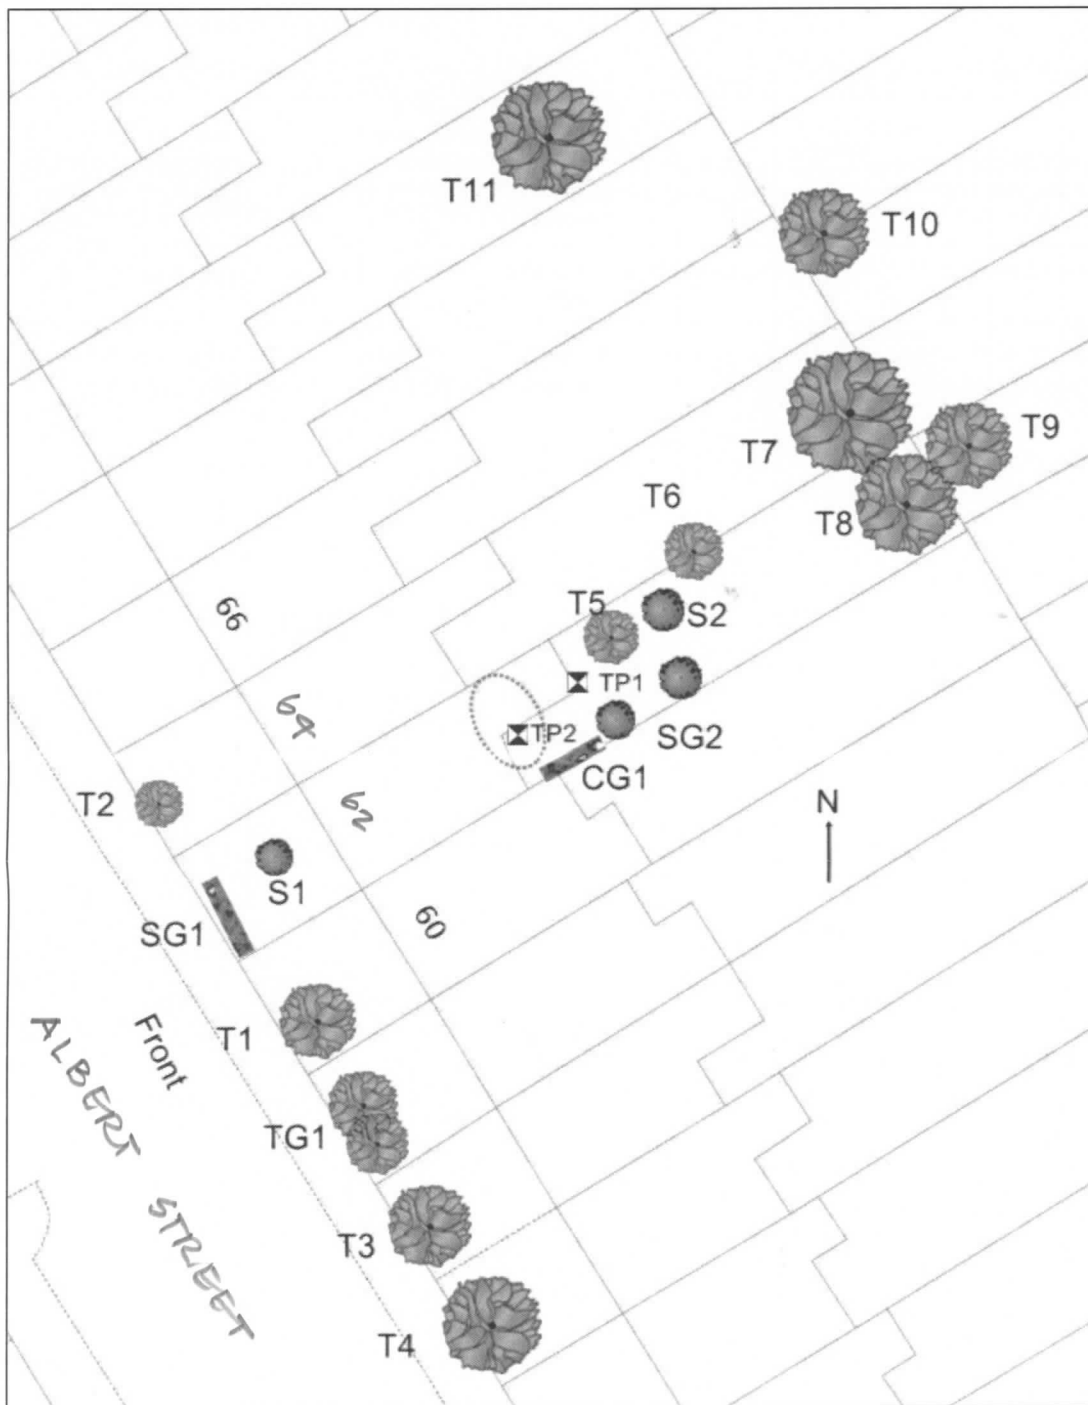
7. Site Plan

There is currently no positive root identification to implicate T5 (Apple) and T7 (Plane (London)), however based on our assessment on site we consider that the footings of the subject property fall within the anticipated rooting zone of this vegetation.

In assessing the potential drying influence of the vegetation on site, T7 (Plane (London)) is considered the dominant feature and accordingly we have identified them as the principal cause of subsidence. T5 (Apple) is also considered to retain a contributory

Trial pits are shown on the site plan for information purposes, however results were not known at the time of our visit.

Tree No.	Species	Age Cat	Approx. Height (m)	Distance to Building (m)	Ownership	Action	Requirement
T5	Apple	1	4	3.7	C - Insured	Remove	Remove and treat stump to inhibit regrowth.
T7	Plane (London)	1	18.5	17.6	A - Third Party No 64 Albert Street. London. NW1 7NR.	Remove	Remove and treat stump to inhibit regrowth.
