Arboricultural Assessment Report

Summary Report on Trees

For:	Client:	Oriel Services Limited
	Insurer:	Aviva
Site:	Policyholder:	14 Greville Road Management
	Risk Address:	Flat 4, 14 Greville Road, London, NW6 5JA
Refs:	OCA Ref:	55206
	Client Ref:	7489761
	Insurer Ref:	9590302120

Survey By:	John Hall		
Title:	Senior Consulting Arborist	Date:	28 th November 2013
Report By:	Andrew Graham		
Title:	Senior Consulting Arborist	Date:	24 th December 2013
Revisions By:	Margaret MacQueen		
Title:	Consultant Arborist	Date:	09 th September 2014

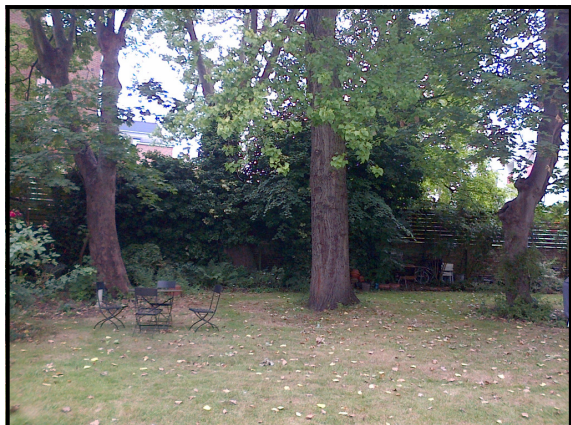
1. T1 to T3 looking west [T4 to left view margin]

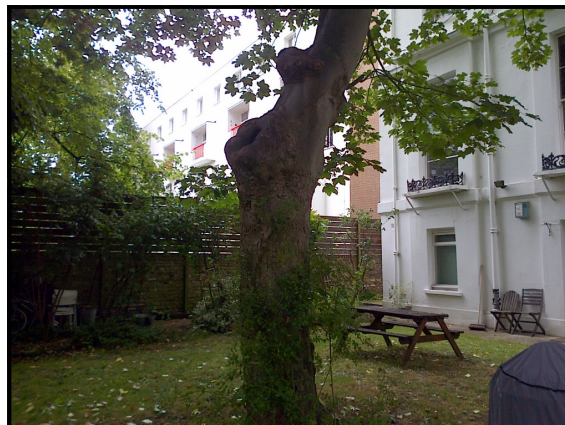
2. T1 Sycamore looking north west

Tree No:	Species	Works Required
T1	Sycamore	Fell as close to ground level as possible and treat the stump
T2	Hybrid Black Poplar	Fell as close to ground level as possible and grind out the stump
T4	Hybrid Black Poplar	Fell as close to ground level as possible and treat the stump

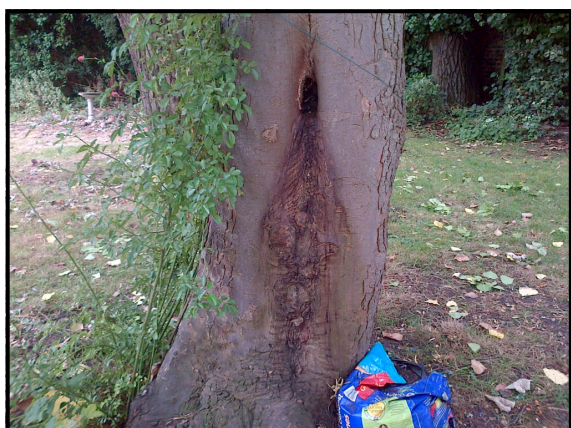
Tree No	Common Name	Age Class	Condition	Height (m)	Crown Spread (m)	Stem diam. (mm)	Dist to bldg (m)	Pruning history	Recommendation	Tree work constraints	Notes	Owner address	Owner
T1	Sycamore	MA	P	18.5	12	540	7.5	Reduced >5 years ago	Fell and treat stump	None	1 sided crown. Historical pollard at 3m. Extensive cavity at 2.5m and cavity in trunk at 1m.	12 Greville Road, London, NW6 5JA	3P
T2	Hybrid Black Poplar	MA	F	23	13	920	12	Reduced >5 years ago	Fell and treat stump	None	Reduced in past to around 18m	12 Greville Road, London, NW6 5JA	3P
T4	Hybrid Black Poplar	FM	F	22	12	800	15.5	Reduced >5 years ago	Fell and treat stump	N/A	Tree is at an angle growing over wall. Irregular shaped trunk due to the wall. All dimensions estimated due to restricted access and views.	12 Greville Road, London, NW6 5JA	3P

3. Cavity T1 Sycamore

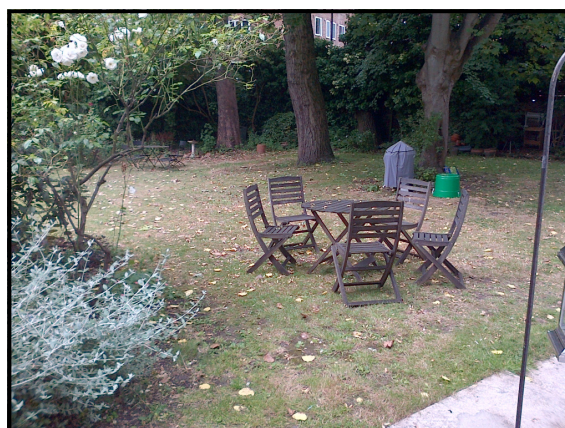
4. Trees looking south in rear garden of No 14

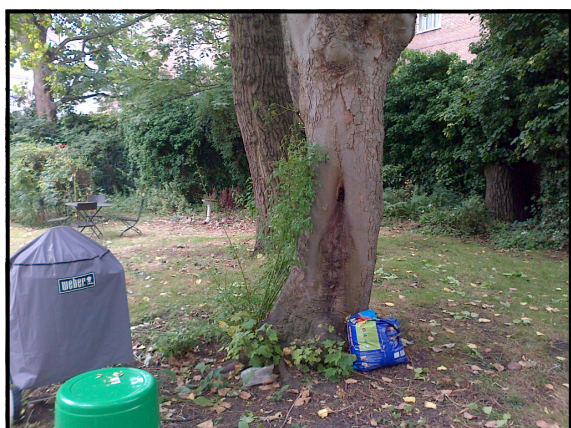
5. T1 Sycamore
