Arboricultural Assessment Report

Summary Report on Trees

For:	Client:	Oriel Services Limited
	Insurer:	Aviva
Site:	Policyholder:	14 Greville Road Management
	Risk Address:	Flat 4, 14 Greville Road, London, NW6 5JA
Refs:	OCA Ref:	55206
	Client Ref:	7489761
	Insurer Ref:	9590302120

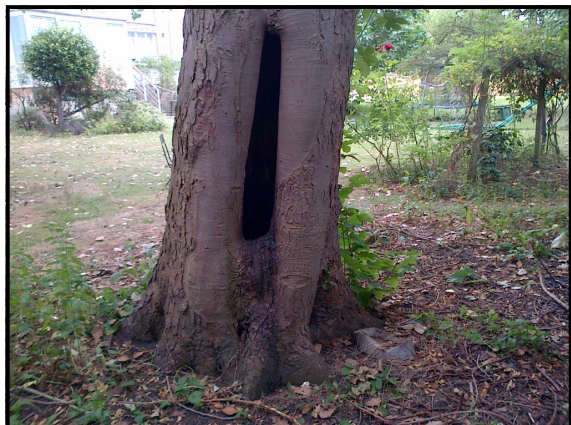
1. Sycamore T3

In the case of Sycamore T3 the extend of the decay is obvious: the hazard is very apparent..

A very significant proportion of what is a woody cylinder has been hollowed out by the decay agent

Sycamore T3 has cavity 2m deep and almost full width diameter with an opening partially facing normal south westerly winds

Tree No	Common Name	Age Class	Condition	Height (m)	Crown Spread (m)	Stem diam. (mm)	Dist to bldg (m)	Pruning history	Recommendation	Tree work constraints	Notes	Owner address	Owner
T3	Sycamore	MA	F	18	12	800	17.3	Crown lifted.	Fell and treat - for health and safety	Overhangs adjacent substation	Significant cavity and decay in main trunk.	12 Greville Road, London, NW6 5JA	3P

Tree No:	Species	Works Required
T3	Sycamore	Fell as close to ground level as possible and treat the stump

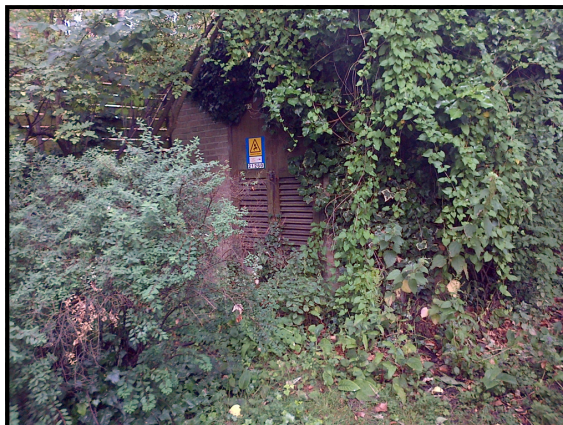
2. The UKPN substation

Trees do not respect physical or property boundaries and the weight or mass above the potential failure point of T3 is growing asymmetrically over the substation .So any degree of tree failure will result in extensive damage .
