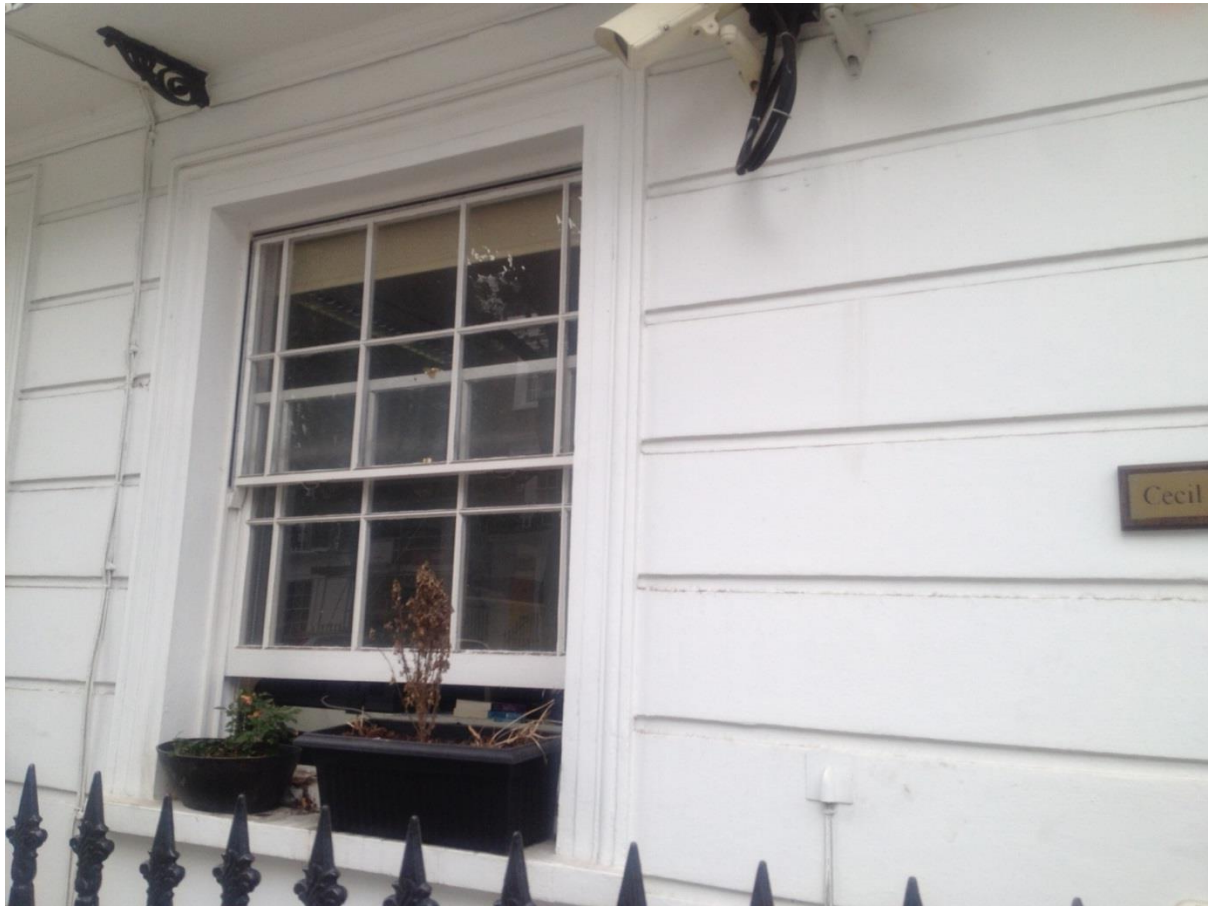
External photograph of the building, showing the works have no changed the access issues to the building or street.
