CAMDEN STABLES MARKET TACK ROOM BUILDING STRUCTURAL APPRAISAL

Rev: 1
Date: 15/01/2015
Project No: 3788
Ref: P:\Projects\3788\Documents\Reports\3788-pm-rpt-0115ksa.doc

REPORT TITLE: TACK ROOM BUILDING, STRUCTURAL APPRAISAL

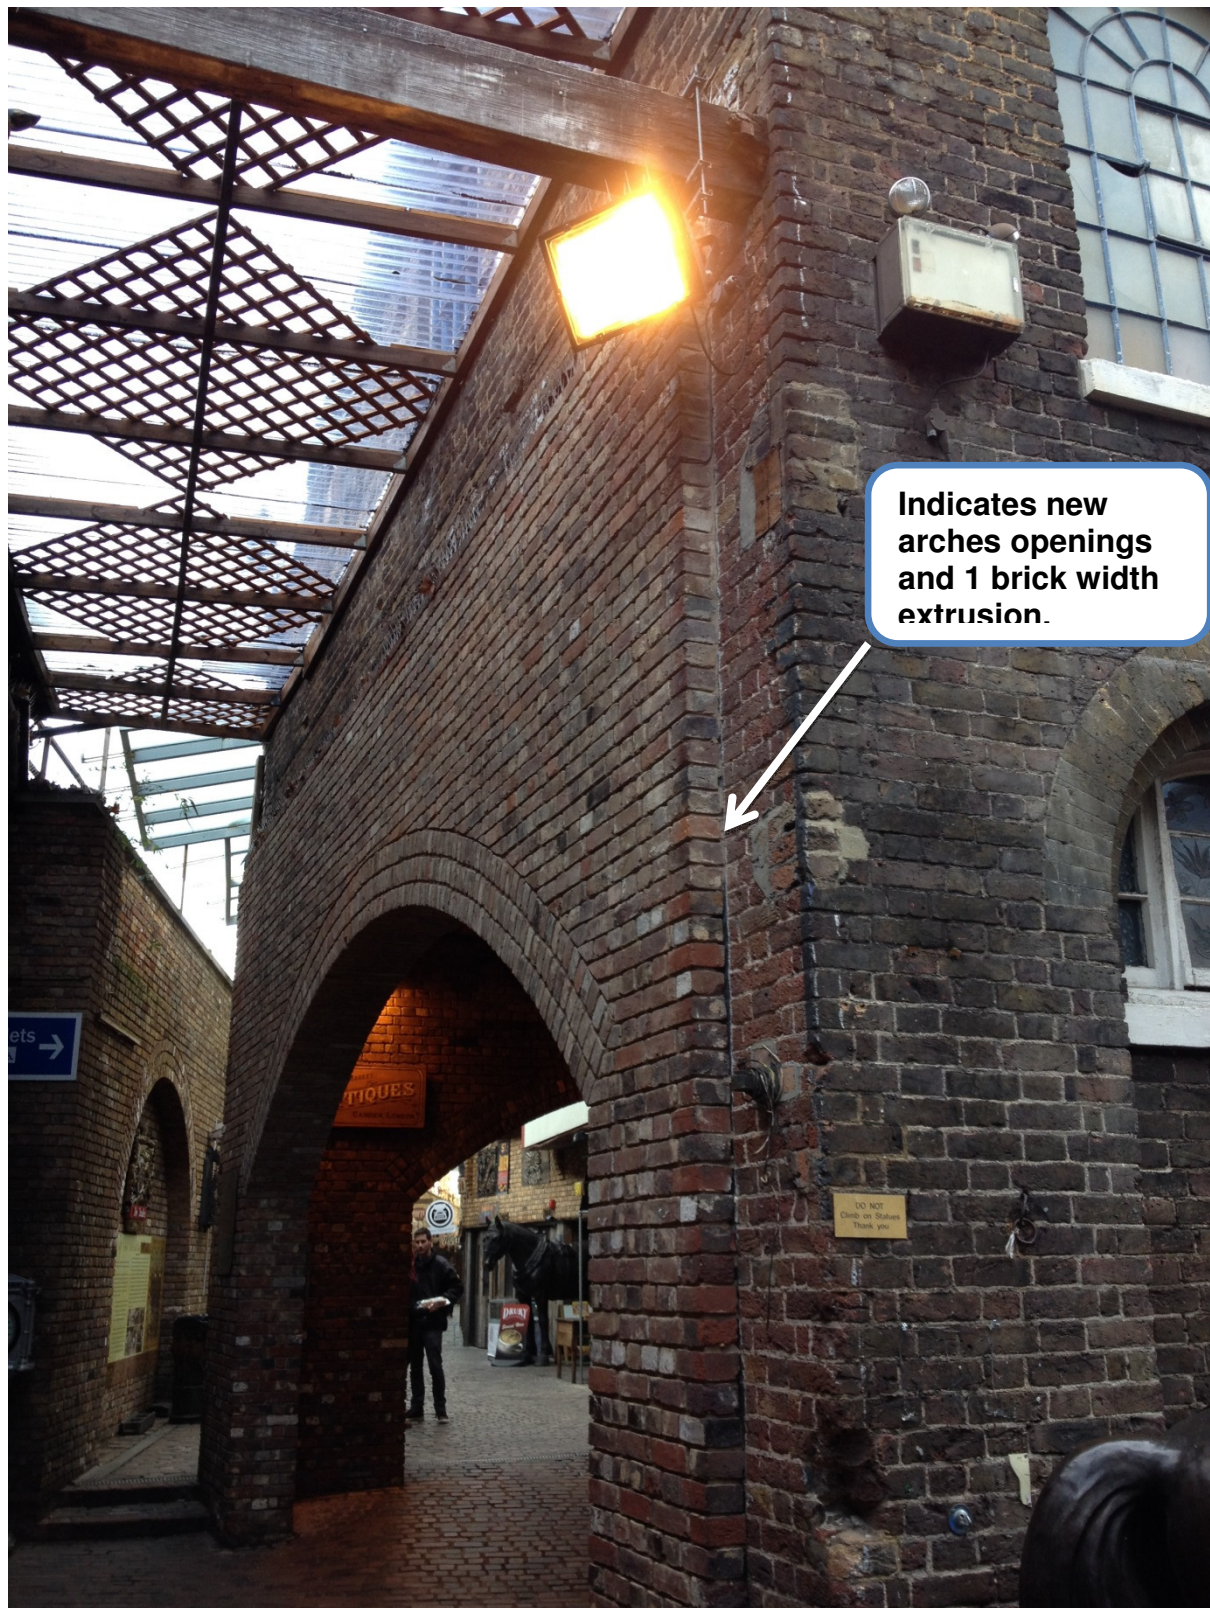
Fig 1

The most recent and visible involved the creation of two large arched openings in the Southern and Western Elevations. **Fig 1** The arches are believed to be structural and supporting the existing section of the wall above, and are approximately 1 brick wider on the outer face.

The proposed works consist of replacing the ground floor south and west elevations which are currently brick arches, and repairing the upper levels of both elevations. The design consists of providing new openings as outlined by Stephen Lavarant Heritage Architecture Ltd drawings, and Walsh drawings 3788-01-P4.

1. Temporary diagonal propping to upper section of wall to be provided on the inner face to secure the upper walls during constructor in the current double height area.
2. Install temp foundations for needle props and permanent foundations for new wall for middle section under arched where possible, being careful not to undermine existing footings.
3. Make temp opening in wall at approximately 900mm spacing to allow needle beams to pass through at upper section.

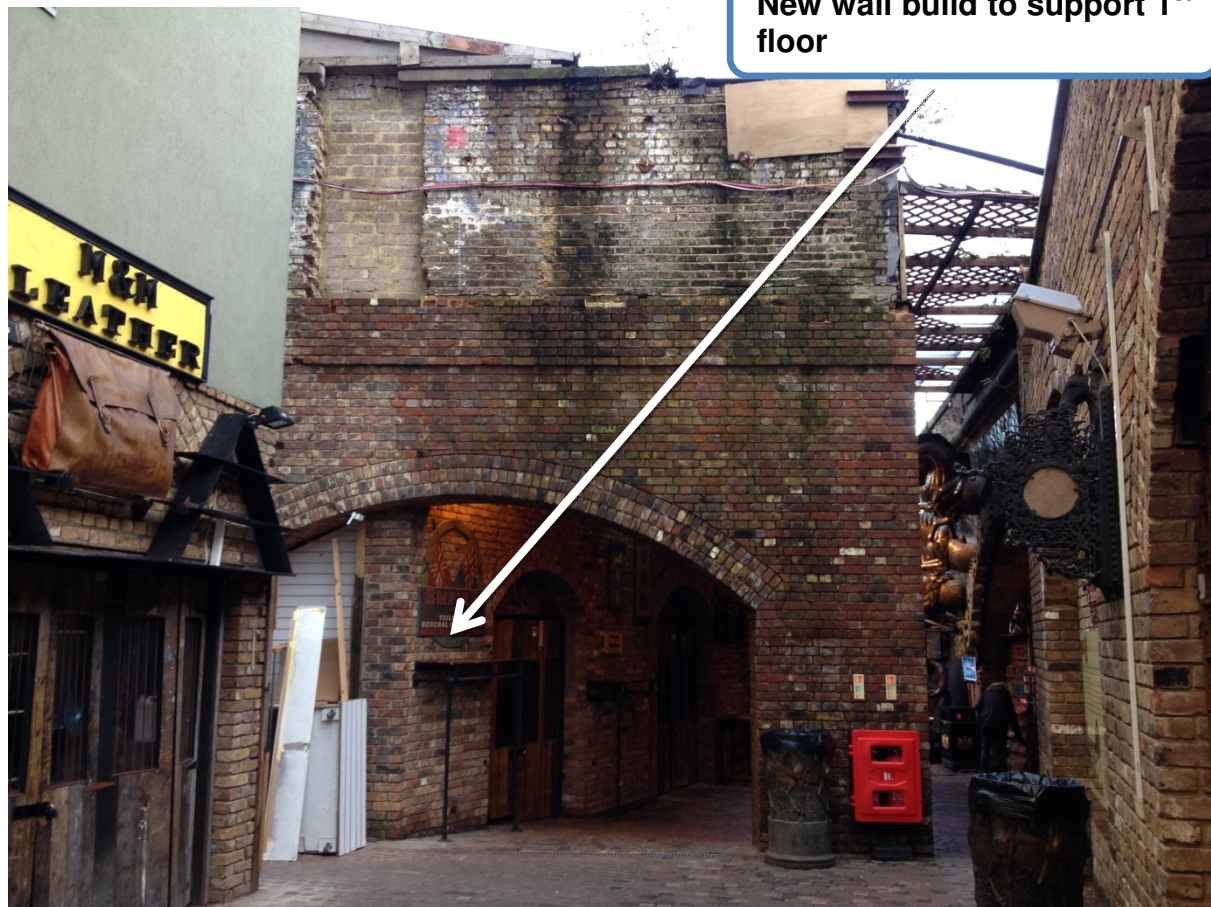
Fig 2

This has been achieved by constructing a new load bearing wall at a slight angle to support the existing 1st floor slab, and resulted in the removal of one of the existing cast iron columns further to the west. **Fig 2**

The building is in generally fair condition, apart from South-western corner of the building. **Fig 2** demonstrates the existing condition of the various masonry walls.

In addition a section in the corner has suffered from vegetation damage that has displaced the bricks enough to allow water to penetrate the joints and loosen the bond. The area was covered by a board from the outside, we assume to protect any loose brickwork from falling.

This area of the building which has seen weather damage should be repaired by temporarily popping the roof locally and removing the bricks one by one where they can be lifted freely by hand. We estimate this will be roughly an area of 1.5mx1m on elevation. Once bricks have been removed the area is to be inspected and if no further determination is noted, the bricks to be replaced using mortar of original composition and bed joint reinforcement to further strengthen the corner.

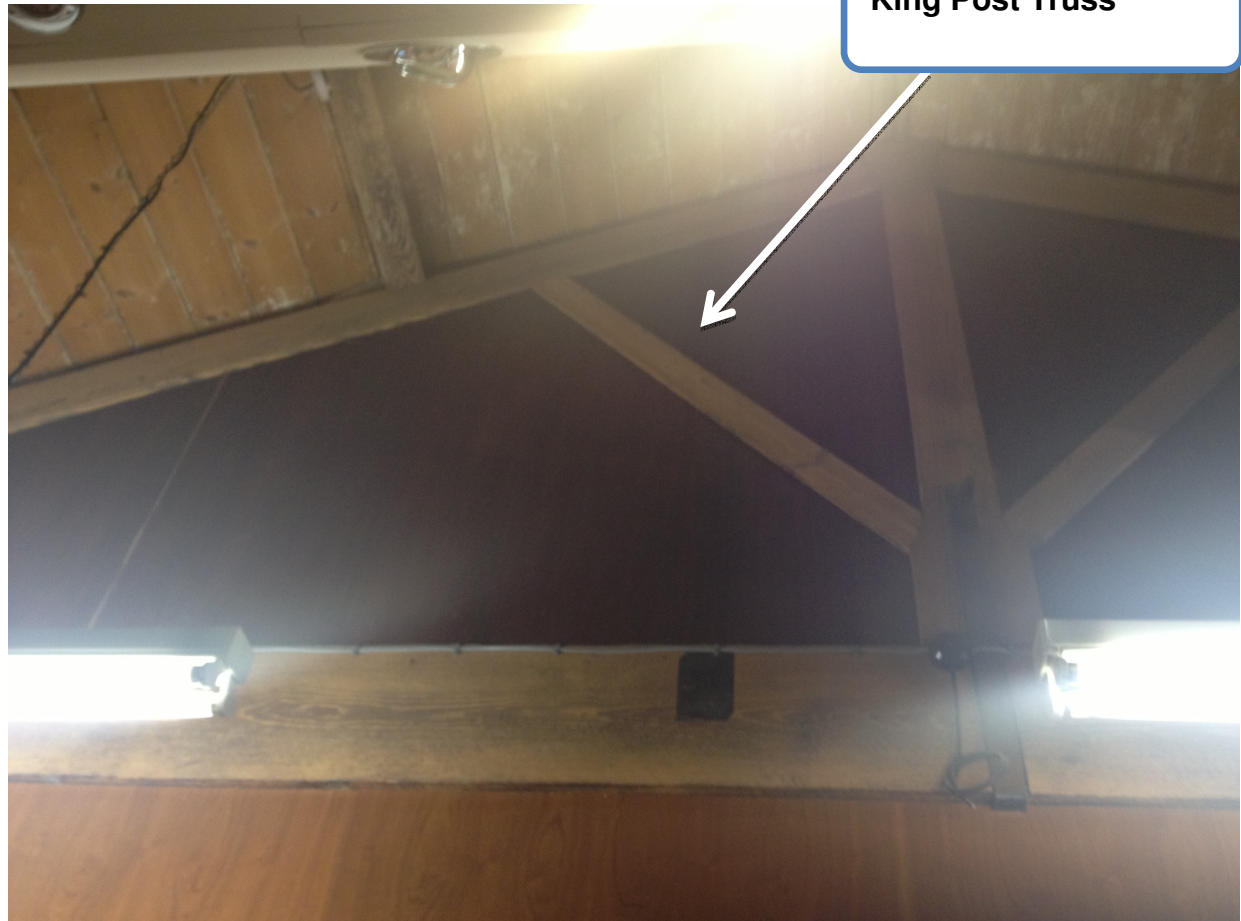
Fig 3

Roof: The roof is believed to be of traditional King Post Truss construction, supporting timber rafters that in turn support a slate roof. **(Fig 3)**

King Post Truss

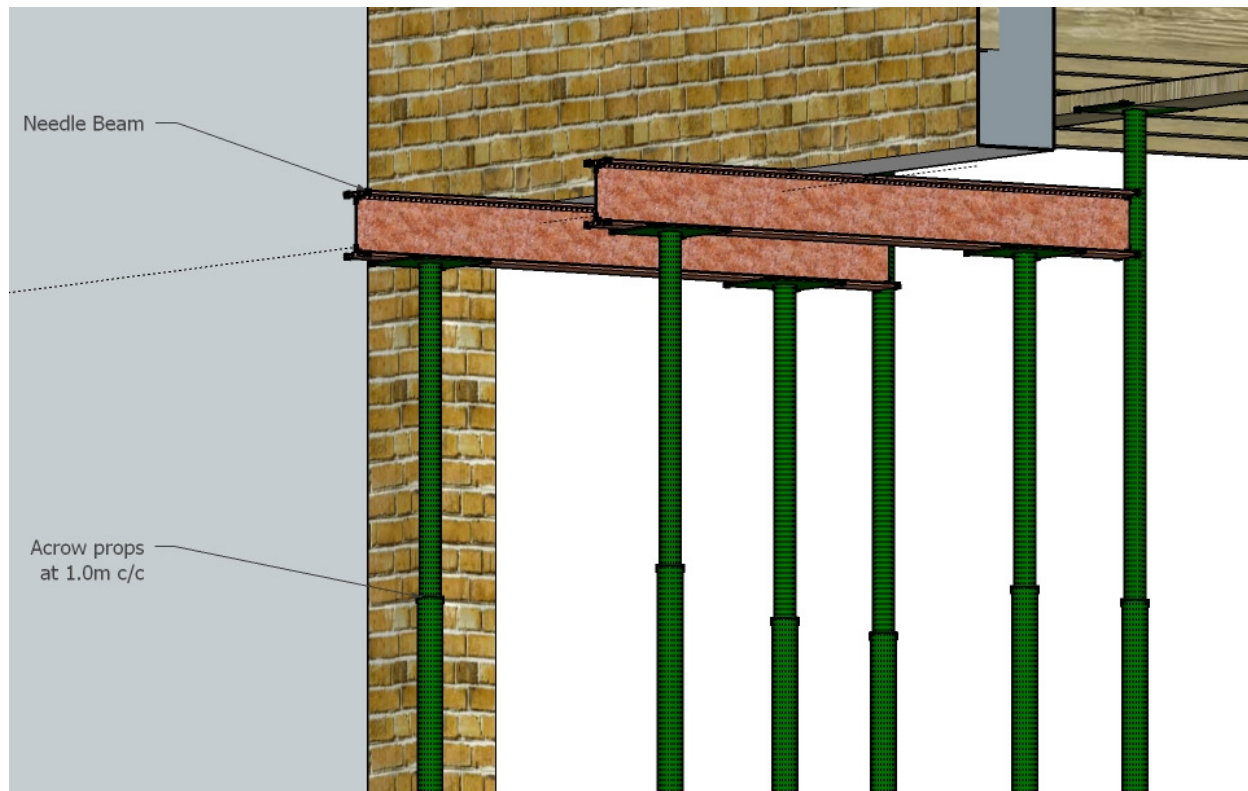
Fig 4

Proposed Wall Needles

4. Install props and needle beams at above spacing and dry pack into place **Fig 4.**
5. Following the sequence on drawings 3788-01, remove one section of wall (max 1/3rd of area on elevation) at a time and construct new wall. **Fig 5.**
