In response to site meeting 07.03.14

Robin Cripps Restoration (stone restoration specialists) were commissioned to compile a specialist report on the existing front entrance stone detailing the repair to replacement of the stone to the entrance, the entrance steps and carry out a survey and report on the condition and repair of the existing internal entrance corridor. This report was prepared by Lee Harris (Director) and is outlined on the following and attached documents & drawings.

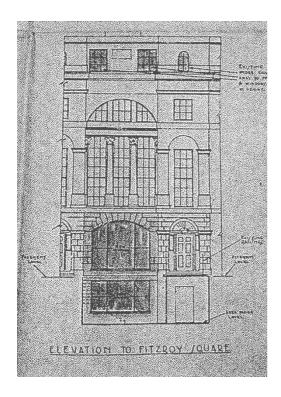
Fig. 22a Elevation to Fitzroy Square in 1931, showing proposed (and executed) new basement and floors
