Condition Report

Railings at 7 Fitzroy Square W1T 5HL, London

Report requested by Clarke Design and Build

Prepared by Susan Cook Managing Director, The Great Gate Company Ltd. 3 April 2014

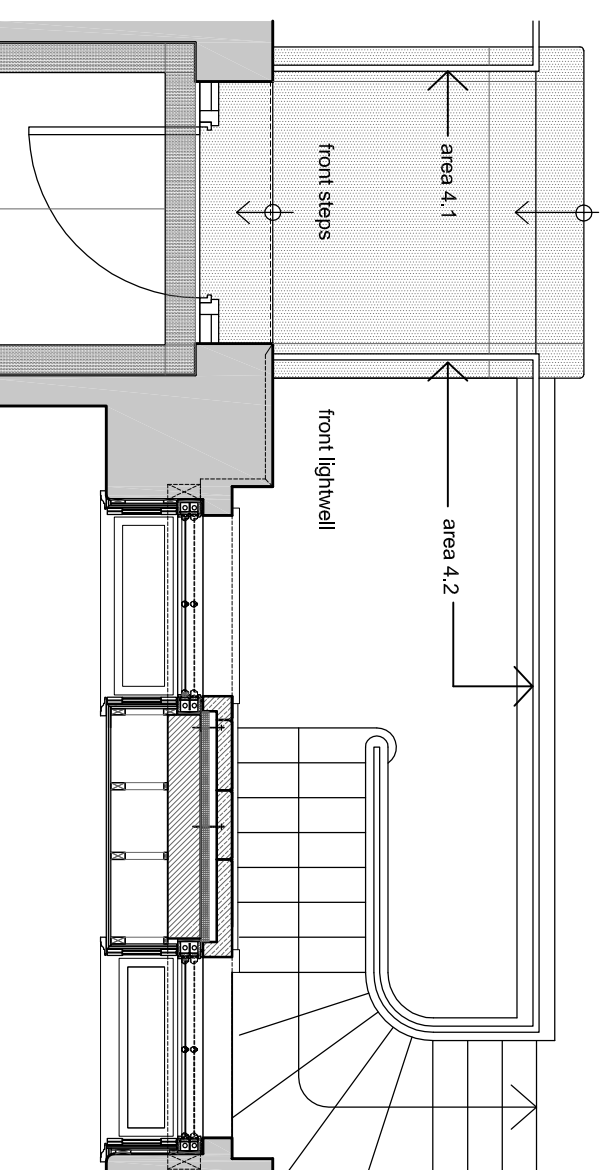
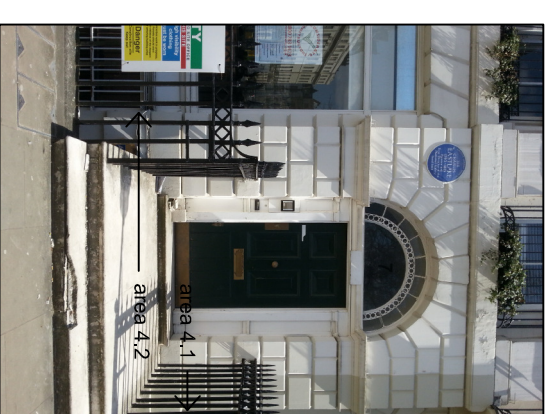
DRAWING NUMBER:
LB 07c 009

Railing report and proposed repair
