**TREE SURVEY, ARBORICULTURAL  
IMPLICATION ASSESSMENT &  
METHOD STATEMENT &  
TREE PROTECTION PLAN  
BS5837:2012**

Title:	<b>Arboricultural Report</b>
Instructed by:	Felix Xylander 25 Hatton Garden London EC1N 8BQ
Site Address:	Christchurch Primary School Christchurch Hill London
Date of Site Visit:	Wednesday 13 <sup>th</sup> August 2014
Prepared by:	Reuben Hayes
Ref:	PA.S
Date

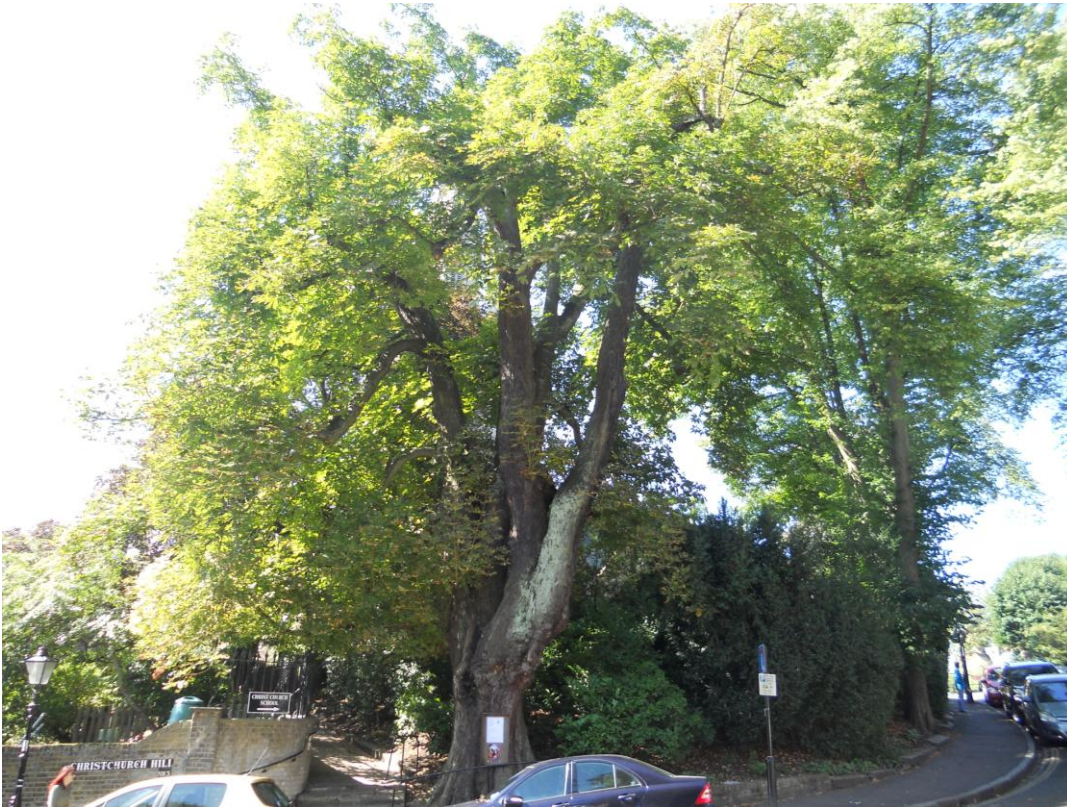
Horse Chestnut tree (T1)

- 10.3. The Horse Chestnut tree T1, is in full public view and on land which borders a road. The tree has been reduced in the past (see photos), and the canopy is in full bloom and not showing signs of decline. However, there is a *ganoderma* spp. bracket near the base of this tree, it also has a large cavity with possible *ustulina deusta* and/or *Polyporus squamosus*. There are also other signs of bacterial infections and cankers appearing on one of the main leading branches. Due to the condition of the tree it is advisable as part of the application to remove this tree.

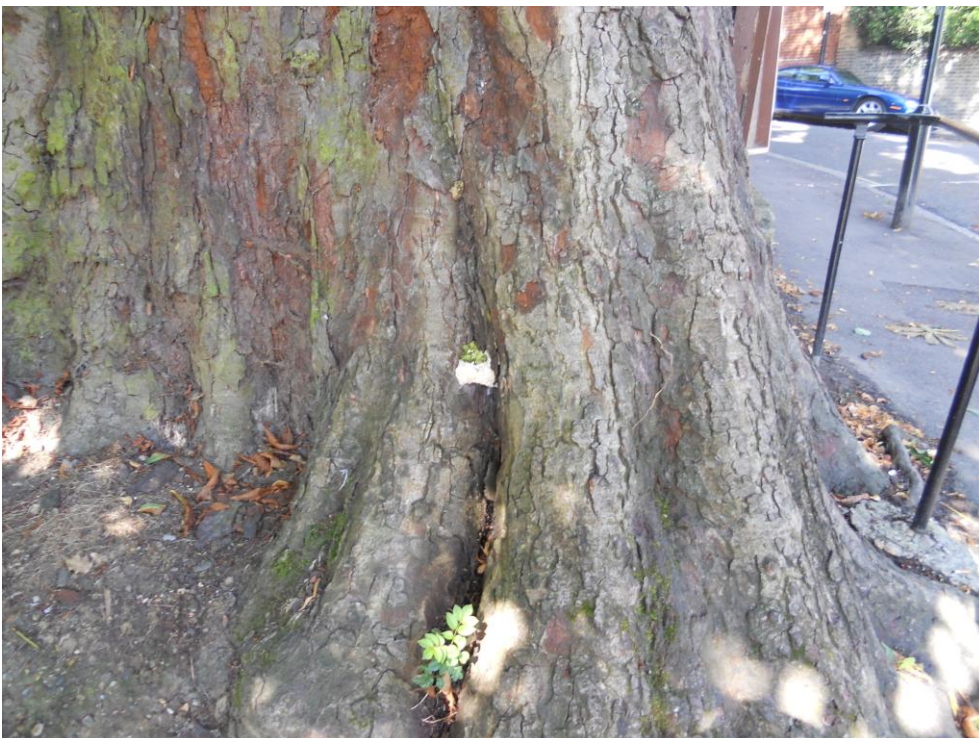
- 6.12. The significant trees on or near to the site are the Horse Chestnut tree, Beech tree and the Sycamore tree.
- 6.13. The Horse chestnut (T1) has high visually amenity value. The itself has a ganoderma spp fungus bracket on the main stem, this is an external sign that decay and rot is occurring on the inside. The tree has also been topped at some point in the recent past (within 10 years), and although new growth is forming, this will be of a weaker attachment. There are also natural branch breaks and sings of further fungus development. Although it is not possible to confirm the fungus, it is likely to be Polyporus squamosus or Ustulina deusta. There are also canker growths at this level on the other side of the main limb.

Ganoderma on Horse chestnut tree (T1)

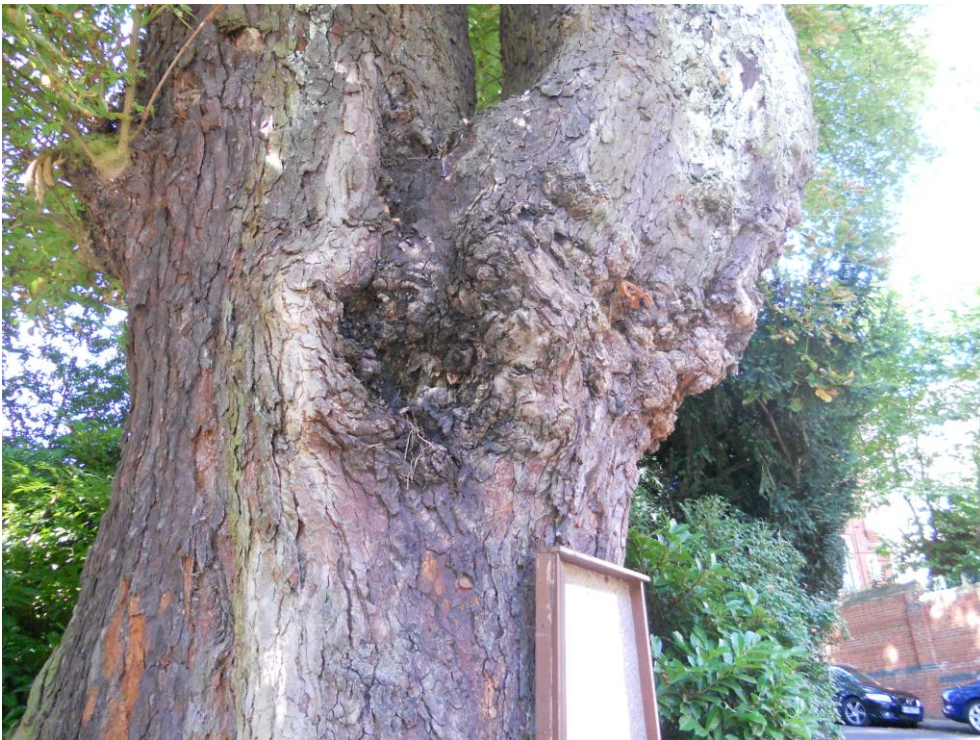
Decay and cankers on Horse Chestnut tree (T1)

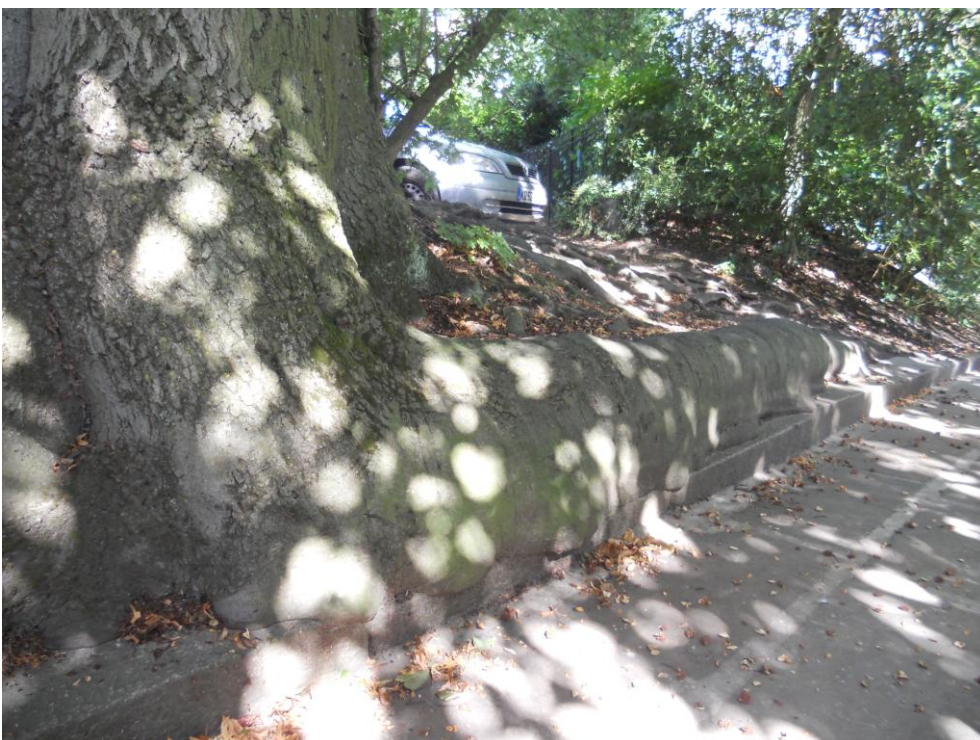
- 6.14. The Beech tree (T4) is a striking copper beech tree. This is a large mature tree with extensive lateral root system. It is likely that the roots will extend towards the car park area and the church area as opposed to the school area.

Lateral roots on Beech tree (T4)

- 11.1. There will be a need to submit a detailed method statement for the inclusion of heavy duty road mats within the RPA of the Beech T4.
- 11.2. There will be a need to outline the phasing of works, and the erection of tree protection.
- 11.3. All tree works recommended are to be carried out prior to any Site personnel being present or commencing works or any materials being delivered. (Reason): to ensure the Site is prepared and ready for the demolition and construction processes to commence.
- 11.4. Tree protection will be required in order to protect the remaining trees, these will include:

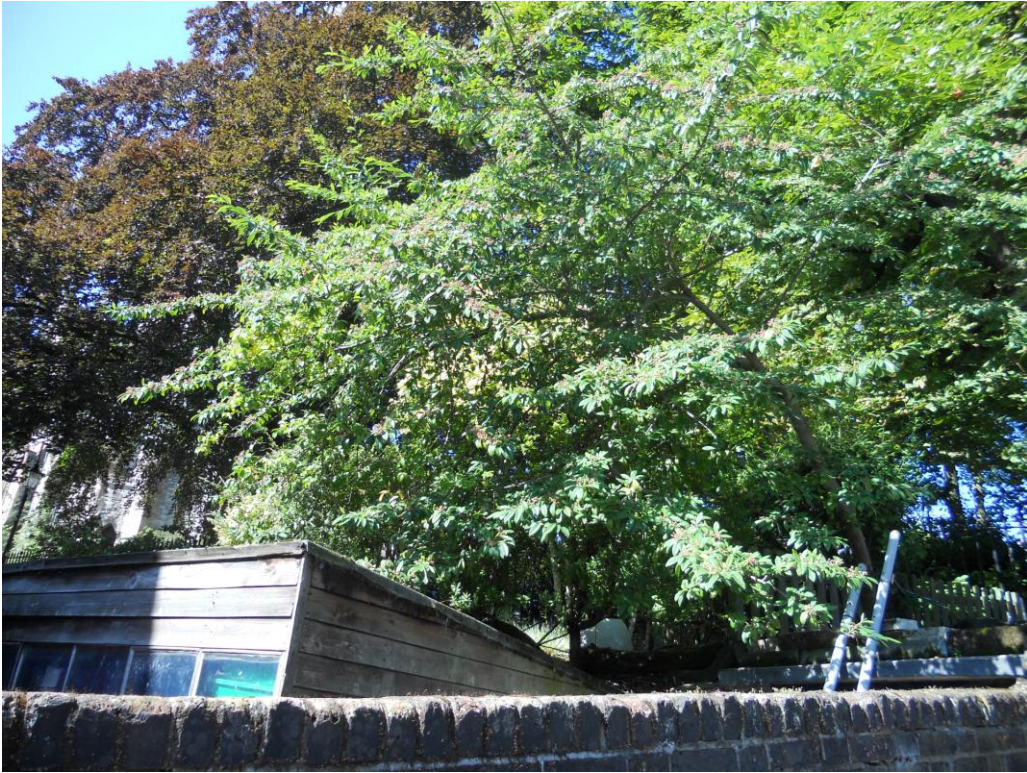
Suppressed Cotoneaster (T5)

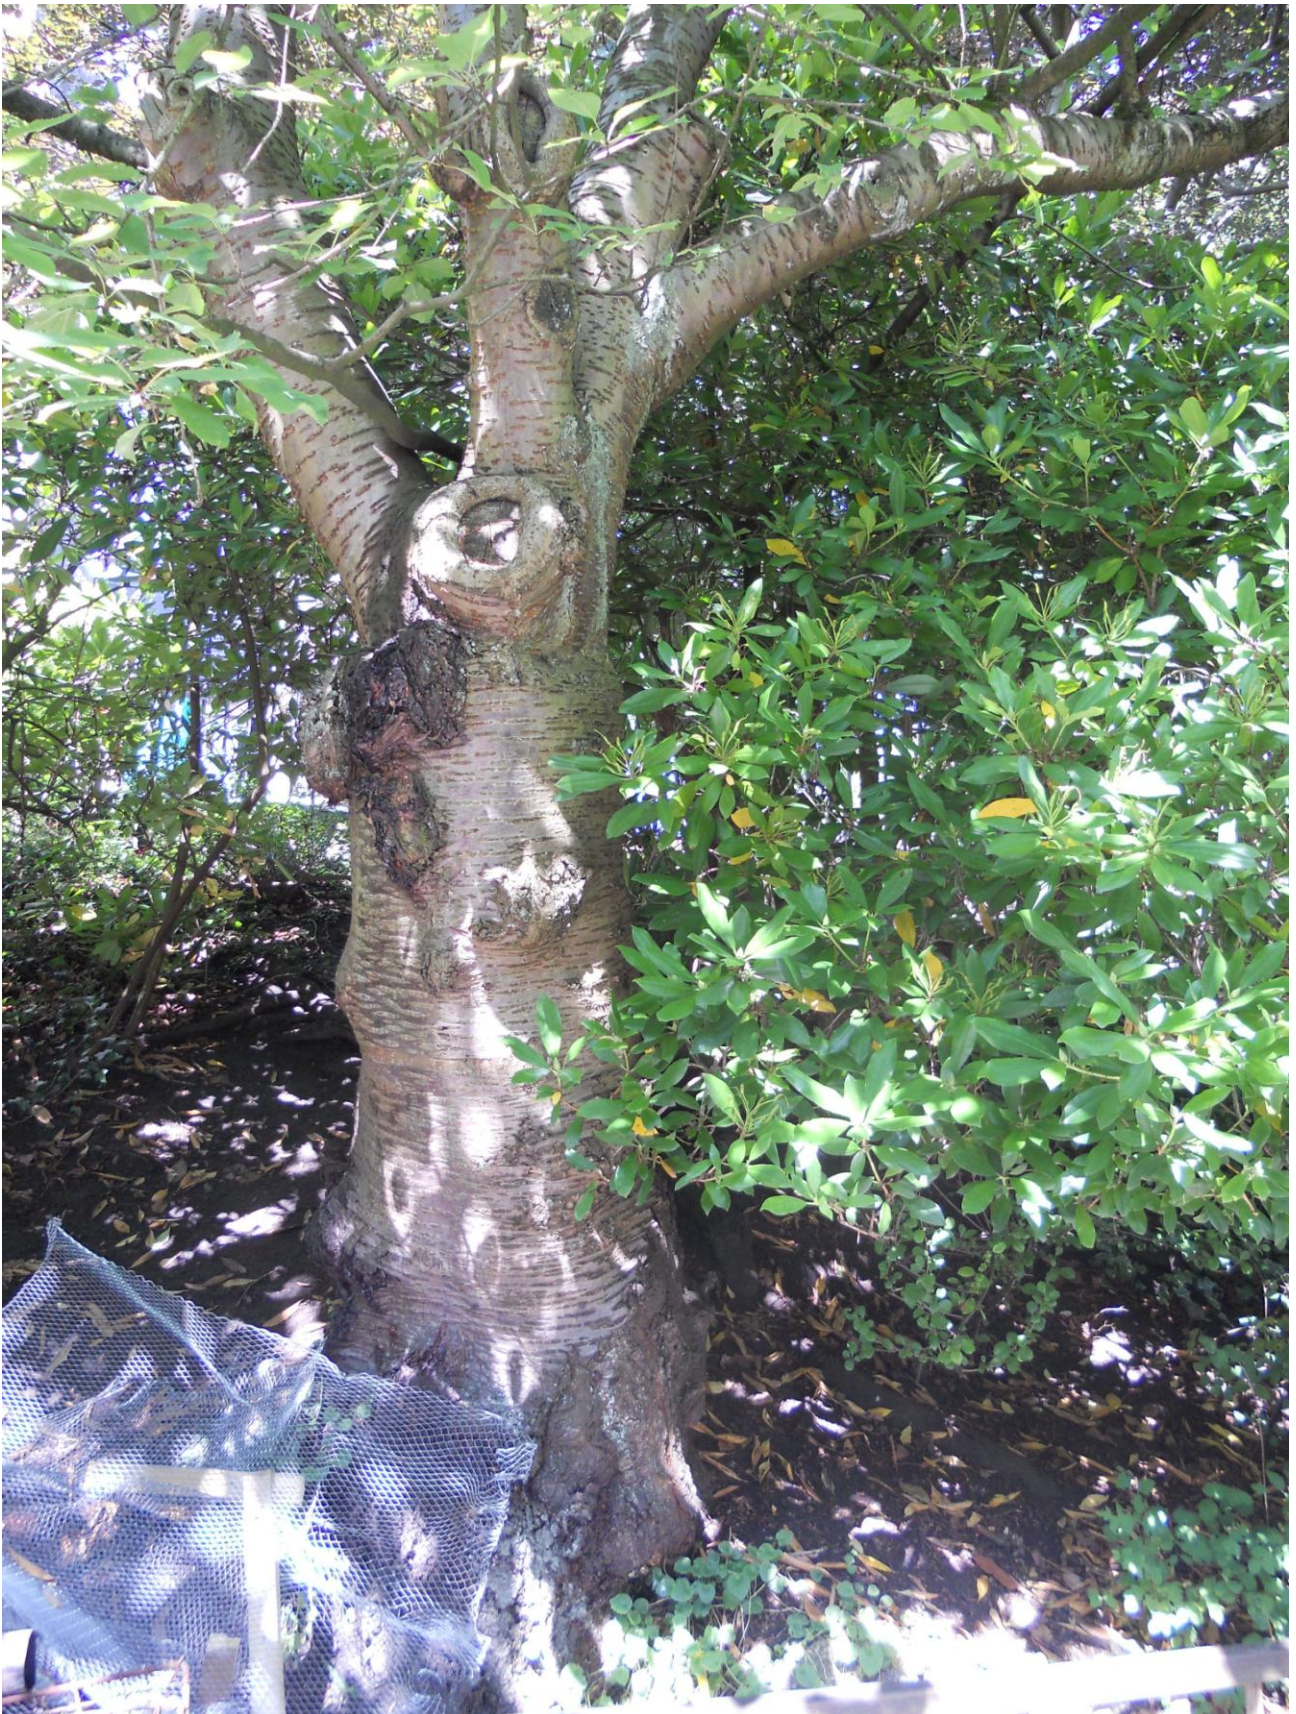
- 10.5. The Cherry tree has bleeding canker and is showing signs of a top graft. This has produced tight forks liable to splitting. The tree is also bottled at the base and there is a strong smell of fungus around the back. Although no fungus was found during the inspection it is possible that this has over wintered and is now part of the soil composition. Due to the defects present in this tree and that it is next to a highly used play area, it is a conclusion that this tree could be removed as part of the development and a replacement planted within the bank area.

Cherry tree trunk with cankers, poor pruning and possible canker (T9)
