**41 / 42 CHESTER TERRACE
STUCCO CONDITION REPORT.
Rev A.**

Author R Greer

Dated 15th July 2014

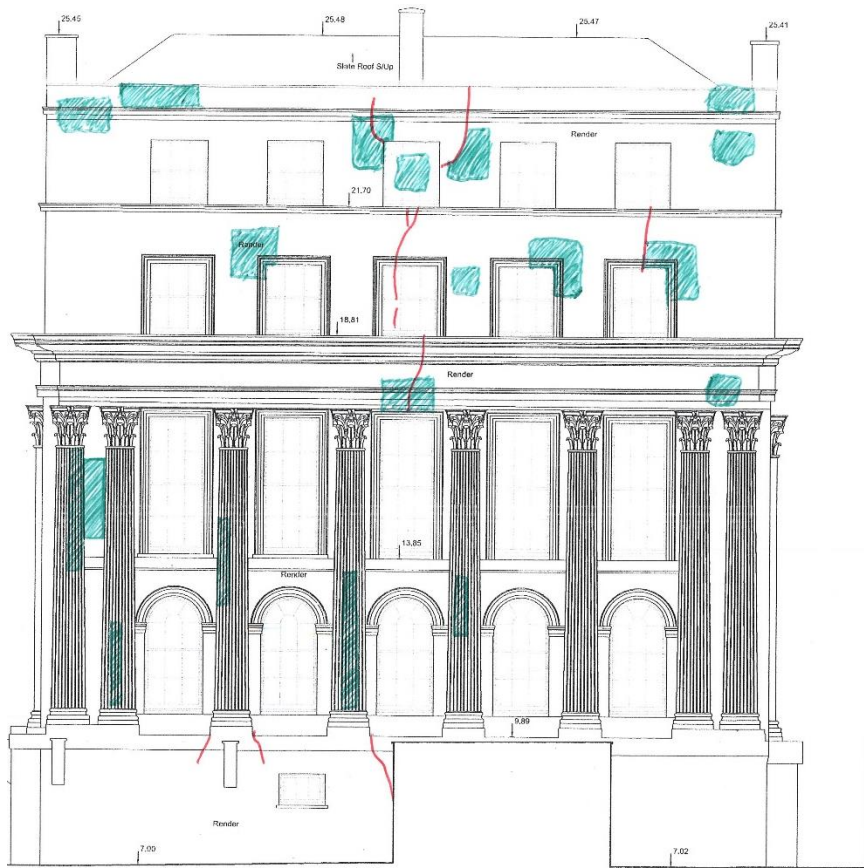
WEST ELEVATION

On the west elevation there is a trend line fracture the full height of the building along the line of the party wall between the two properties.

- 39 The fracture is shown on the marked up drawing of the west elevation running through the basement wall, second floor cornice, through the blind window on the second floor and then either side of the third floor windows.

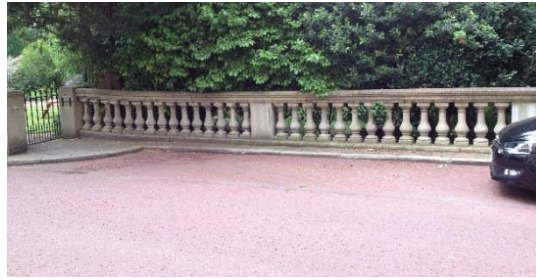
- 1 The Chester Terrace balustrade walling adjacent to the communal garden gate is undecorated reconstituted stone with some minor discolouration and carbonation.

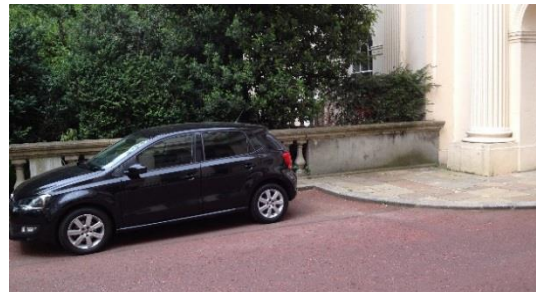
- 2 The pointing to the plinth wall and balustrade connecting to the house is open and should be repointed.

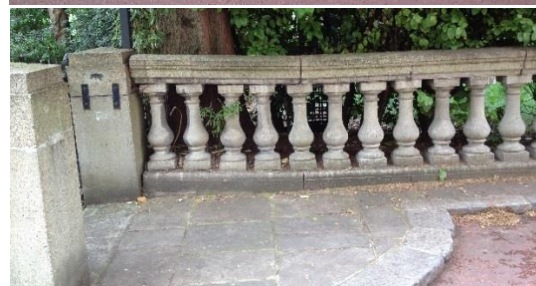
- 3 The pointing to the southern end of the balustrade is also defective. The level of the balustrade and gate post has also lifted and displaced which was probably caused by the roots of the adjacent tree

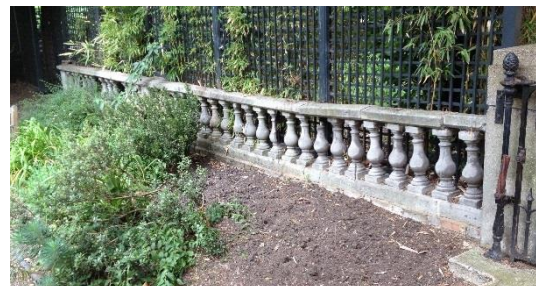
- 4 The balustrade along the garden line dividing the private garden from the communal garden is in a poor condition with excessive displacement and settlement.

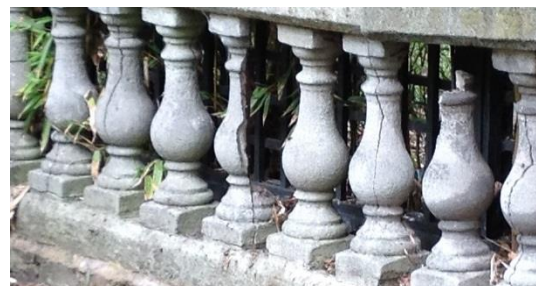
- 5 A majority of the bottles have split and fractured and require replacing. It is anticipated that the remaining bottles are in a similar condition and the whole wall should be reconstructed.

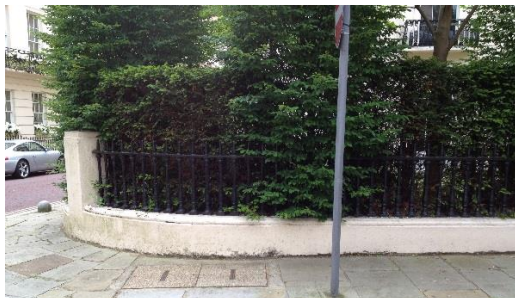
- 13 The boundary wall to the Cumberland Place elevation is constructed of three bays.

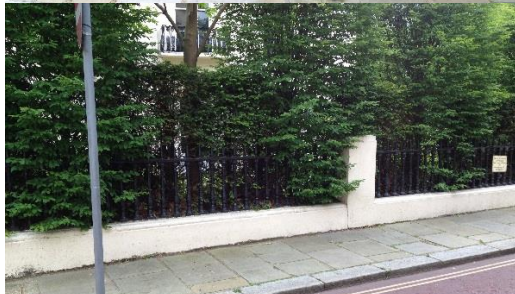
- 14 The conifer tree screening has been planted close to the boundary wall but at present root disturbance is not evident.

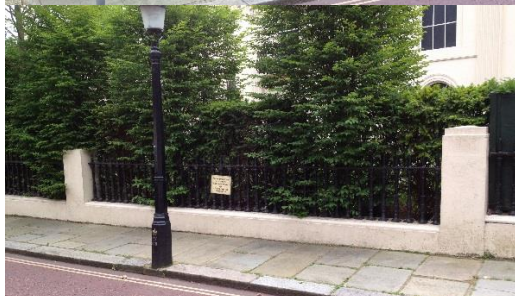
- 15 The wall is in reasonable condition with only minor shrinkage cracks evident that would be covered with the decoration scope of works.

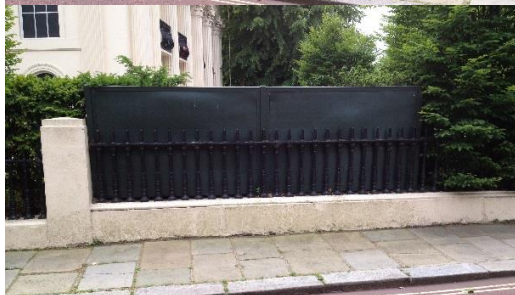
- 16 The screening to some of the bays have been replaced with plywood screening which is sat on the plinth coping. Over time this will increase the moisture content within the stucco which could cause freeze thaw damage.

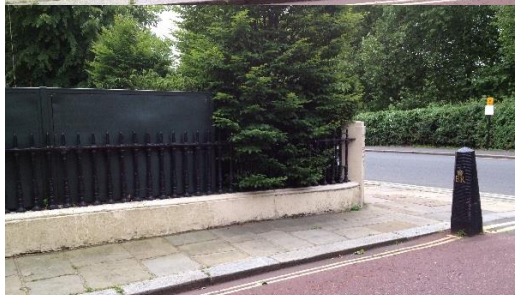
- 17 The pier on the corner of Outer Circle and Cumberland Place has been repaired previously.

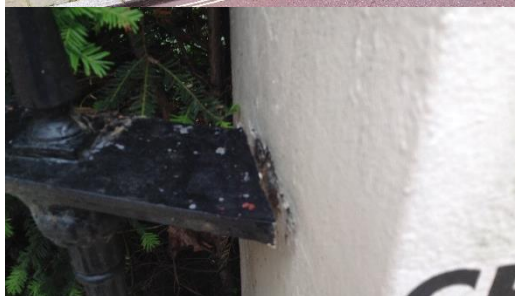
- 18 The top rail of the Cumberland Place balustrade has been disconnected from the boundary wall pier.

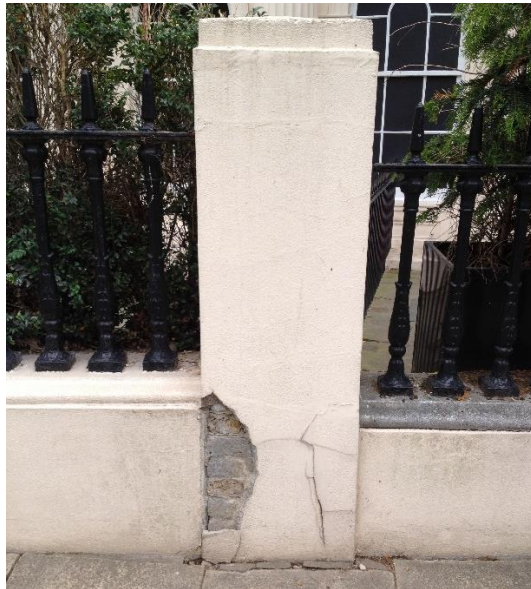
- 25 The stucco render to pier 2/3 has failed in three locations. The junction between the cap and column has failed in a similar manner to pier 1/2.

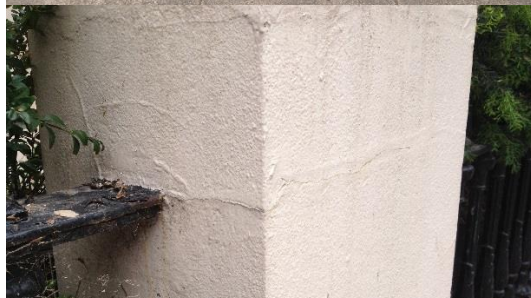
- 26 The stucco to the bottom of the pier has blown and failed

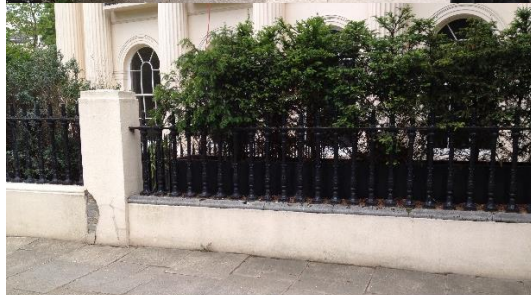
- 27 The pier has fractured at the level of the balustrade top rail. On closer inspection it is apparent that the corrosion of the top rail is the cause of the fracturing.

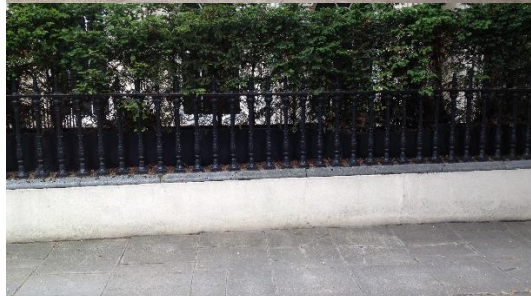
- 28 The reconstituted stone coping stone to bay 3 is heavily eroded and not decorated.

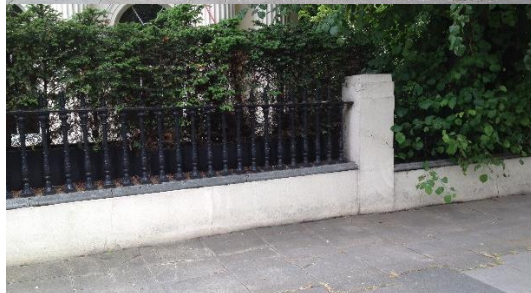
- 29 A small patch of hollow render is evident to bay 3 located either side of a fracture through the balustrade wall.

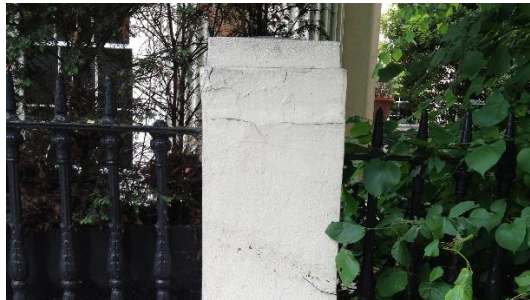
- 30 A small planter box has been constructed directly behind the wall which is providing a water trap to the coping detail and allowing the stucco to become saturated.

- 31 The pier cap to pier 3/4 is fractured and hollow due to a combination of water ingress and displacement caused by the corroding railing top rail connection.

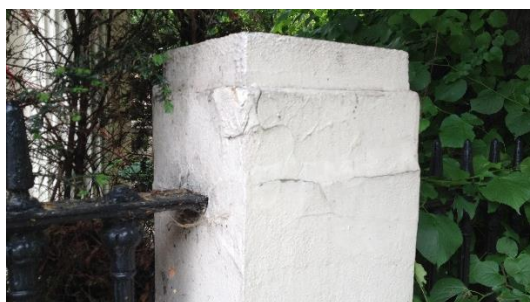
- 32 The pier column is fractured at the junction with the balustrade wall.

- 33 The render to the pier cap is sounding hollow on all sides.

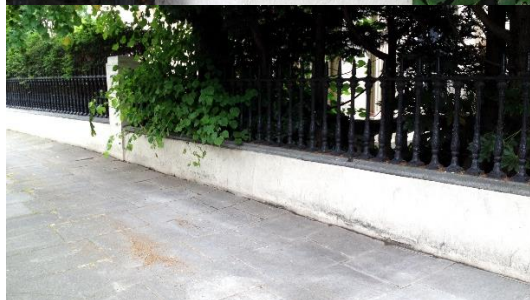
- 34 The wall to bay 4 is fractured in 4 locations with render sounding hollow around one of the fractures.

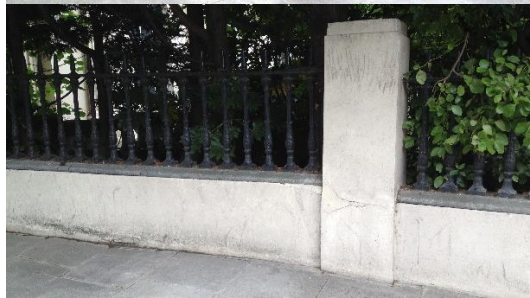
- 35 The column shaft to pier 4/5 is fractured at the connection with the balustrade wall.

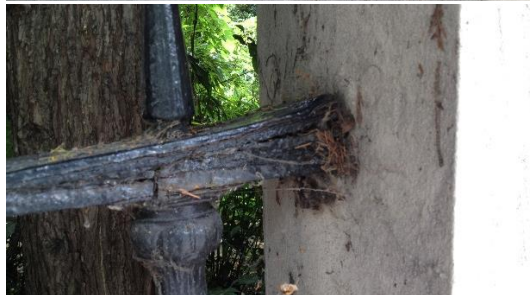
- 36 The railing connection within the southern pier to bay 5 is fractured at the level of the top rail and at the junction between the column and the balustrade.

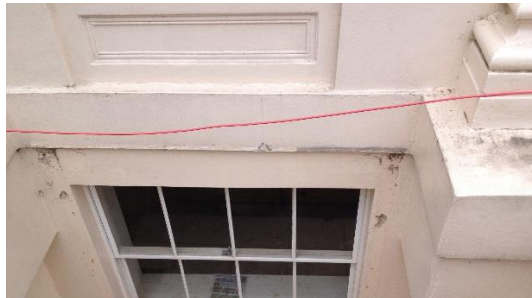
- 37 Where window grills have been removed within the basement area damage has occurred around the redundant fixing holes that require making good.

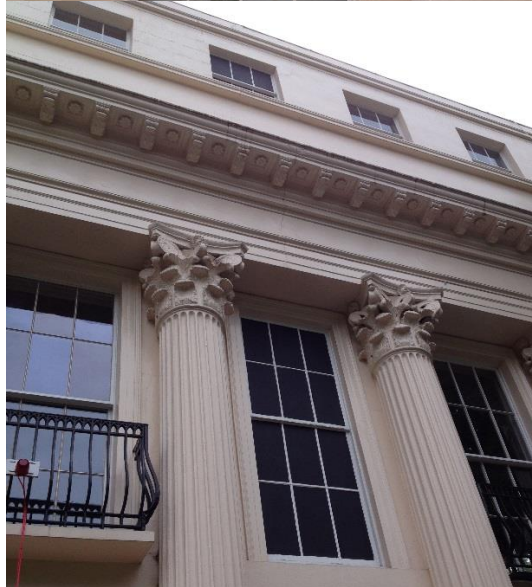
- 38 On the west (Outer Circle) elevation there is a fine vertical fracture approximately on the line of the party wall.

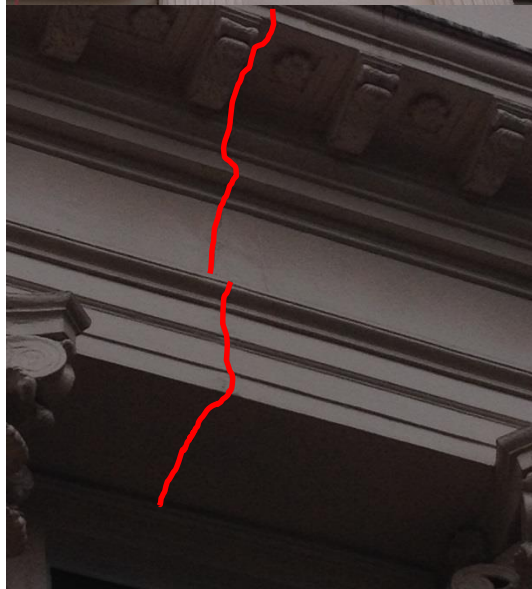
- 40 The fracture is most noticeable through the lintel and frieze of the second floor cornice.

- 41 It would be prudent to ascertain the method of cornice construction and window lintel construction once access is available to allow any repair strategy to be finalised.

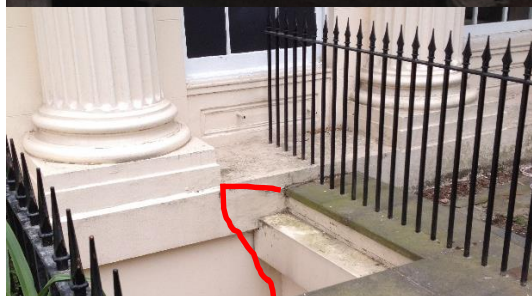
- 42 Fracture through the basement wall / column plinth.
