Tree Survey / Arboricultural Statement
'The Cottage', Spaniards Road, London, NW3 7JH

Tree Survey & Arboricultural Report (Stage 1)

**The Cottage, Spaniards Road
London, Hampstead Heath
NW3 7JH**

Written By;
Sylvie Gabbey - Landscape Architect

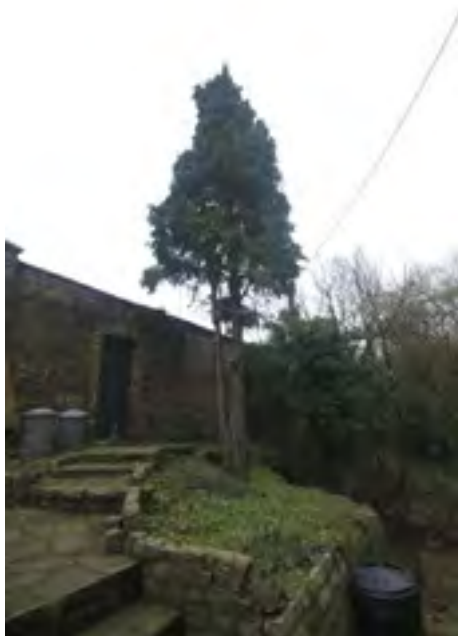
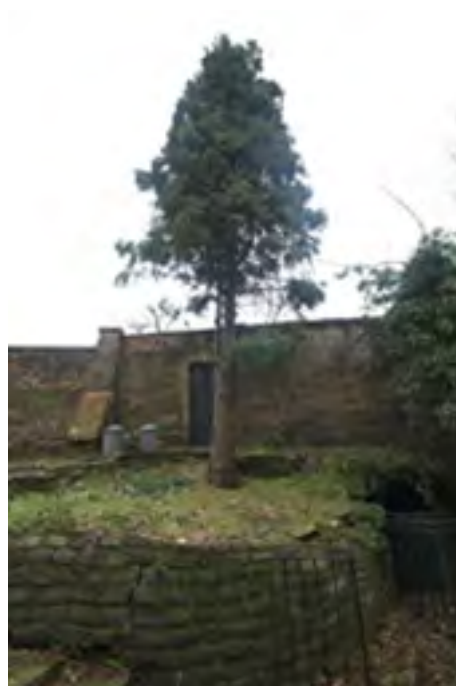
- T1& T2 *Chamaecyparis* (Cypress) have stubs and dead branches
- T35-T39 *Tilia* sp (limes) Have dead wood, stubs and require crown reduction and crown reshaping.
- T10 *Prunus* sp (Cherry) has broken branches
- T12 & T13 *Prunus* sp (Cherry) have broken branches
- T5 & T6 *Ilex aquifolium* (common Holly) lift canopy to form tree
- T7 *Quercus* sp (Oak) re-balance canopy
- T8 *Prunus ceracifera* (Cherry Plum) re-shape canopy
- T9 *Prunus* sp (Cherry) Remove stubs

T1 – *Chamaecyparis* sp (Cypress) showing the terracing and change of levels around the tree.

T1& T2	Chamaecyparis (Cypress)	Remove stubs and dead branches
T35-T39	Tilia sp (Lime)	Remove dead wood and stubs, require crown reduction and crown reshaping.
T10	Prunus sp (Cherry)	Remove broken branches, dead wood and stubs
T12 & T13	Prunus sp (Cherry)	Remove broken branches, dead wood and stubs
T5 & T6	Ilex aquifolium (common Holly)	Lift canopy to form tree
T7	Quercus sp (Oak)	Prune to re-balance canopy
T8	Prunus ceracifera (Cherry Plum)	Prune to re-shape canopy
T9	Prunus sp (Cherry)	Remove broken branches, dead wood and stubs

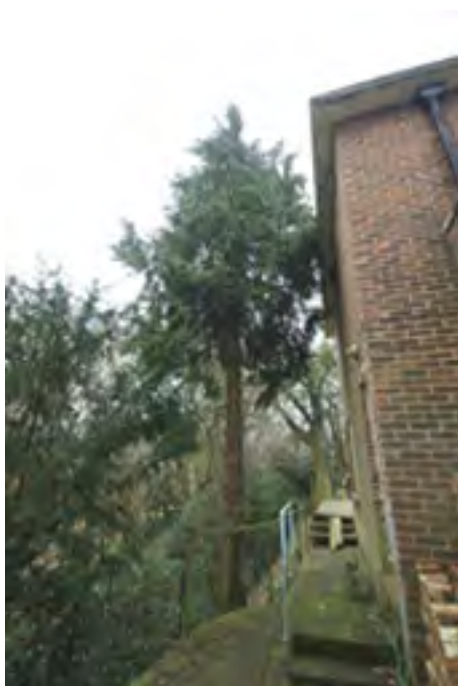
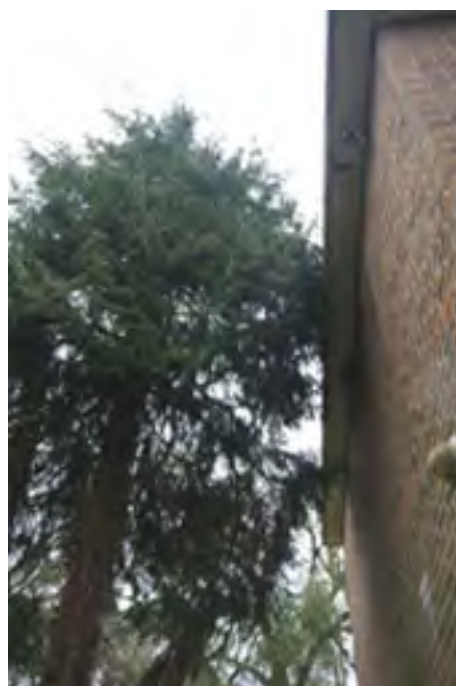
T2 – *Chamaecyparis* sp (Cypress) showing the proximity of the tree to the existing building.

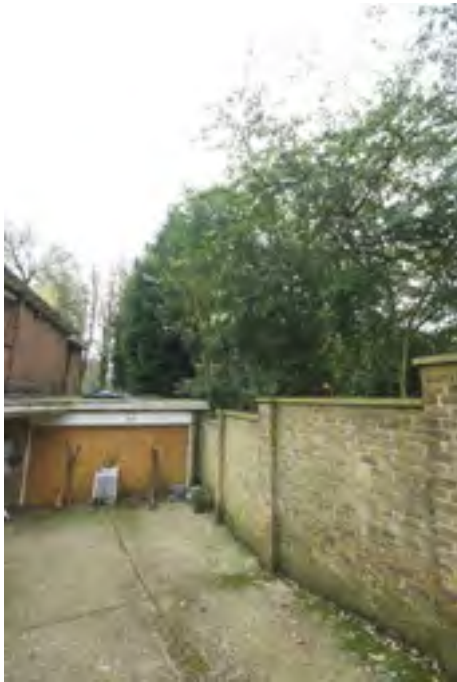
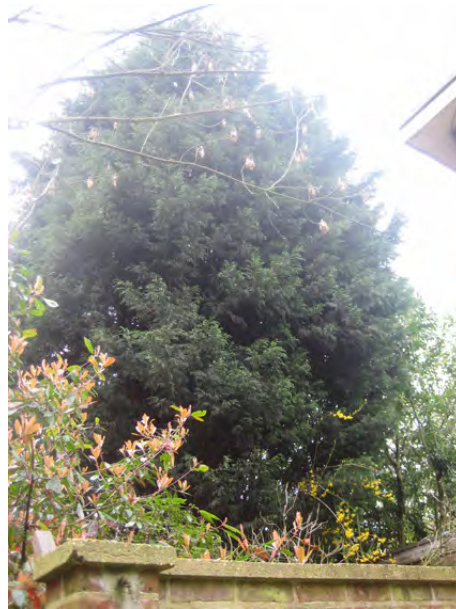
T3- X *Cupressocyparis leylandii* (Leyland Cypress) adjacent to the house in adjoining land.

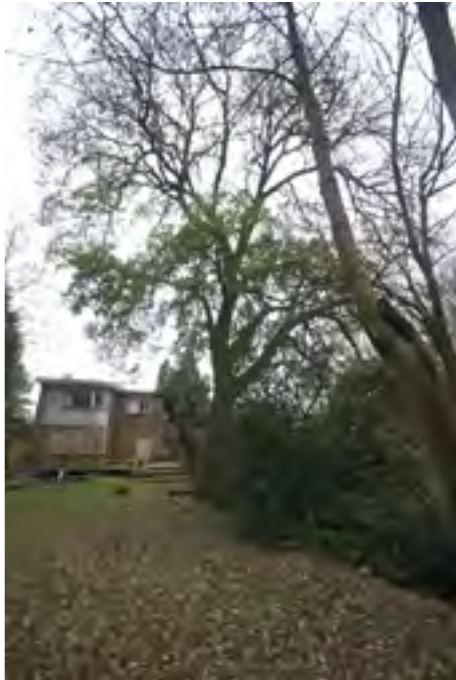
T5& T6- *Ilex aquifolium* (Common Holly)

T5	Ilex aquifolium (Common Holly)	4	15	N 1 W 1 E 1 S 1	-	Y	Fair	Fair	Form: Single stem History: No evidence of maintenance Defects: No leader, shrub like Others: Self seeded	Lift canopy	10-20	C

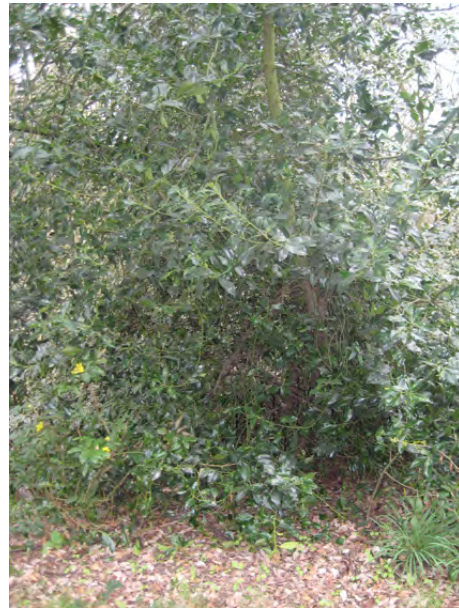
T5 & T6 Large shrubs/small trees

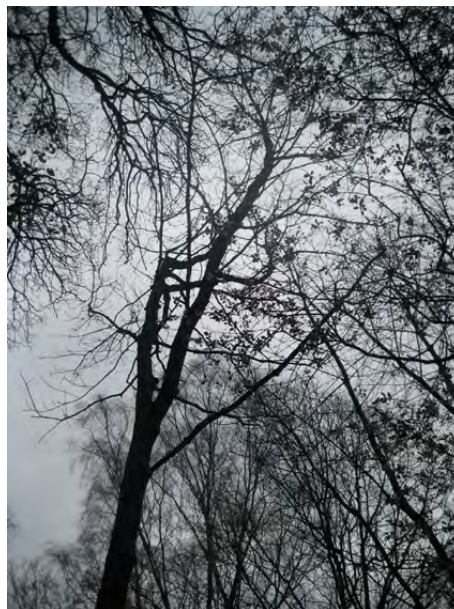
T7- showing unbalance canopy

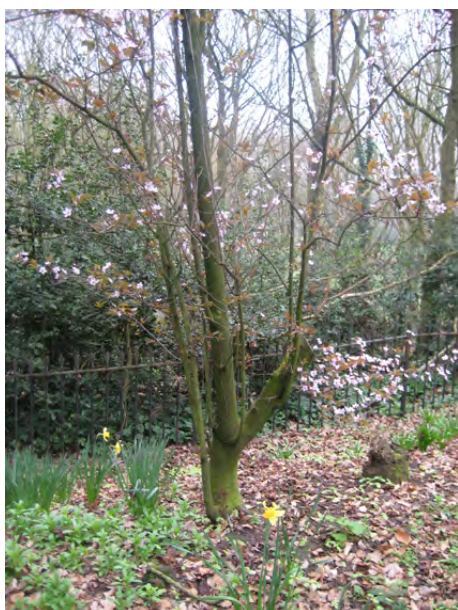
T8- cherry sp (plum cherry)

- T8 *Prunus ceracifera* (cherry Plum) Poorly shaped tree
- T11 *Acer pseudoplatanus* (Sycamore) is growing too close to cherry group and is rubbing against another tree.
- T14 *Fagus Sylvatica* (Beech) has an abrupt bend where decay may enter the callus weakening the main trunk.

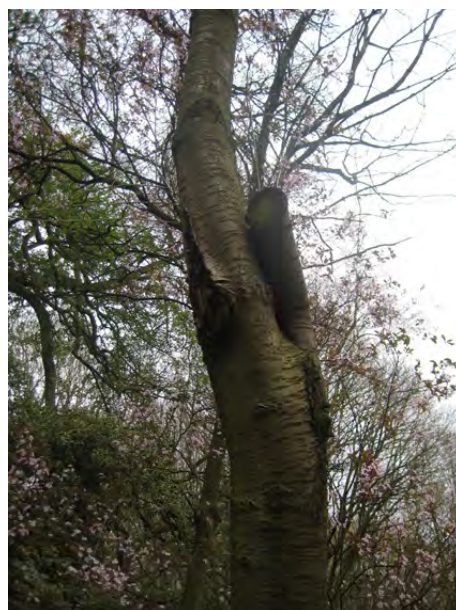
- T9 *Prunus* sp (Cherry) has potential area of structural weakness cause by branch union and should be monitored for signs of decay.
- T14 *Fagus Sylvatica* (Beech) has potential area of structural weakness cause by wound cavity and should be monitored for signs of decay.
- T35-T39 *Tilia* (Limes) are over-mature trees with poor maintenance and should be monitored for signs of decay.

T9 – showing poor pruning & large stub

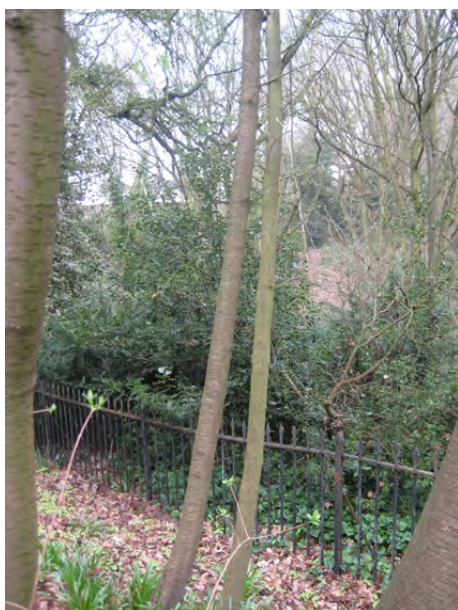
T10 Cherry & T11 Sycamore growing too close to each other

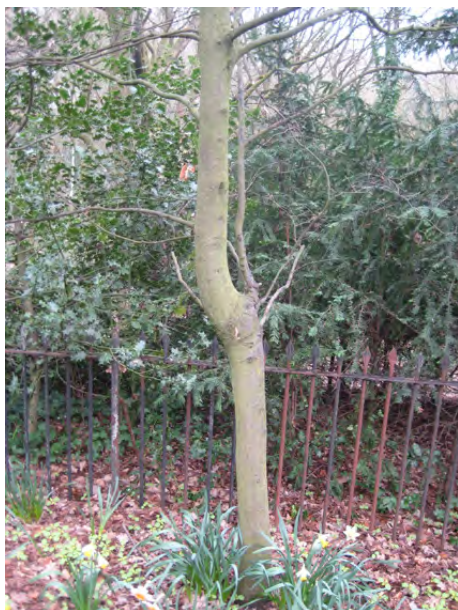
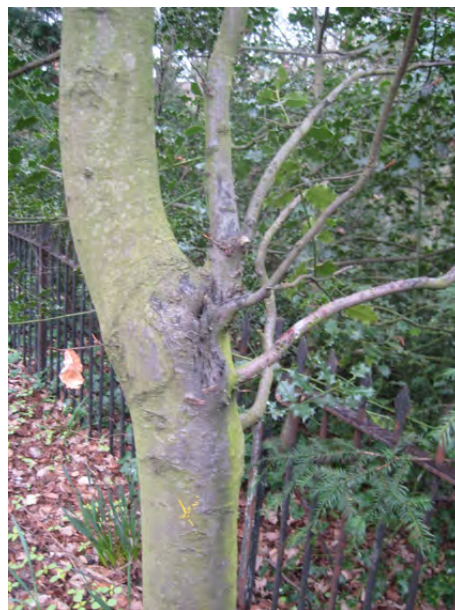
T14 *Fagus Sylvatica* (Beech)

Poor specimen tree with curved trunk and possible decay

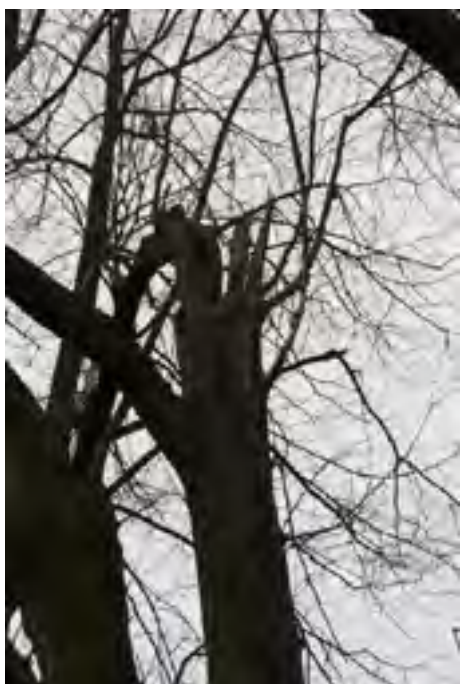
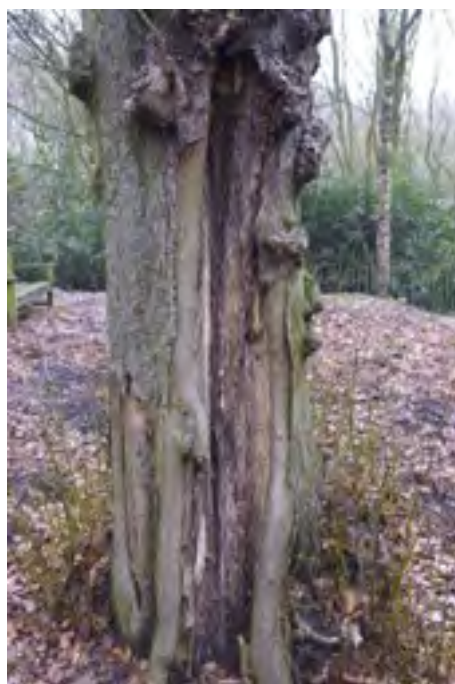
T35	Tilia sp (Lime)	25	85	N 9 W 4 E 14 S 9	-	M	Fair	Fair	Form: Single stem. History: Poor maintenance Defects: Broken main branches, hanging dead branches, unbalance canopy Others: Potentially dangerous,	Remove dead branches, reshape canopy by reducing the crown by up to 30%	10-20	C

T35- Showing extensive maintenance pruning and decay assessment will be required

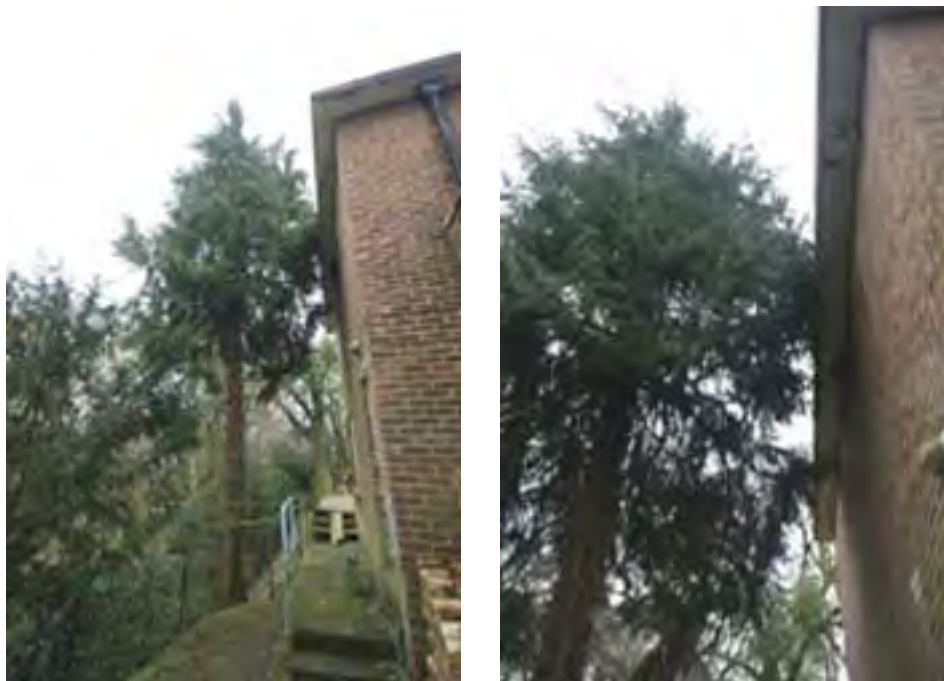
- 4.2.1. T1 & T2 are proposed to be removed for the purposes of development. Both are low category trees; T2 is growing too close to the existing house, and it is also not suitable to retain T1 as the stepped access to the house will be re-built and re-graded.

T2 – Tree is growing too close to the existing building

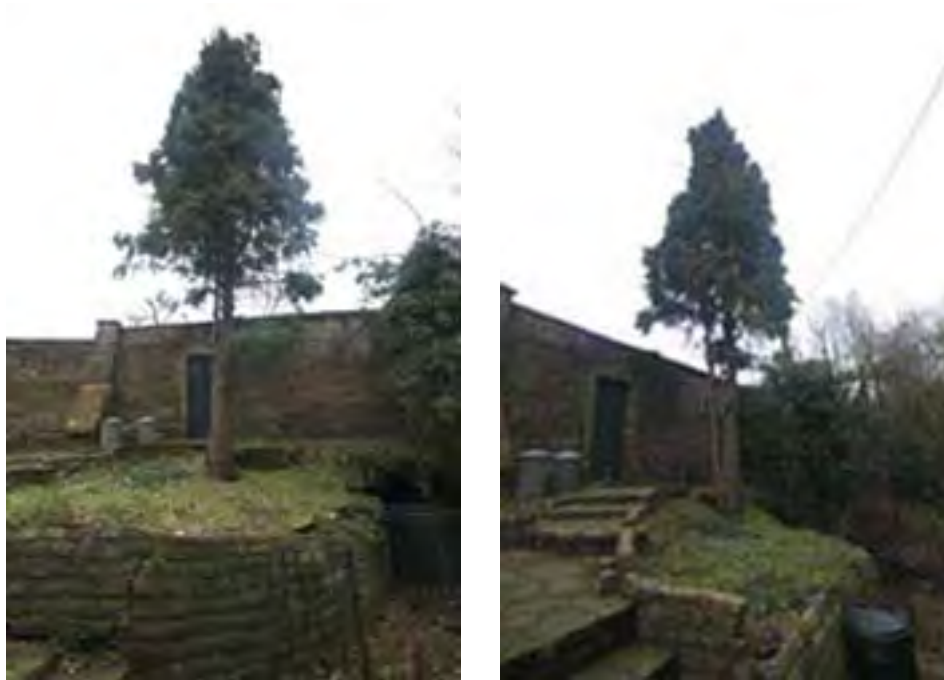
T1 – Stepped entrance require re-building and re-grading.

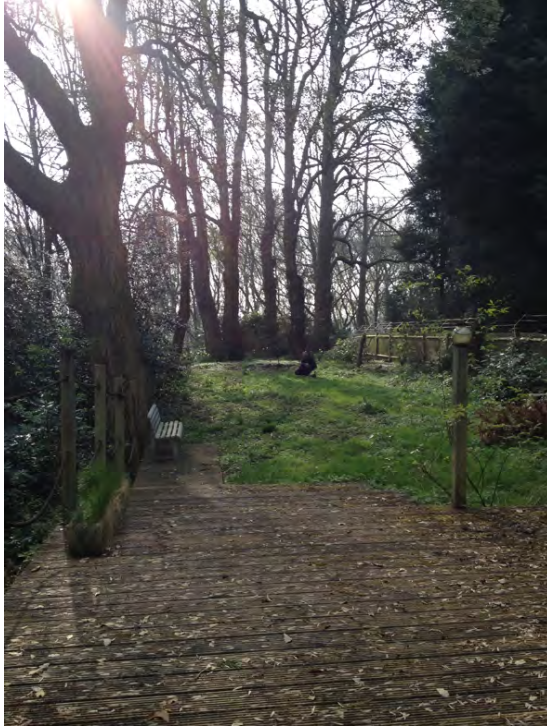
- 4.8.2. All ground surfaces are to remain the same or similar in properties (permeable) for most of the trees except for T4 which will have a portion of its RPA built over by the new extension.
- 4.8.3. The RPA of T4 is calculated as 594m² in area, of which 88m² (15%) is proposed to be built over by the new extension.
- 4.8.4. The adjacent trees T19, T20, T22 T T24 will also have a small portion of their RPA built over.

Photograph showing existing area of existing decking adjacent to T4.

- 4.10.1. The excavation within the RPA of T4 should be done carefully by hand to avoid any damage to the roots.
- 4.10.2. Piles and beams technique will be used to minimise impact on the existing trees.

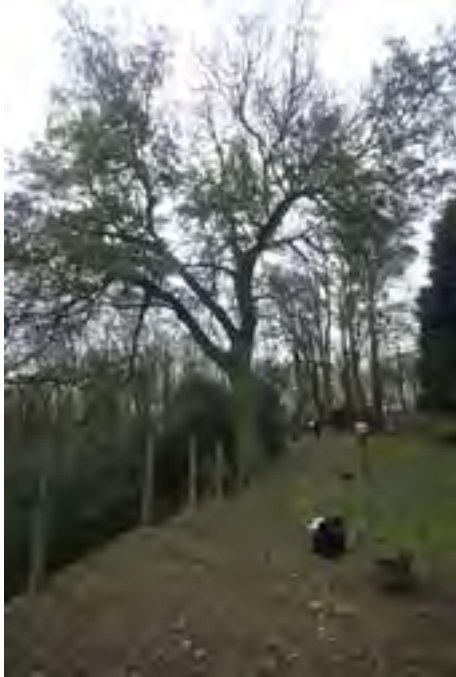
- 4.13.1. Most of the existing trees to be retained are situated at sufficient distance from the proposed development so that future growth will not affect the new extension.
- 4.13.2. Part of the new extension is proposed to be built underneath T4's canopy but as the tree's main lower branches are located over the Heath, the branches are not conflicting with the new built.

T4 – Lowest branches are located over Hampstead Heath, away from the new extension.
