ELR:	STR No:	Structure Name:	
JRT2	5	Church Hill Road Footbridge	
Asset Type:	Work Type:	BP UID:	OP No.
Footbridge	Replace	LNE - 002170	129588
Mileage From:	Mileage To:	OS Grid:	Postcode:
2m 0593yds	2m 0593yds	TQ289858	NW5 1DX
Visited on: 19/11/2012	Richard Jakeman

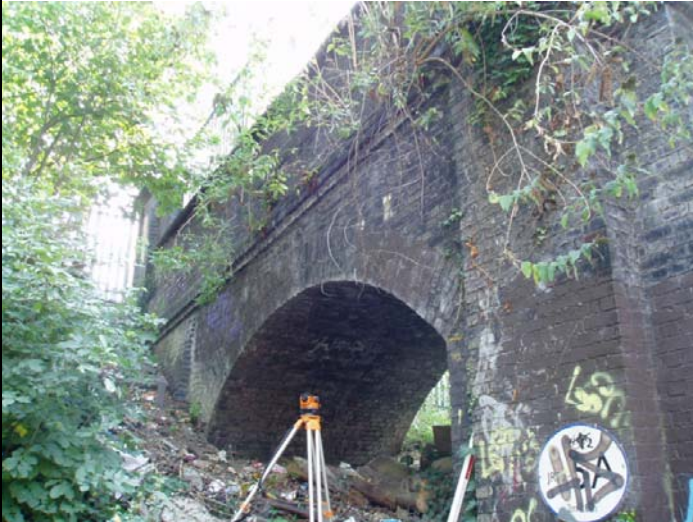
Severe fracturing and displacement of brickwork in upside arch (southernmost of three central arches) - between JRT2 and GOJ (northern/central arches). Ref 2010 Assessment Report. Brickwork defects to the downside southern approach arch. - SME to confirm

Defective Brickwork, South East Arch Elevation

Undertake minor brick work repairs and re-pointing to open joints and areas of missing mortar to the exposed areas of brickwork following the reconstruction of the footbridge.

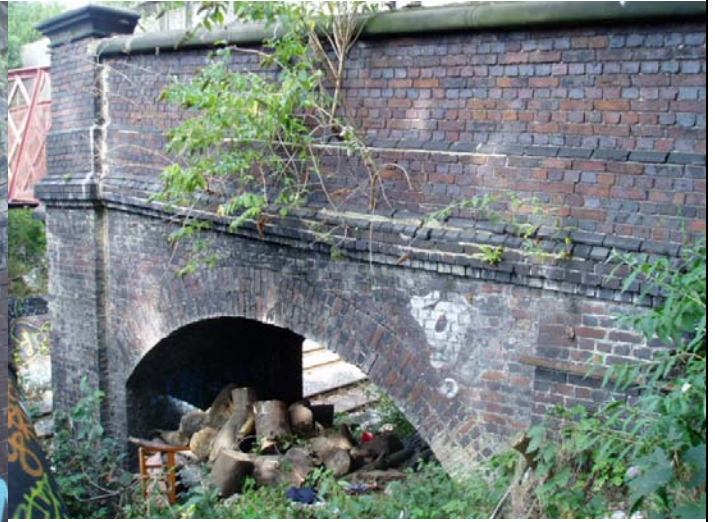
Defective Brickwork, South West Arch Elevation

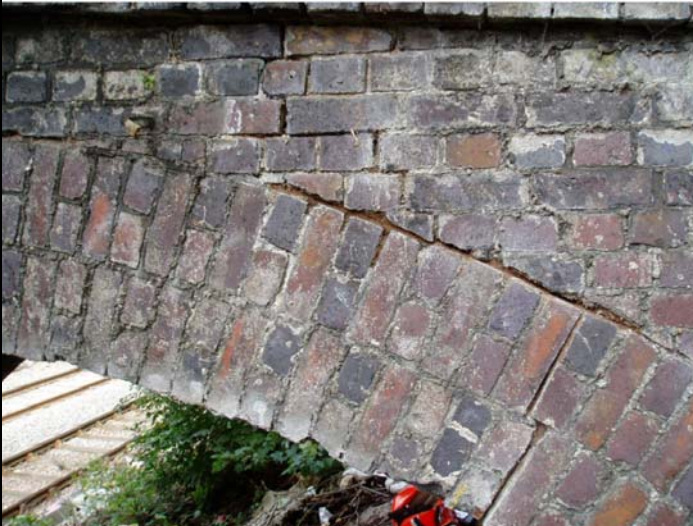
Defective Arch Brickwork Profile.

Either demolish and provide a longer footbridge or Infill upside/central approach arch which is showing signs of distress. Consider LNE approaches to accommodate 2m width if not prohibitively expensive. Asset Manager to agree what is to be done with approaches prior to construction commencing.
