STRUCTURAL ENGINEERS REPORT

19, HOLLY HILL

HAMPSTEAD

Ref: MD/J4099

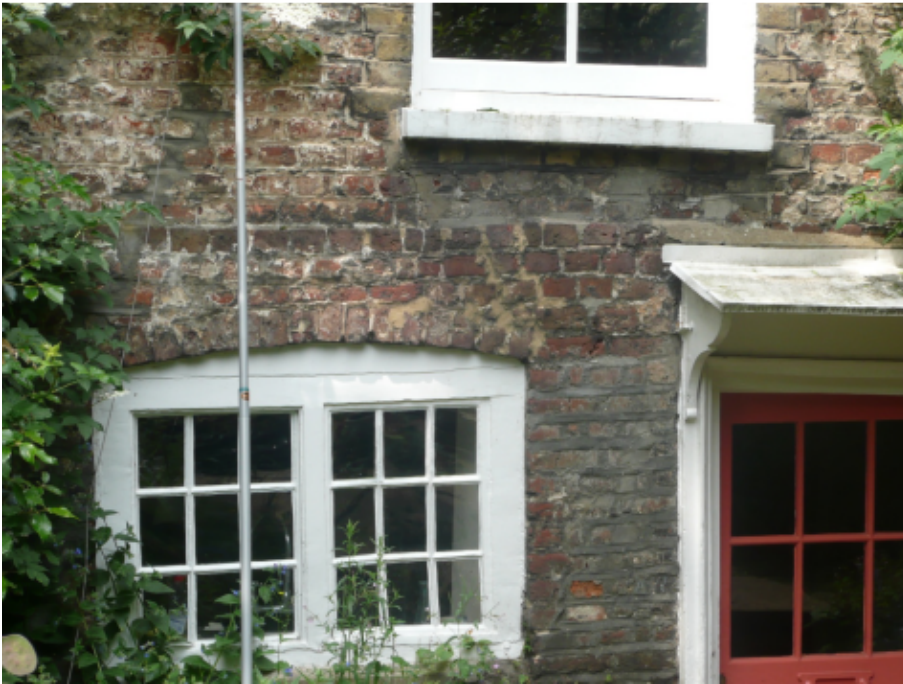
5.4 At the time of the inspection, we noted that the frame to the front door wall distorted sloping down to the right, and the window also distorted sloping down to the left. The short length of brickwork between the 2 appeared level, but a check on it verticality reported that it was out of plumb by approx 80mm.

- 1. External view on front door and kitchen window.**
- 2. Indicative record of amount that the pier between front door and window is out of plumb, measured down from first floor.**
- 3. External view on flank wall- front area.**
- 4. External view on flank wall central area.**
- 5. Indicative record of amount that wall is out of plumb between upper ground floor and first floor**
- 6. Indicative record of amount that wall is out of plumb between external ground level and upper ground floor.**
- 7. Internal view on front elevation at second floor level showing cross fall to floor.**
- 8. Internal view towards front elevation at first floor level showing cross fall to floor and out of square**
- 9. Internal view on front elevation at upper ground floor level.**
- 10. Internal view on front door and window at lower ground floor level**

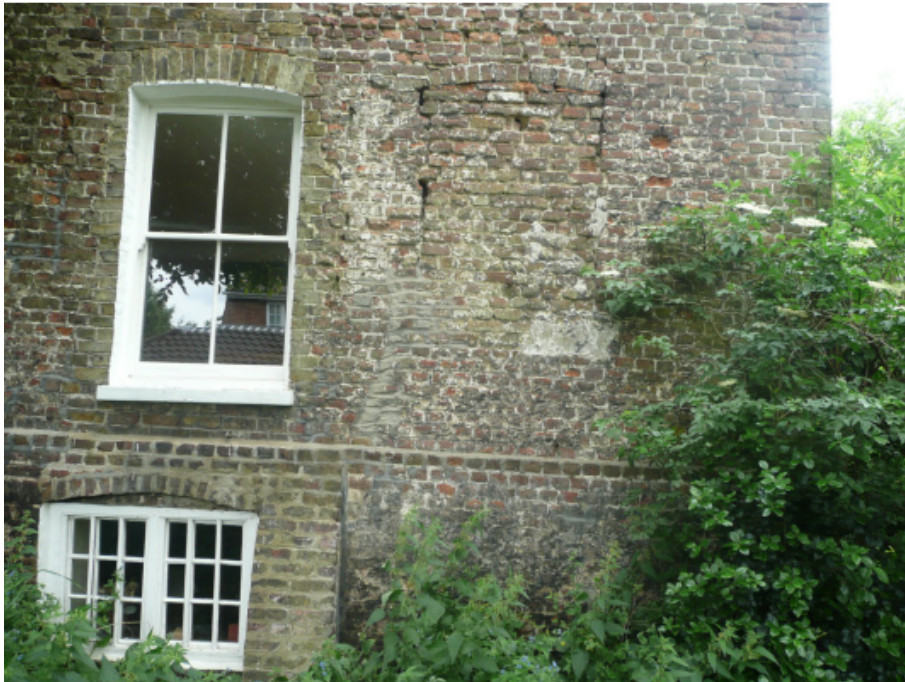
3.

5.6 The left the flank wall shows many signs of past movements and repair, evident by vertical fractures some attempted repaired by re-pointing, some not. A window opening has been in filled and there are irregular bed joints and panels of various bricks and mortars.

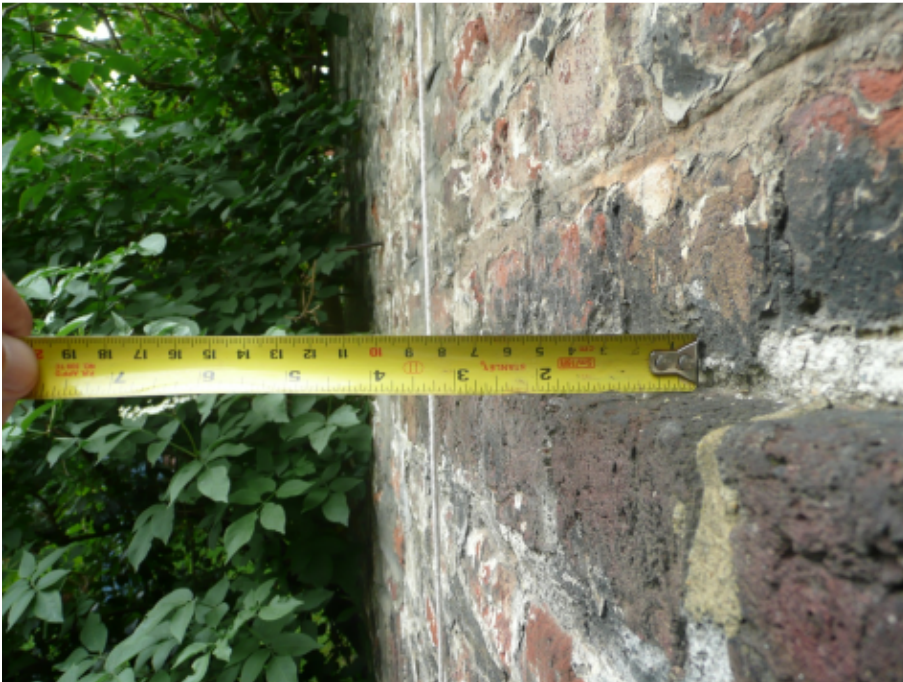
5.

5.7 The flank wall does lean outwards, and measurements indicated that the brickwork at first floor level leaned out by approx 50mm – 85mm beyond the wall at upper ground floor level, and the wall at upper ground floor leaned outwards by about 50-85mm beyond the wall at external ground floor level, being about 700 above lower ground floor level. Resulting in a combined out-of-plumb dimension of about 100-170mm

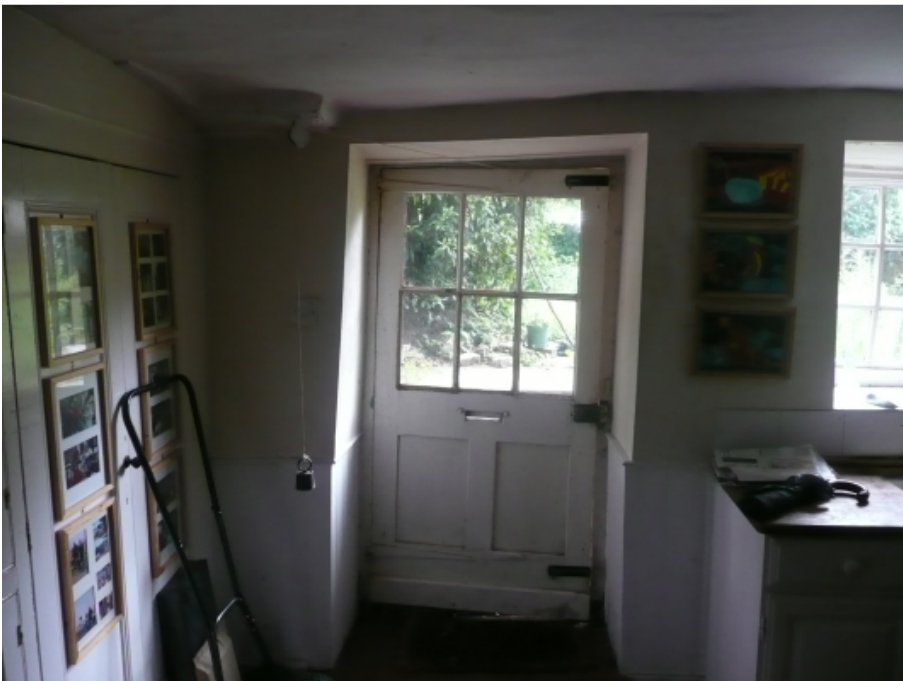
10

- 5.16 On the lower ground floor there is cracking to the central chimney, and as previously noted the front door and window are both out of square.
- 5.17 On the ground floor in particular the external walls are out of plumb, however the internal waterproofing and lining prevent sight of the masonry.
