Arboricultural Survey (BS5837:2012) &
Impact Assessment Report

15 Bromwich Avenue
London
N6 6QH

30th July 2014

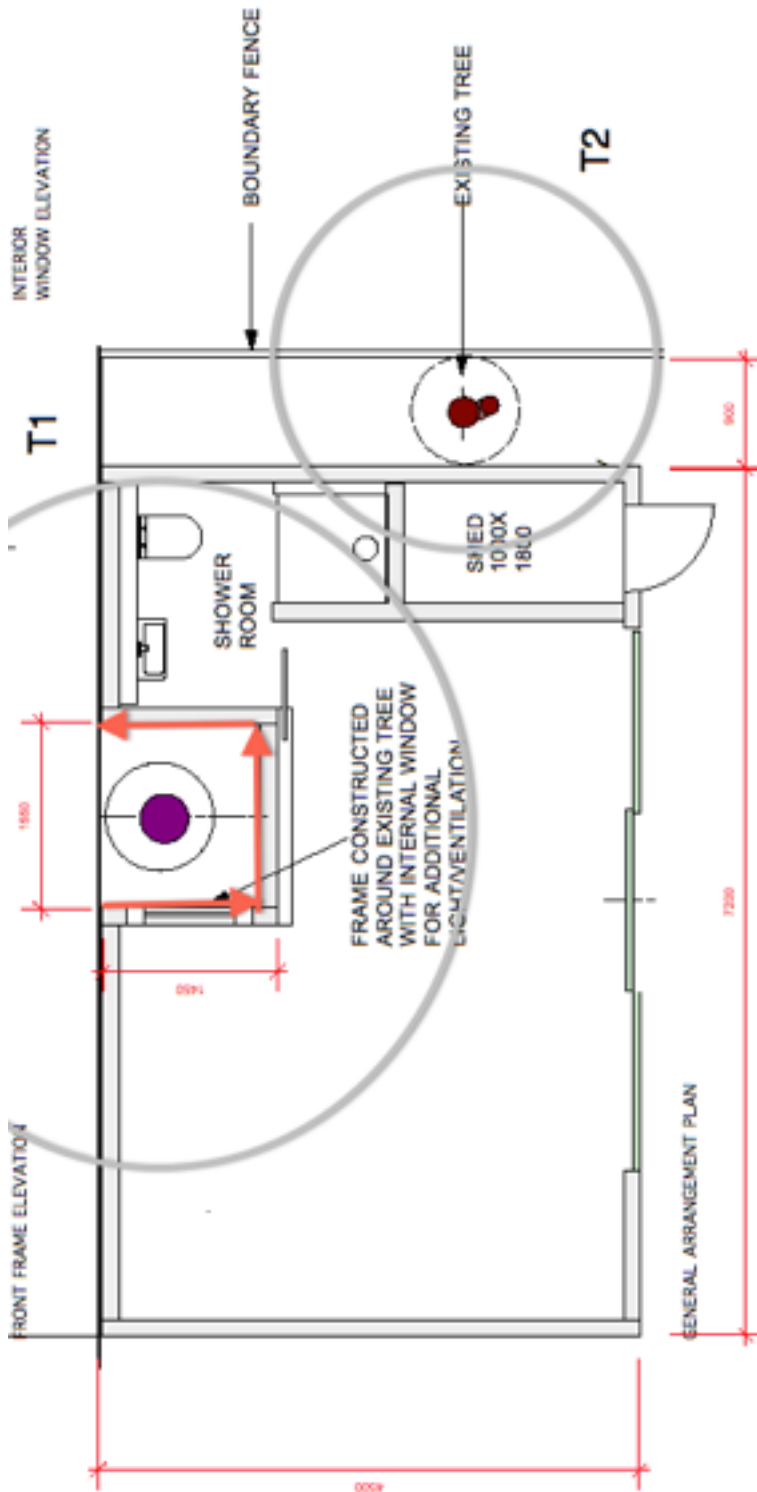
General Arrangement Plan

1. Grey tree canopy outline denotes C.1 Category Rating (BS5837:2012)
2. Red arrow outline denotes area for ground works in upper 1.0m of soil / hard landscape surface to be HAND DUG only. Close adherence to the tree root excavations guidelines is required when undertaking excavations in this area.

- **All excavations within the rear garden area as outlined on the *Tree Root Protection Outline (Appendix B.3)* must be hand dug to a depth of 1.0 metre from ground level with close adherence to the specifications as highlighted below.**
- **The severance of any tree roots encountered larger than 25mm in diameter MUST NOT occur without prior consultation with the Local Authority Tree Officer or appointed Arboricultural Consultant.**
- **If at any point it is deemed not possible to continue with excavations without having to damage very significant tree roots, the Local Authority Tree Officer and / or the appointed Arboricultural Consultant must be contacted.**

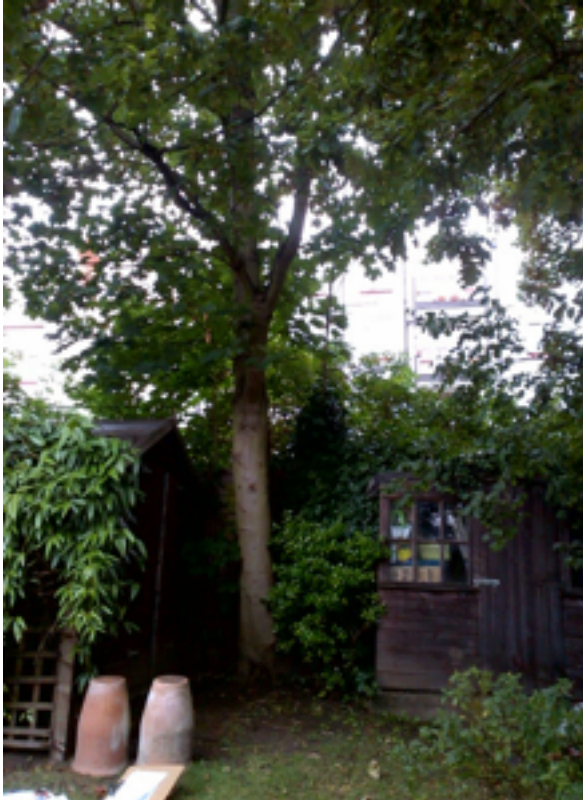
4.6 Tree T1 is a mature and structurally sound Sycamore tree (*Acer pseudoplatanus*) at the rear of the property on the northern boundary. The tree is 14 metres in height and has good vigour in the mid and upper crown, with relatively balanced crown shape. Tree T1 is in good condition at the base with exposed buttress roots close to the main stem, particularly to the east and west. The main stem is in good condition and continues to form a dominant single stem to crown break. The tree has been previously crown reduced approximately 3-4 years ago and has also been crown lifted in the past to give clearance from the existing garden buildings and rear lawn area.

4.7 With its location within the rear garden, age and form, the tree offers some amenity value and is rated as C.1 (BS5837: 2012). Therefore the tree is to be retained and should be protected during the proposed development to the greatest extent possible. The recommended root protection distance for the tree is 4.7 metres (BS5837: 2005). The root protection distance is achievable for the majority of the root plate due to the complete protection on the northern root plate by virtue of the tree growing on the boundary with the neighbouring property where no works will be taking place. In addition, the location of existing concrete bases to the east and west of the main stem within the rear garden will offer some protection as adventitious root development beneath these in the past will offer protection for the tree in addition to these existing footprints being used within the development.

4.8 Construction works directly to the south, east and west of the main stem require encroachment within the root protection area in order for the proposal to be implemented. The construction of the garden building is proposed 1.0 metre from the trunk of tree T1 to the south, 0.95 metre to the west and 1.2 metre to the east. However, the nature of the existing site, comprehensive protection for the remainder of the root plate, and the implementation of full tree protection means that the tree's long-term retention can be ensured, by taking into account the various existing site factors and the construction method / implementation as outlined below.

C.1 Photograph of tree T1 located within rear garden of 15 Bromwich Avenue, London, N6 - as viewed from south to north

T1: Sycamore	Crown thin 20% and remove all deadwood Crown lift to 4-5m
T2: Plum	Crown thin 20% and remove all deadwood Crown lift to 3m
T3: Oak	Crown lift lightly to 3 - 3.5m

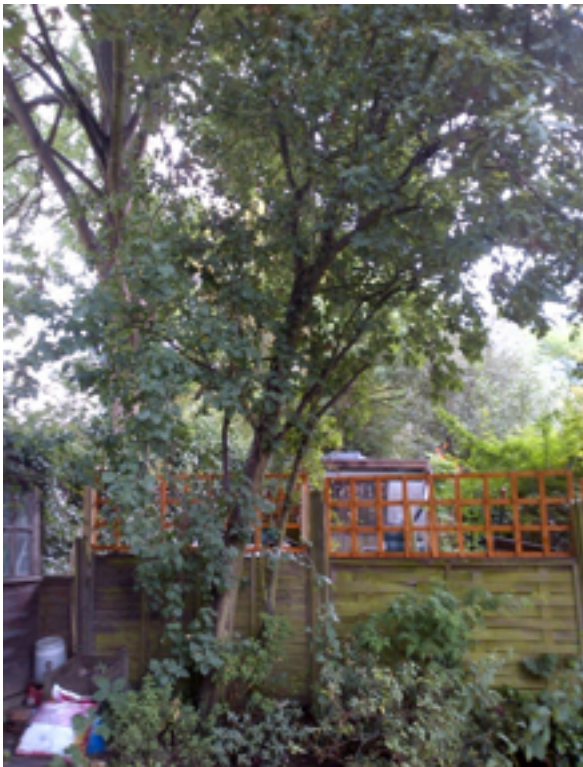
4.12 Tree T2 is an early mature to mature, Plum tree (*Prunus spp*), which has columnar and suppressed form. The tree is a structurally sound specimen located on the eastern boundary of the rear garden. With some minor pruning of low epicormic growth and some light pruning / thinning as specified in *Section 5* the tree will be an improved specimen which can continue to provide light screening from the neighbouring garden.

4.13 Tree T2 is classified as C.1 (BS5837:2012) and is proposed for retention within the development. The recommended tree protection distance for this tree is 2.1 metres and therefore protection is required in order to prevent damage to the western root plate within the garden of 15 Bromwich Avenue. Although the full 2.1 metres may not be entirely achievable on the western section of the root plate this is not deemed problematic as the tree is relatively young with good vigour. Any excavations that do occur within close proximity of this tree on its western side should be undertaken with close adherence to the specifications as outlined in *Section 4.17*.

C.2 Photograph of tree T2 located within rear garden of 15 Bromwich Avenue, London, N6 - as viewed from west to east

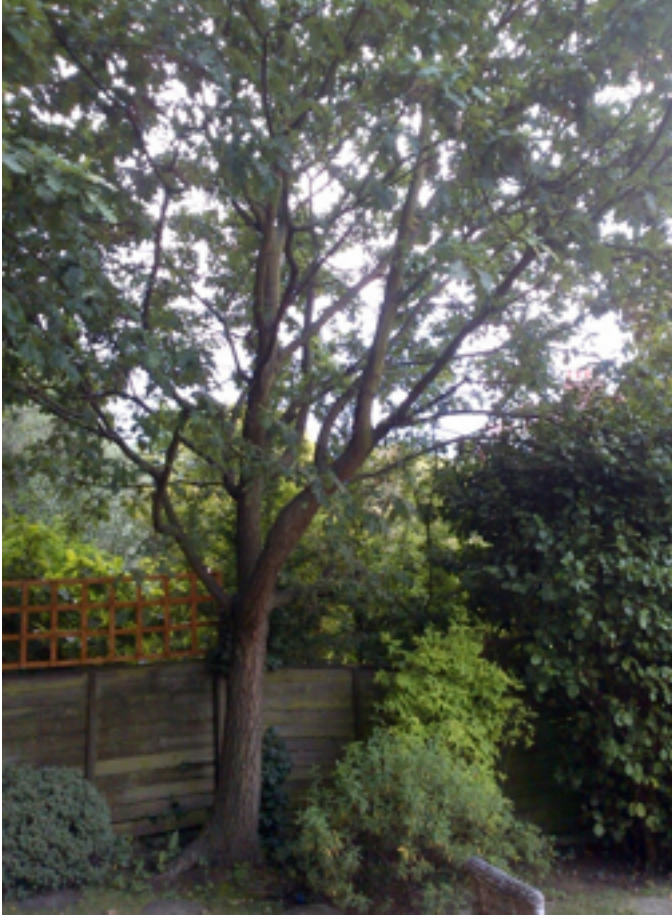
4.15 Tree T3 is a young to early mature Oak tree (*Quercus robur*), located within the rear garden on the eastern boundary; this tree is sited furthest from the proposed development and closest to the main property. The tree is in good condition and as a developing specimen with a relatively low and broad domed crown offers average amenity value, therefore being rated C.1 (BS5837:2012).

4.16 The tree is located over 6 metres from the closest point of the proposed development and will not be affected by the proposed development - the recommended root protection area is 3.5 metres (BS5837:2012). It is very unlikely that construction activities would encroach within the vicinity of tree T3, but to ensure that full protection of the root plate and canopy are provided, the following is recommended:

C.4 Photograph of tree T3 located within rear garden of 15 Bromwich Avenue, London, N6 - as viewed from west to east
