R10241/GP/KMS

## **42 BELSIZE SQUARE, NW3**

I write further to my inspection of the chimney stack yesterday morning, Monday 14 July.

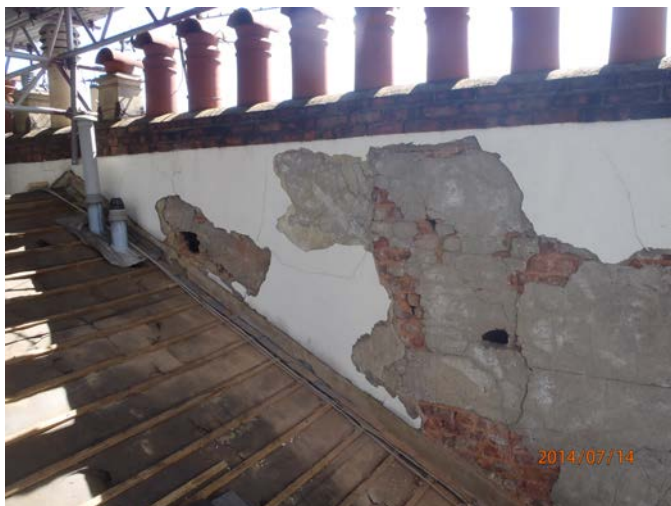
PHOTO 1

Over the front half of the stack extensive removal of render has been undertaken. This has revealed that the brickwork behind is constructed of soft bricks and lime mortar. The bricks are very fragile due to old age and deterioration from flue gases over the years. The lime mortar is crumbly to the touch. There are several coats of render with an overall thickness of about 50mm. The brickwork has been damaged by the removal of the render and the flues have been broken into at two or three locations. There is vertical cracking in the brickwork probably reflecting flues and withies behind (photo 1).

In conclusion, given the very poor condition of the brickwork and the risk of damage to the brickwork by the removal of the render, the most reliable remedy would be to rebuild the chimney stack. Rebuilding of the brickwork should be with durable bricks of classification FL to BS3921 and 1:0.5:4.5 mortar. As the brickwork would be rendered it is important that bricks with low sulphate content are used – sulphates can wash out of the bricks and attach the render causing cracking.

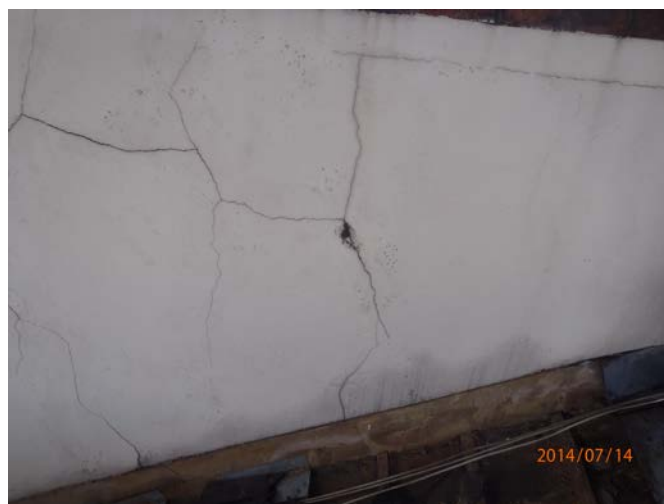
PHOTO 2

Over the rear half of the stack the render is still in place (photo 2). It contains extensive random cracking and sounds hollow when tapped. Such render is potentially unstable and needs to be removed.
