## H and J architecture

32 Aqua Apartments  
Goodchild Road  
London  
N4 2BP

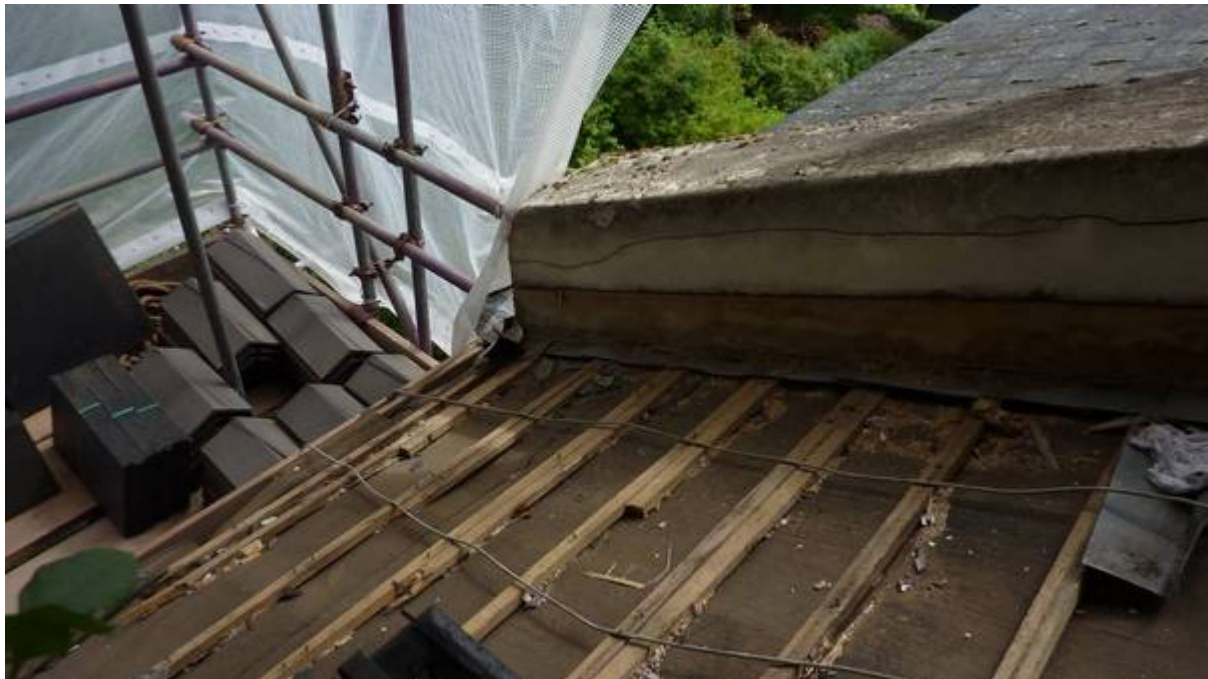
(1) Existing parapet wall to the rear of the property looking towards the eaves

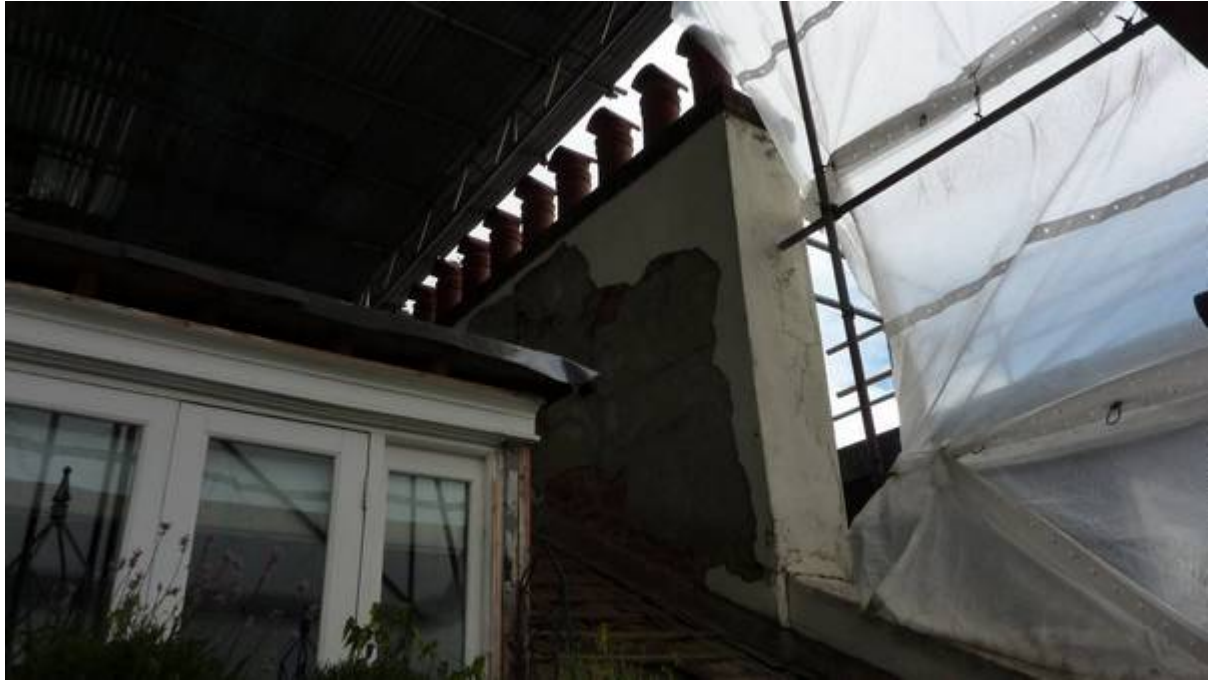
(4) Damaged render and exposed brickwork to the chimney stack on the street side of the property

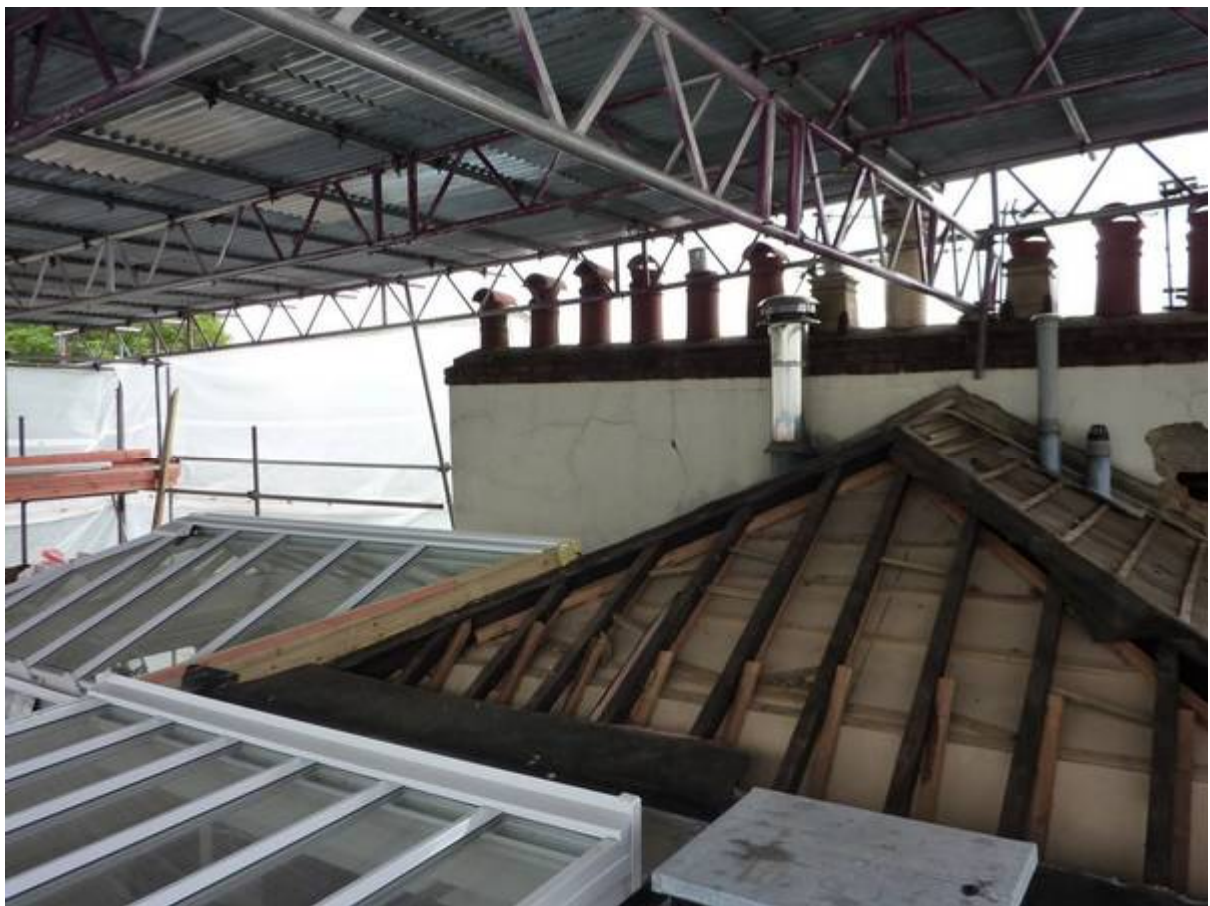
(5) Severely cracked render to the chimney stack on to the rear of the property
