MISCELLANOUS PHOTOS

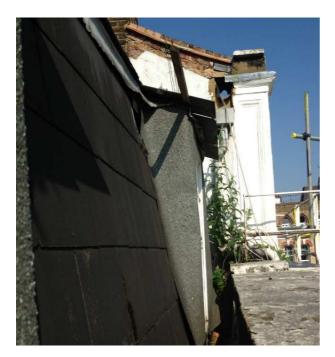
Photo 01
Existing Roof
Eternit Slates and Felt To Dormers

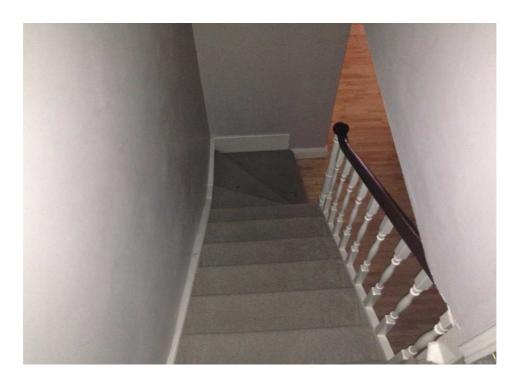
Photo 04 Stairs to Lower Ground Floor

Woodworm at upper level and damp rot at lower level Replace with new, pine staircase to match, Retain handrail. New square spindles

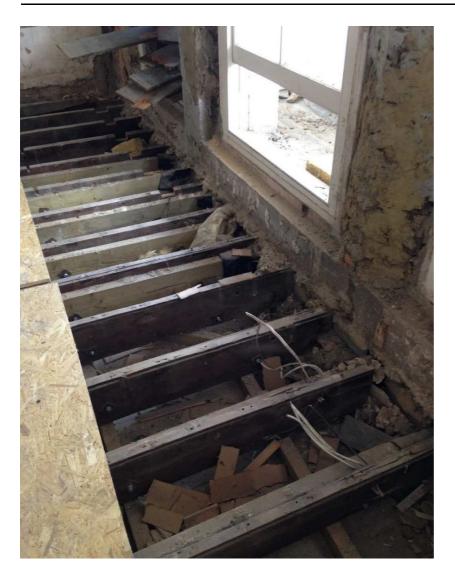
Photo 05
First Floor Drawing Room, F02
Showing existing Concrete beam under windows
Concrete infill in between windows
Joists extended and bolted to existing

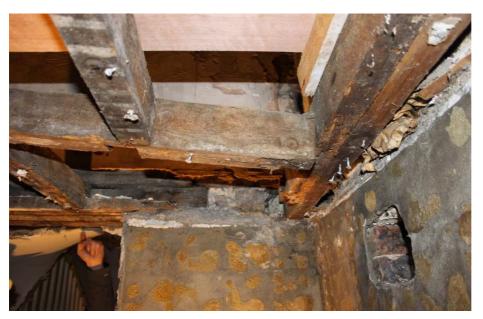
Photo 06 Landing G04 Rotten floor joists. (Woodworm) To be replaced

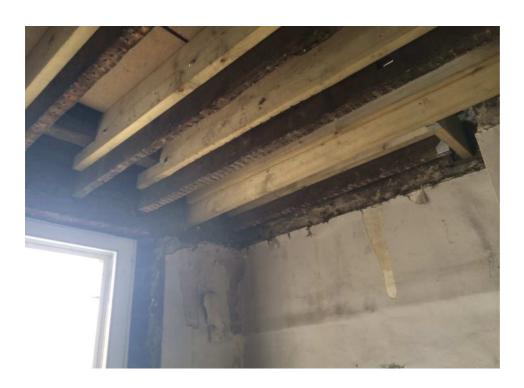
Photo 07 Master Bedroom S01 Photo showing new floor joists bolted to Origional

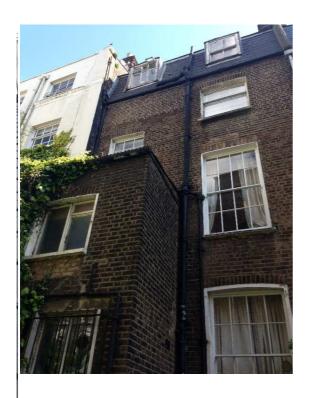
Photo 08
Existing Rear Elevation
Some non Origional Windows, poor brickwork and Pointing

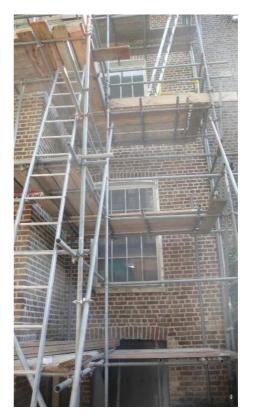
Photos 09 and 10 New Lime Mortar pointing Bricks replaced with second hand bricks to match Downpipes replaced with cast Iron

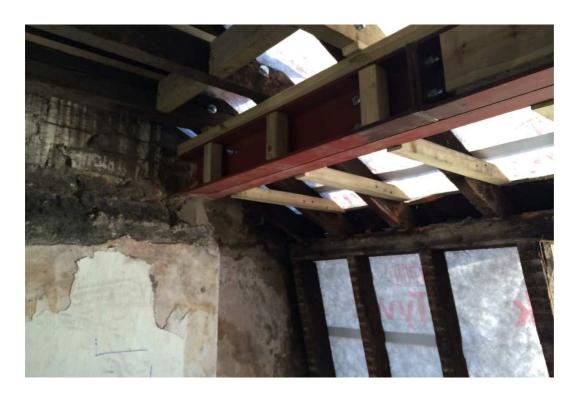
Photo 12 Third Floor, Rear Room T03 Showing new steels to take up sag in roof. Ex celing joists and roof rafters retained
