## RE: 22 Frognal Way, NW3. Climbing inspections and observations

The following is a brief description of the observations with regards to the trees climbed for closer inspection at the above address.

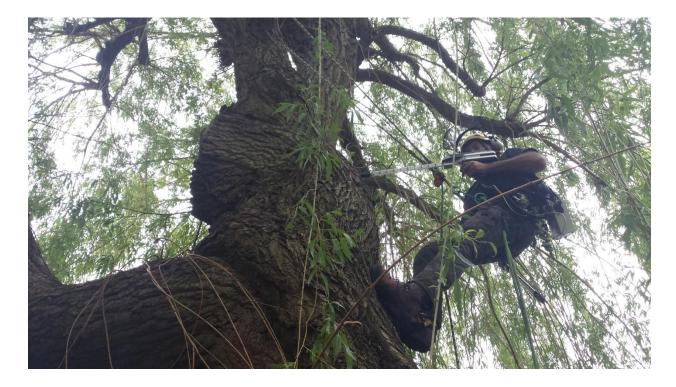
## T3: Salix spp.

Woodpecker hole @ 5m SW side of main fork is confirmed to be an indication of a hollow. The hollow extends vertically and is located between the two major stem unions at 4m and 6m. A decay probe was made opposite the hole to indicate the depth of the hole and determine the remaining residual wood.

The diameter of the stem at this height is 86cm. The results below show resistance against the probe 23cm then a void. Therefore the residual wood percentage opposite the hole which is likely to be the highest transversely surrounding the void is 27%. Field trials by C. Matteck and H. Breloer; *Reasearch for amenity Trees no. 4* show the a critical point for failure is 1/3 and below for trees with a full crown. Considering the location of the hollow I would not consider this tree for long term retention.

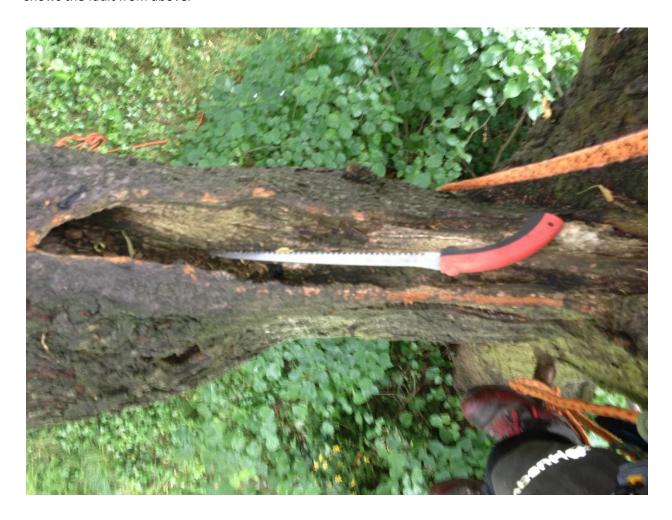
## T1 Tilia spp.

No major faults with the crown albeit those identified within Adam Hollis report. The photo below shows the fault from above.
