**BRICK AND TIMBER CONDITION REPORT**

**65 SWINTON STREET, LONDON, WC1X 9NT**

**Date: 20<sup>th</sup> June 2014**

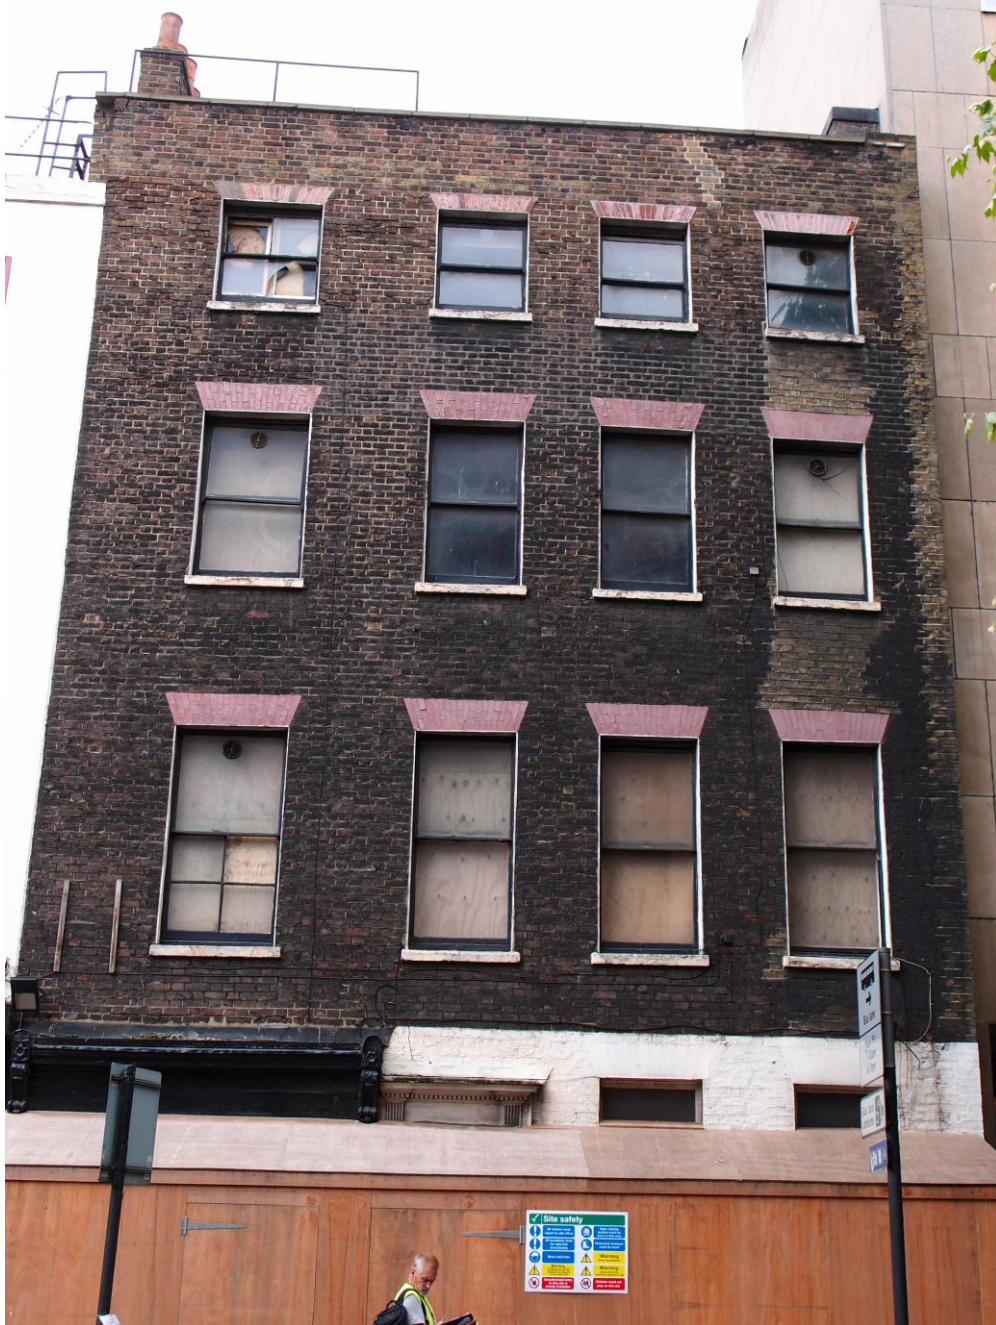
2.1.1 Brickwork appears to be yellow multi stock in Flemish type bond, 1½ brick thick with pink voussoir gauged brick flat arch window heads and stone cills, with render applied to jambs and soffits, parapet detail at roof level with what appear to be non-original flag copings. The brickwork has a paint finish from ground floor head level to floor level of basement. Figure 1

2.1.2 The front elevation has heavy carbon/ atmospheric pollution deposits.

**Figure 1 – Front Elevation**

4.1.2 We would recommend the external brickwork is cleaned using mild chemical lightly agitated and low pressure rinse, followed by cut out of all joints and lime mortar pointing.

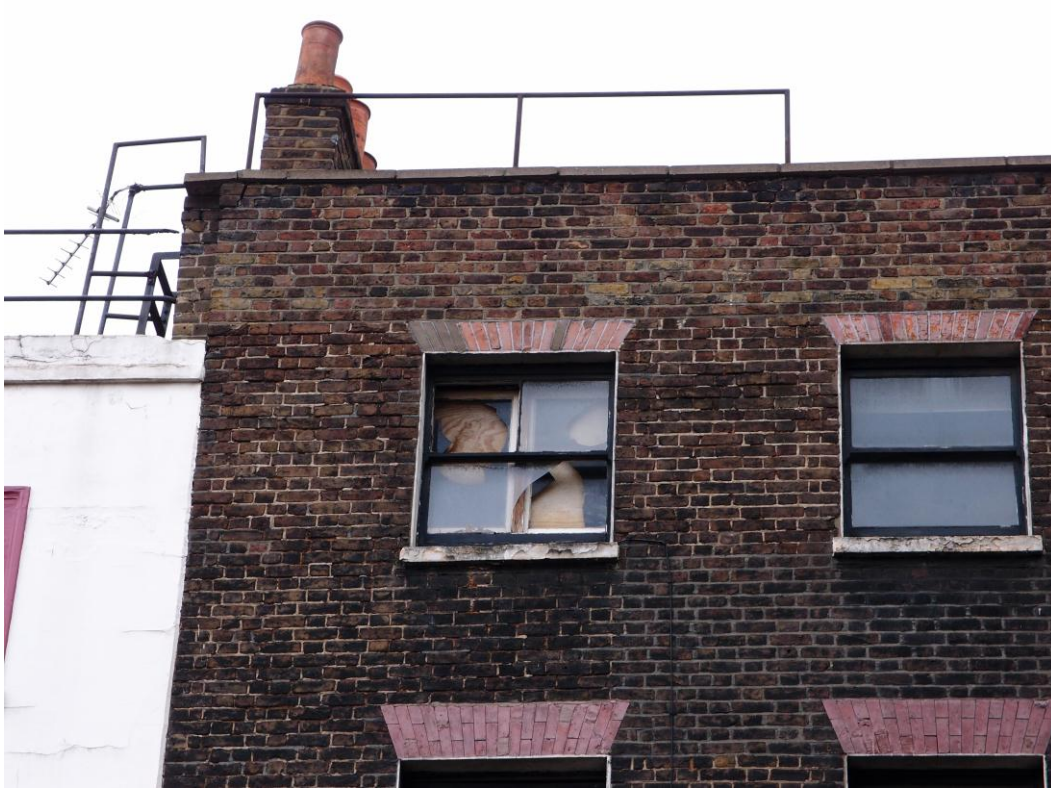
2.1.3 The exposed brickwork appears in reasonable condition with areas that have been patch repaired in the past, low level cracks at ground floor head level and upper left shows signs of displacement at coping level possibly due to corrosion 'jacking' of handrail in that area, large areas of pointing to this elevation appears worn. Figure 2 & 3

**Figure 2 – Front Elevation upper floor window head & displaced coping brickwork**

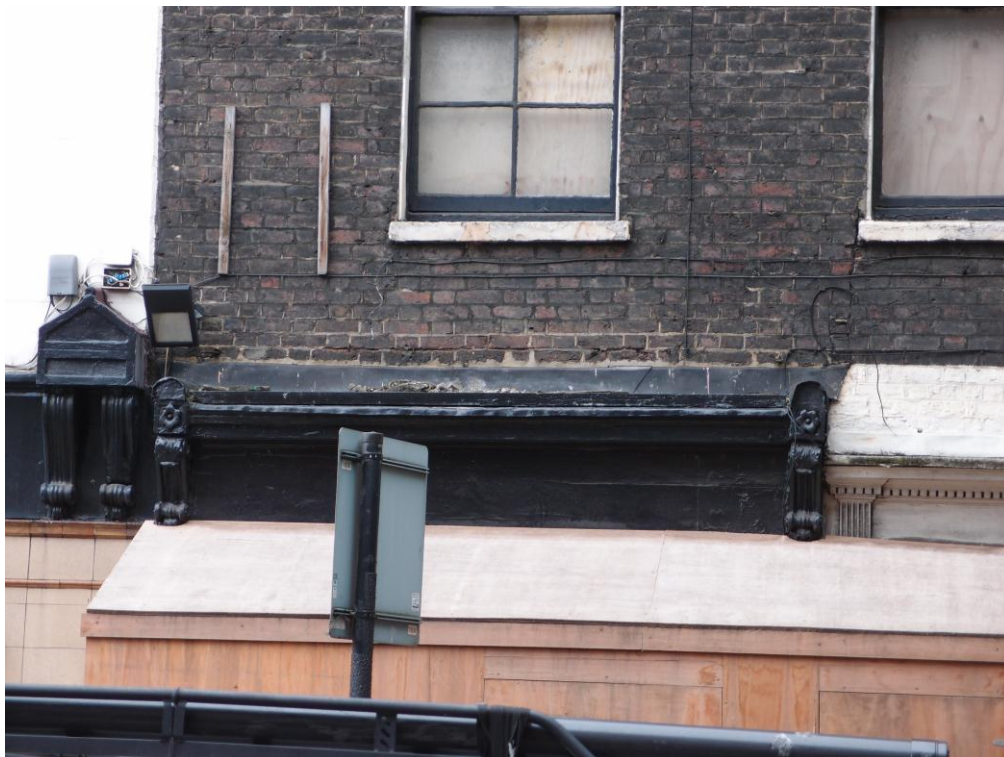
**Figure 3 – Front Elevation displaced brickwork at door head**

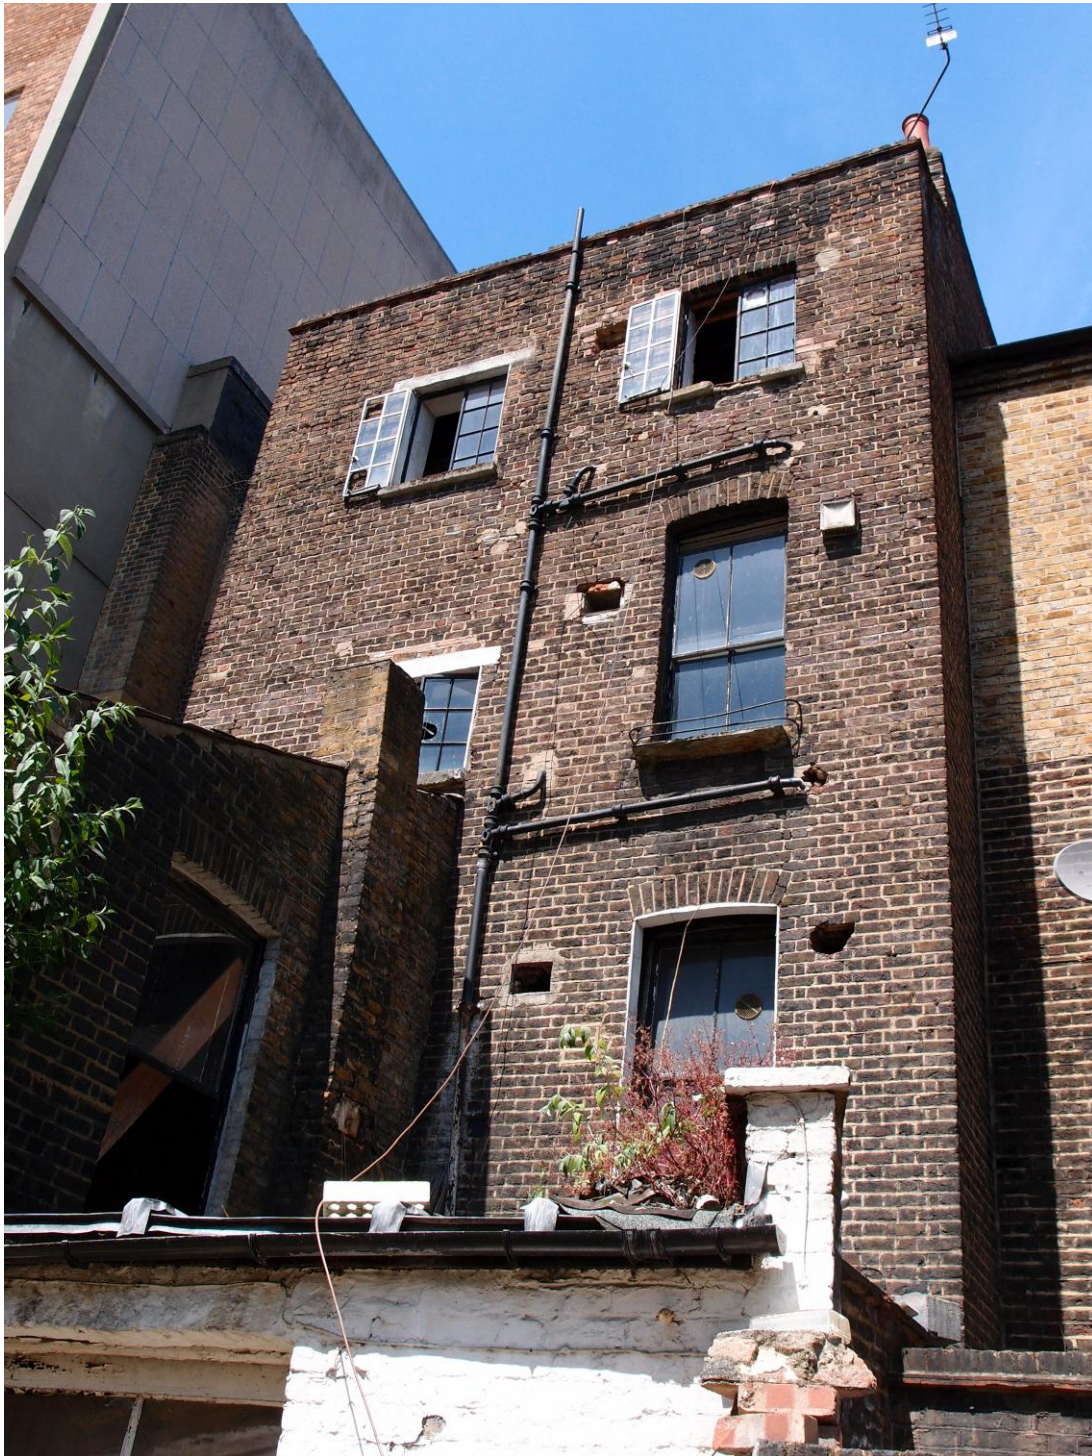
2.2.1 Brickwork appears to be yellow multi stock in Flemish type bond 1½ brick thick, with a mixture of brick arch and concrete lintel window heads, with cills that appear to be concrete and some render to jambs and soffits with carbon/ atmospheric pollutant deposits throughout. Parapet detail at roof level original brick on edge coping atop double creasing tiles. Figure 4.

2.2.2 Rear facing walls, upper levels a number of missing coping bricks and areas of broken creasing tiles, brickwork has some areas of mis-matched replacement bricks, approximately 5 number holes penetrate the rear wall where services have been removed, vertical cracks are present in several locations. . Figure 4

**Figure 4 – Rear Elevation**

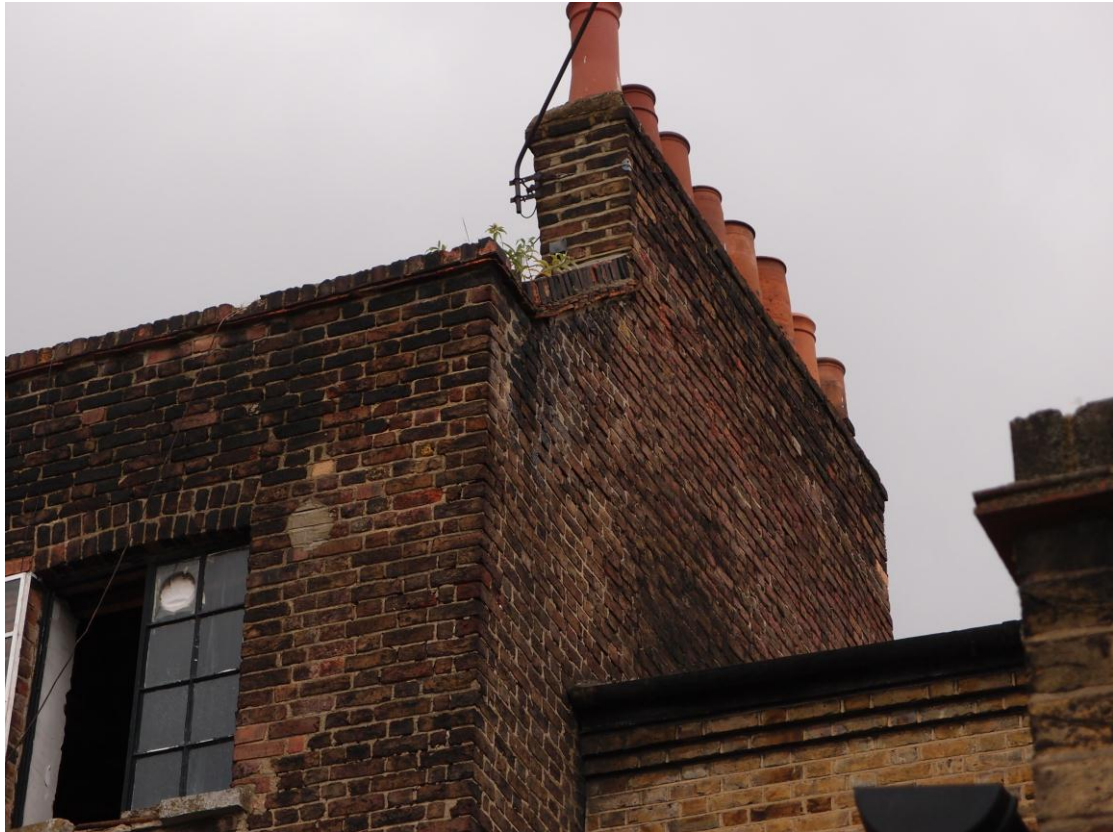
2.3.1 Chimney appears to be leaning inwards to roof structure- further investigation required when access available. Figure 5

**Figure 5 – Partition wall & chimney**

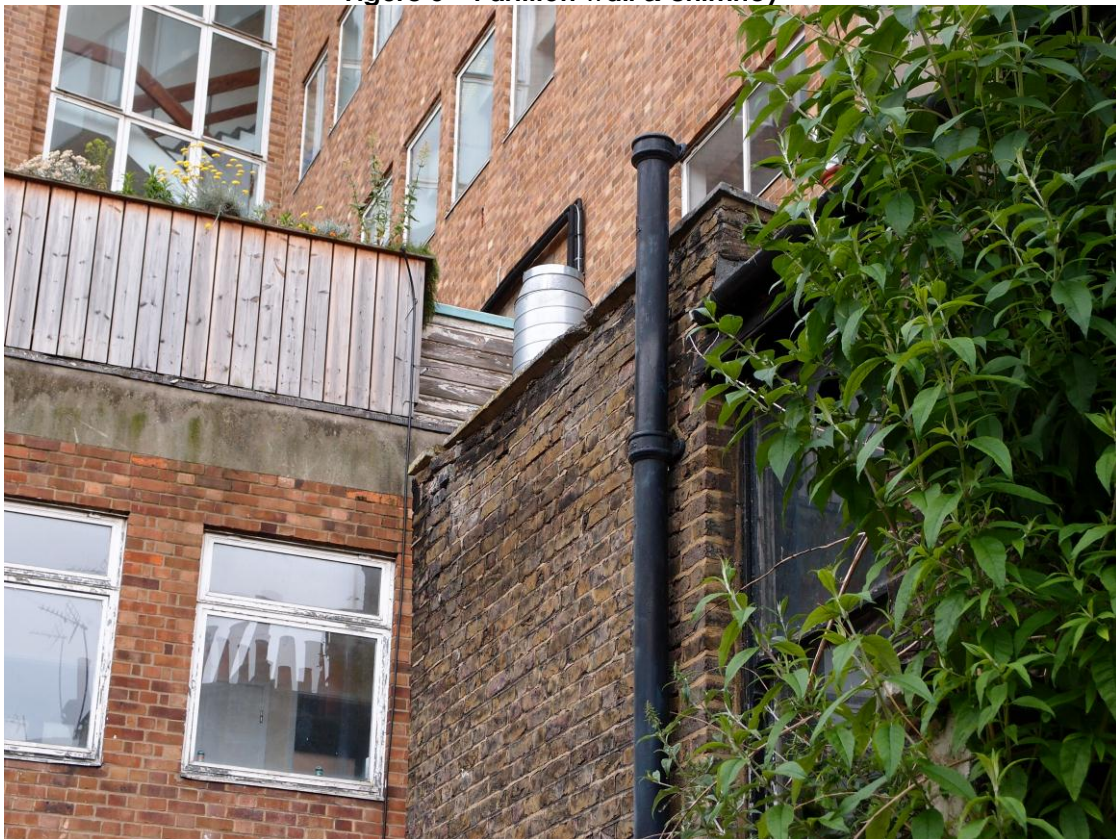
2.2.3 Left hand extension wall, upper parapet wall at roof level leaning inwards towards roof structure approximately upper ten courses, plant growth distorting brickwork at lower right hand side where brick nib projects past face line. The midpoint where perimeter wall intersects wall has large open joints where plant growth has been removed. Ground floor area is painted with signs of efflorescence stone cill appears in poor condition. Figure 6 to 10

**Figure 6 – Rear extension parapet leaning inward**

4.1.1 It is our conclusion that the majority of the brickwork structure is in reasonable condition with the exception of the areas noted within this report which will require remedial measures. We would recommend that the excessively distorted or badly bowed brickwork is carefully taken down and rebuilt to the required heritage method and specification. The vertical cracks identified (noted on attached drawings) we would recommend these are stitch repaired to the correct method and specification such as the Helifix system Appendix 2.

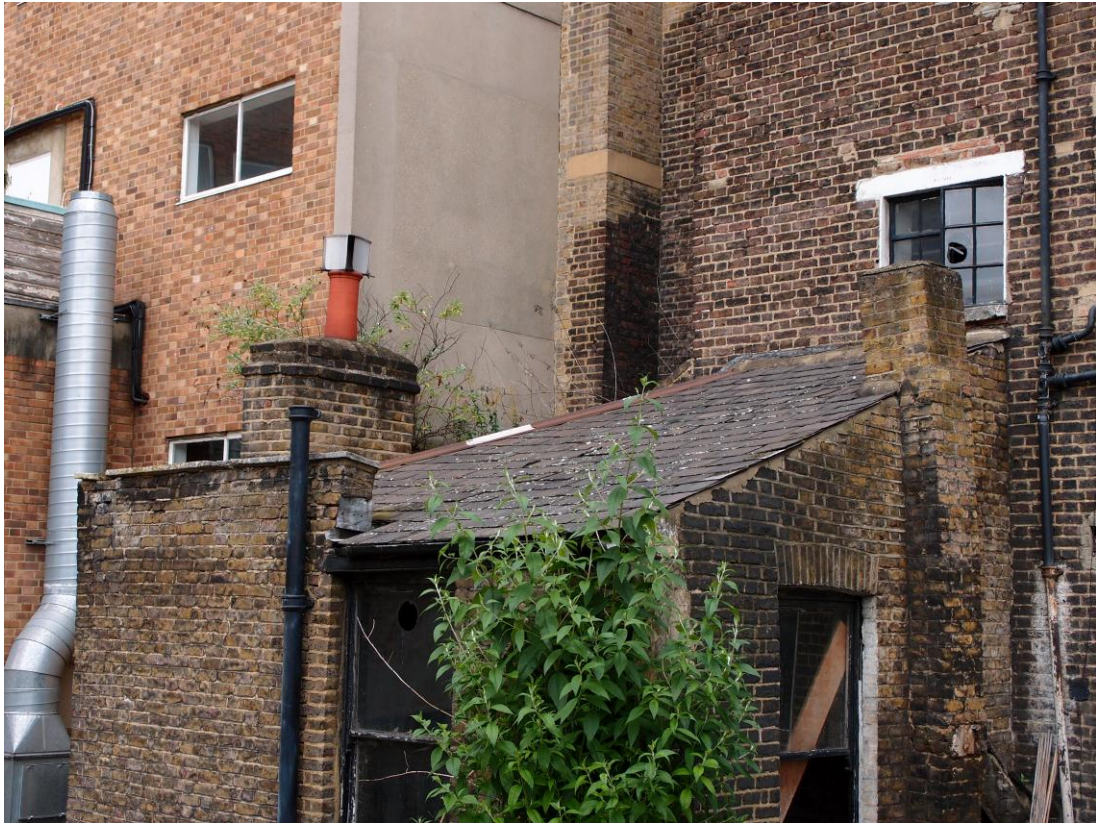
2.2.5 Flank wall two floor extension, chimney and wall badly bowed in unsafe condition. Figure 4, 7

**Figure 7 – Rear extension return wall & Chimney**

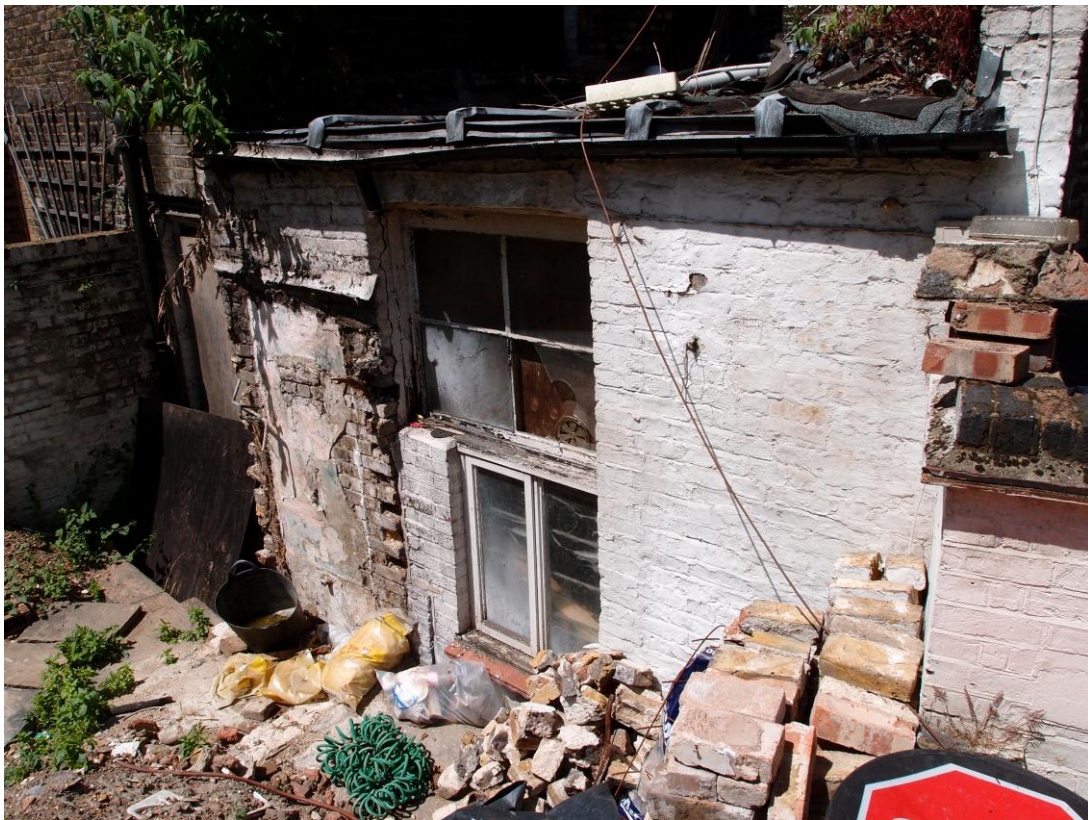
2.2.4 Ground floor infil area right hand of doorway, painted brickwork in poor condition with signs of collapse of arched brick window head. Figure 8.

**Figure 8 – Rear ground floor external wall**

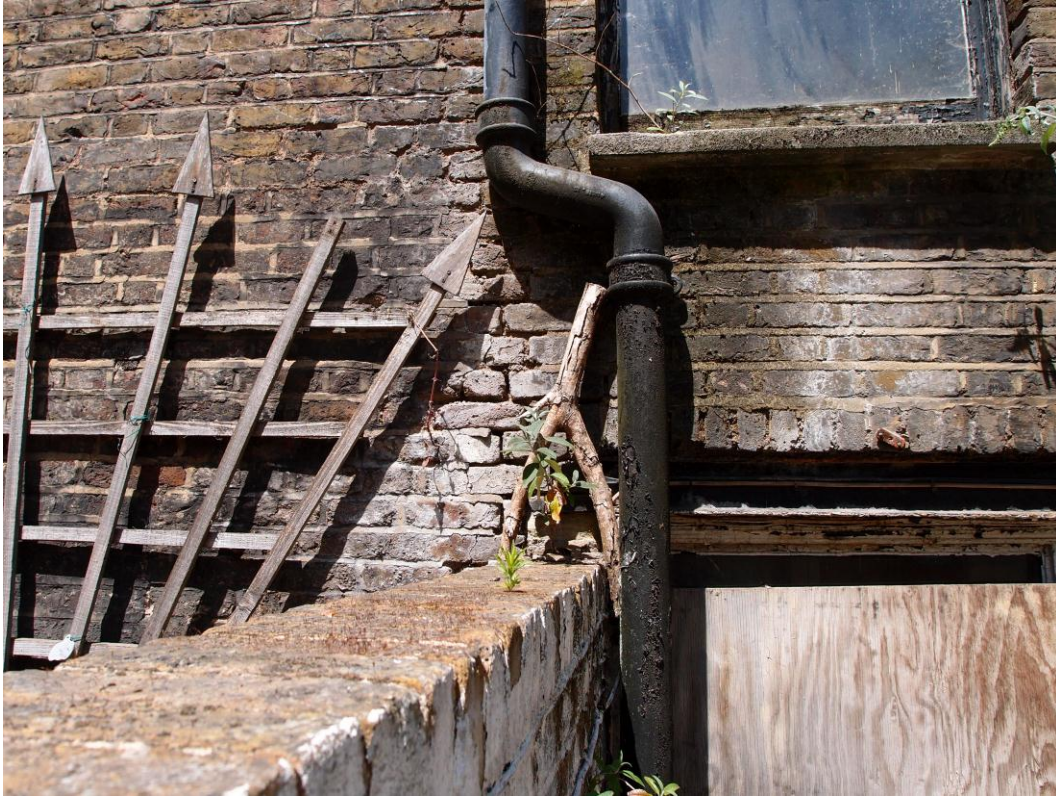
**Figure 9 – Rear extension brickwork affected by plant growth**

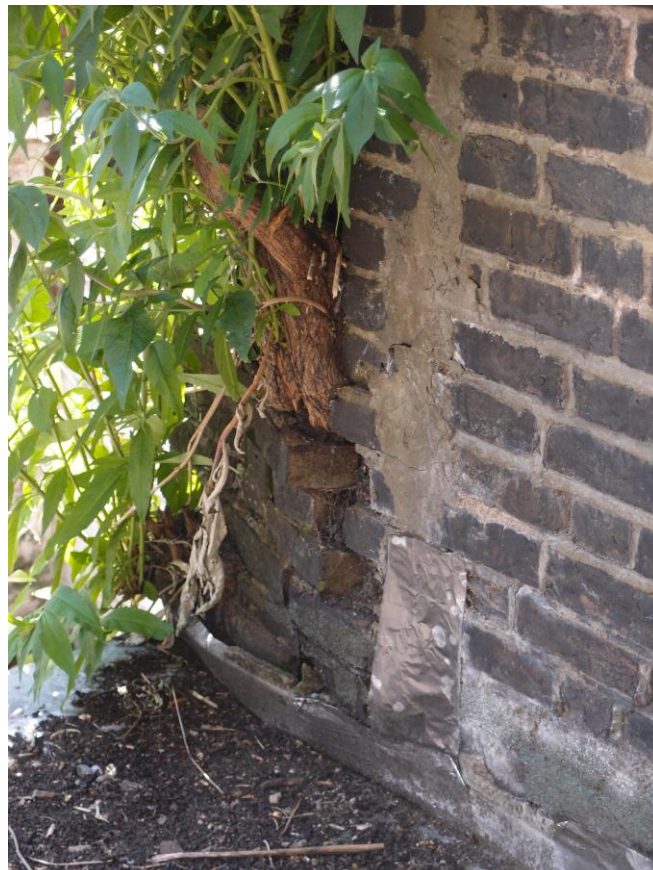
**Figure 10 – Rear extension brickwork affected by plant growth**

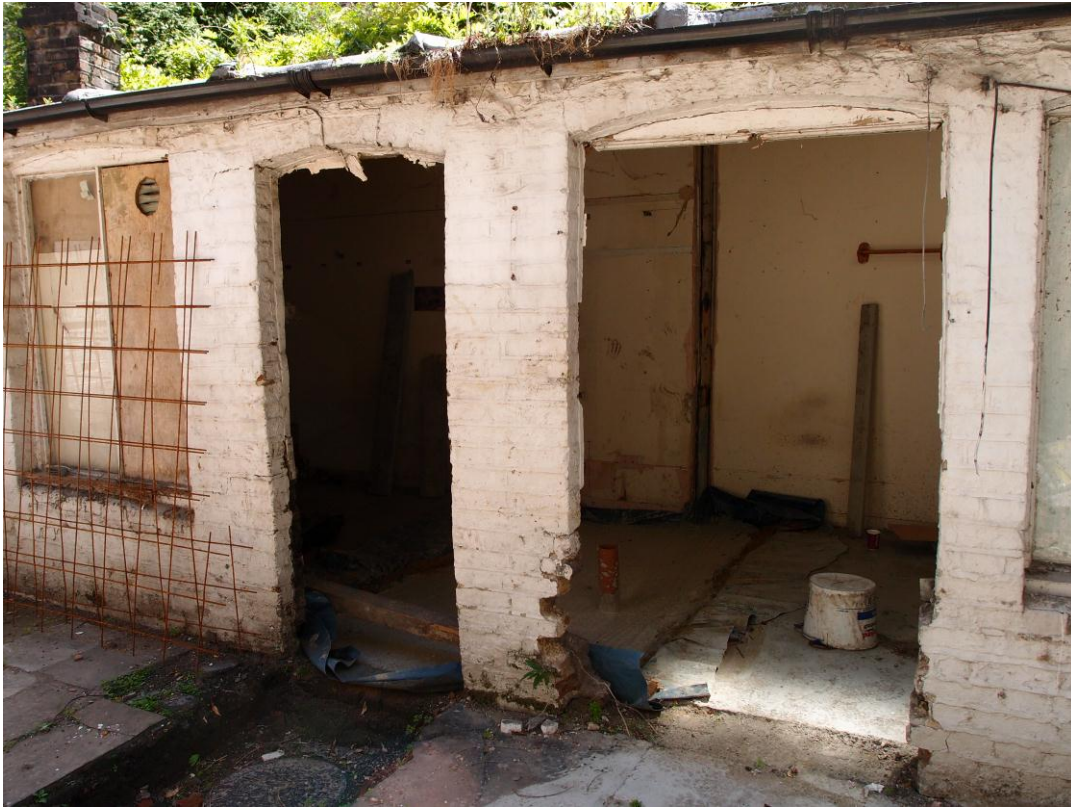
2.2.6 External out building, severely bowed walls in unsafe condition. Figure 11

**Figure 11 – Rear yard outbuilding**

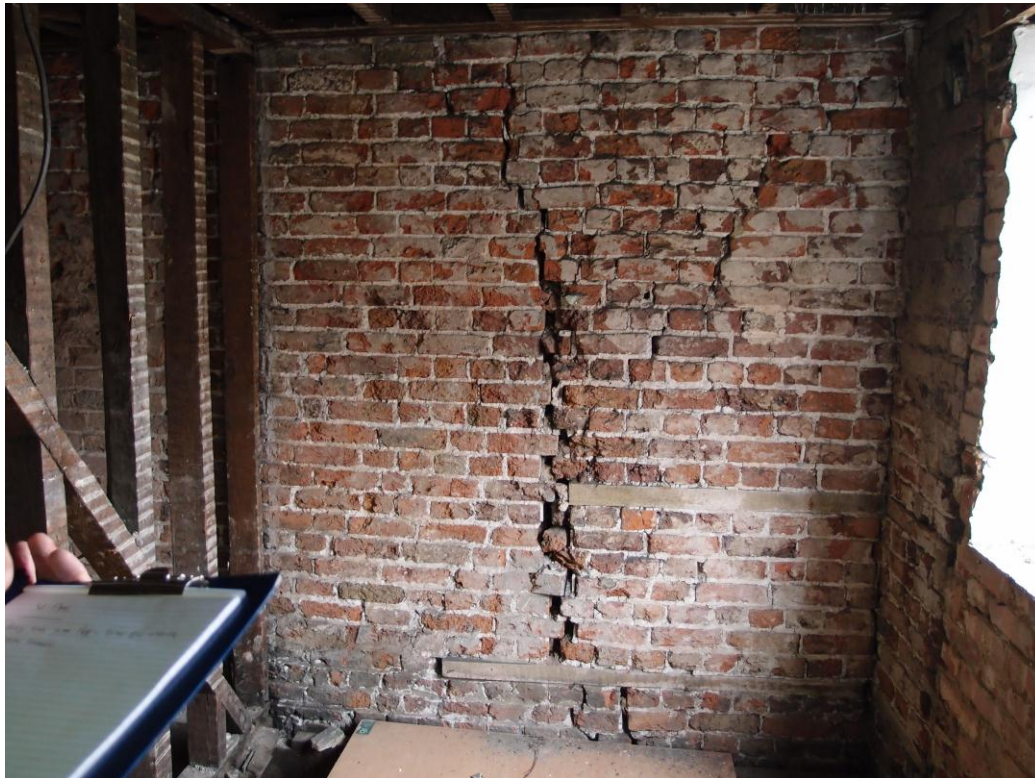
- 2.4.5 Corridor brickwork appeared in reasonable condition
- 2.4.6 Upper floors: brickwork generally in reasonable condition again with damage where it is assumed mechanical method have been used to remove surface coatings. There are areas where movement/ cracking have occurred and have been recorded on the accompanying drawings. Figure 12 & 13

**Figure 12 – Internal brickwork upper floor crack at partition wall**

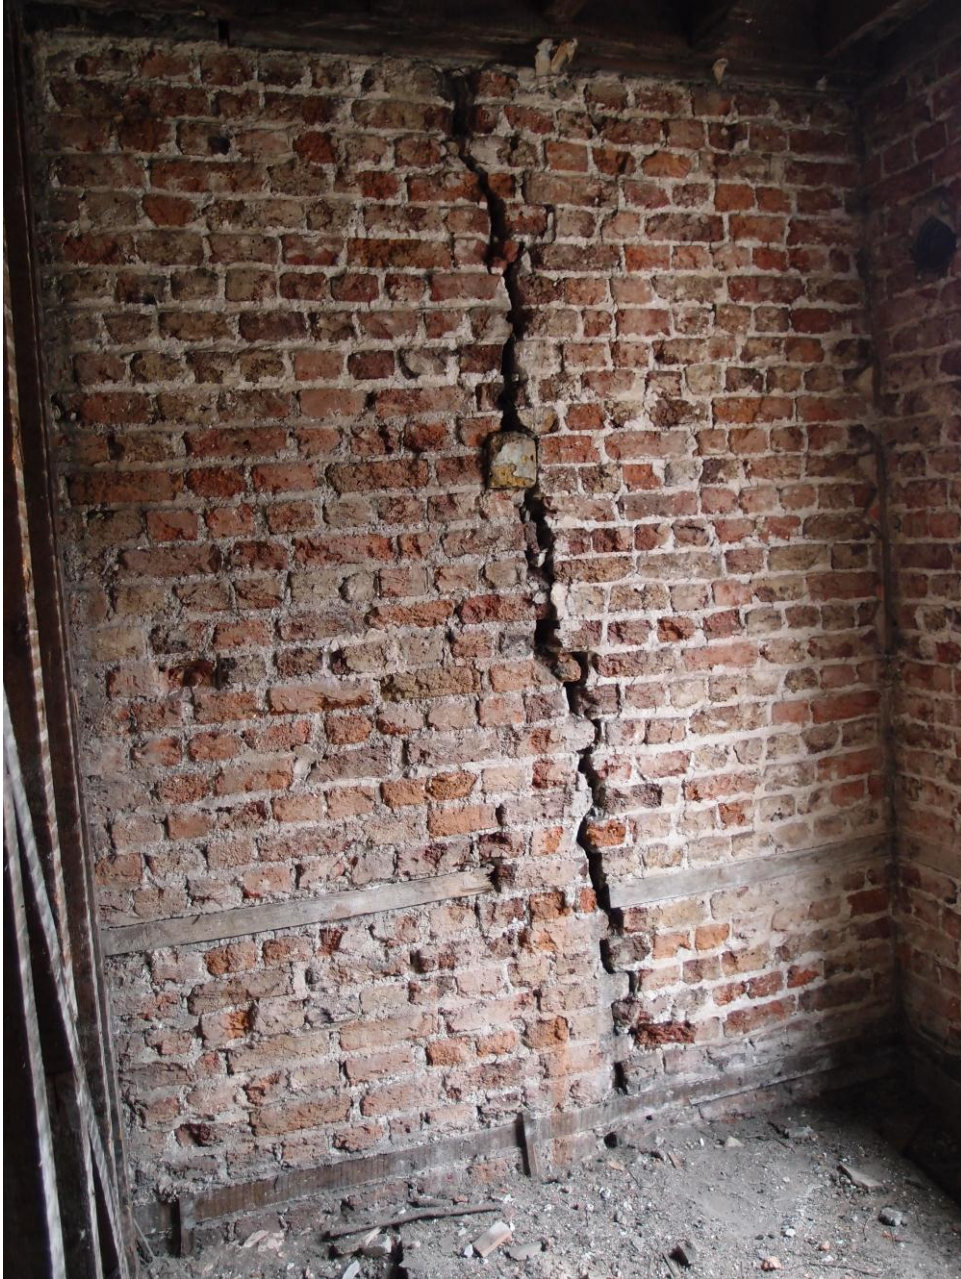
**Figure 13 – Internal brickwork second floor crack at partition wall**

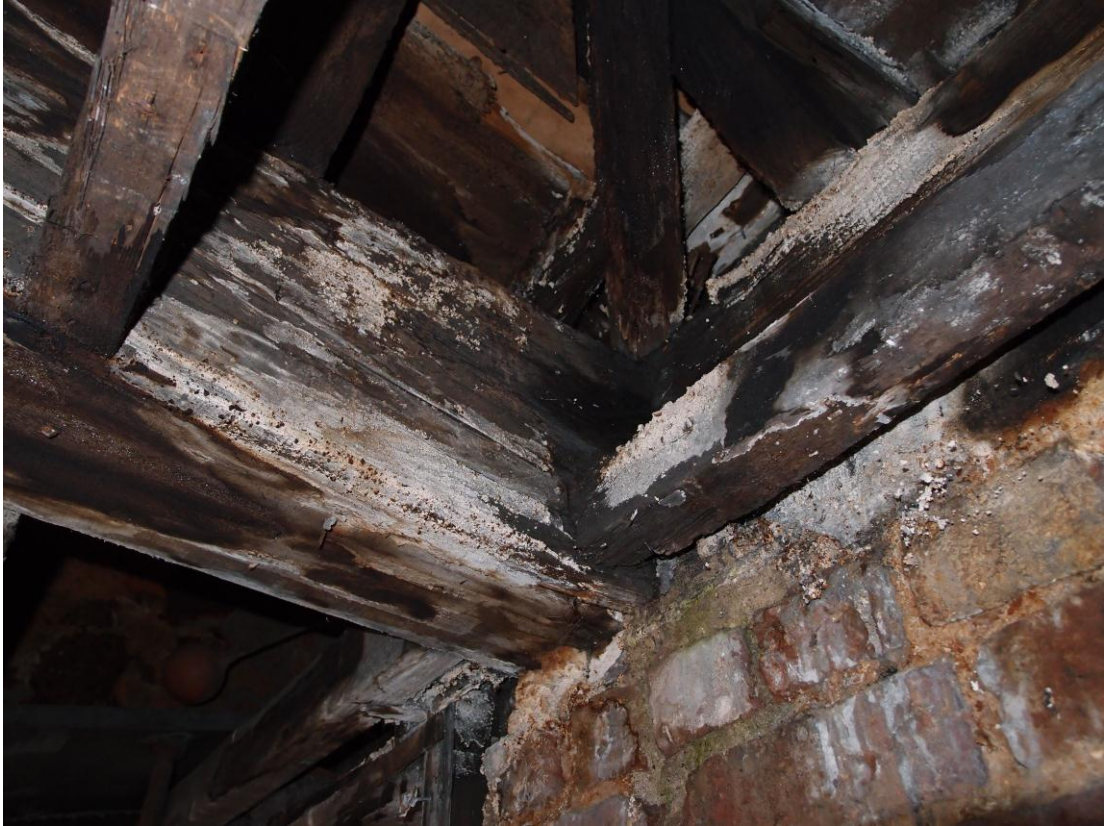
- 3.1.1 The main building roof structure (visual inspection above ceiling joists only) generally appears in reasonable condition with some historic water staining and general surface deposits moisture meter readings below 18%.
- 3.1.2 However the large timber beams which sit underneath both outside gullies at the rear of the building show signs of decay due to moisture penetration, moisture meter readings in excess of 40% . Figure 14 & 15
- 3.1.3 Wall plates and window heads appeared in fair condition visual inspection only.

**Figure 14 – RHS roof beam underside gully showing signs of decay**

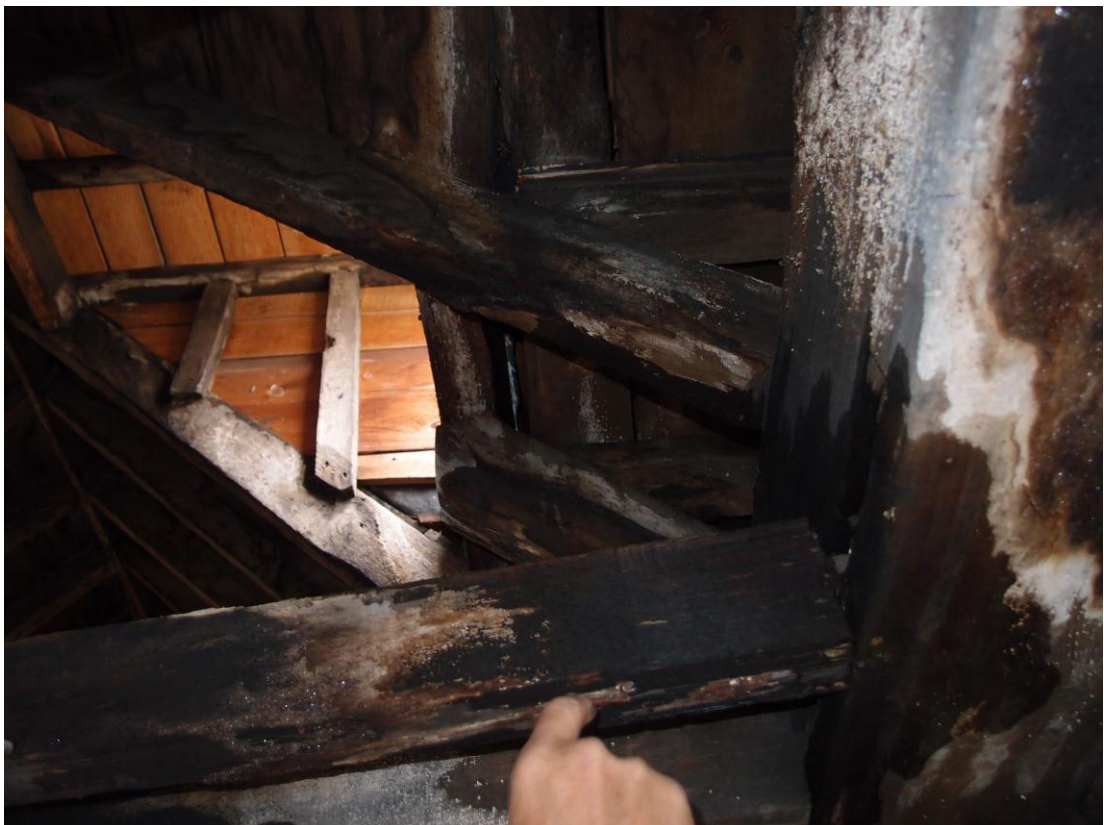
**Figure 15 – LHS roof beam underside gully showing signs of decay**

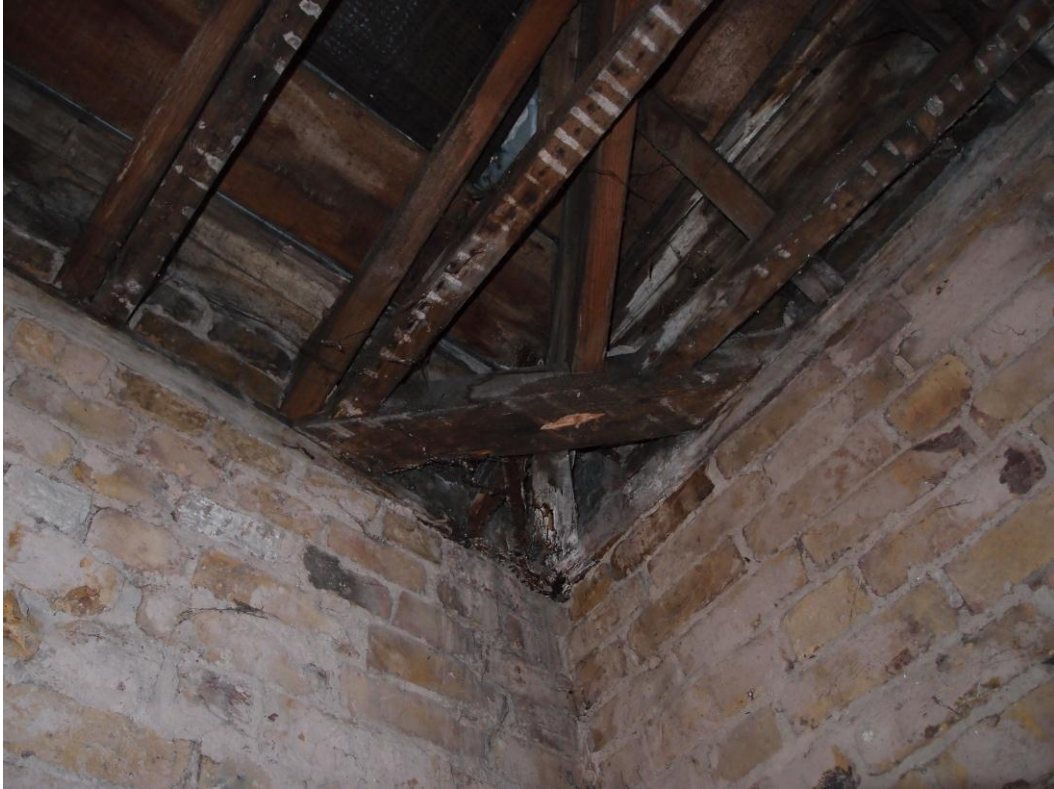
- 3.2.1 Visual inspection only, timber appears in reasonable condition with some historic water staining and general surface deposits.
- 3.2.2 External corner hipped end timber appears to be wet with some decaying elements. Fig 16

**Figure 66 – Rear two story roof structure external corner hip**

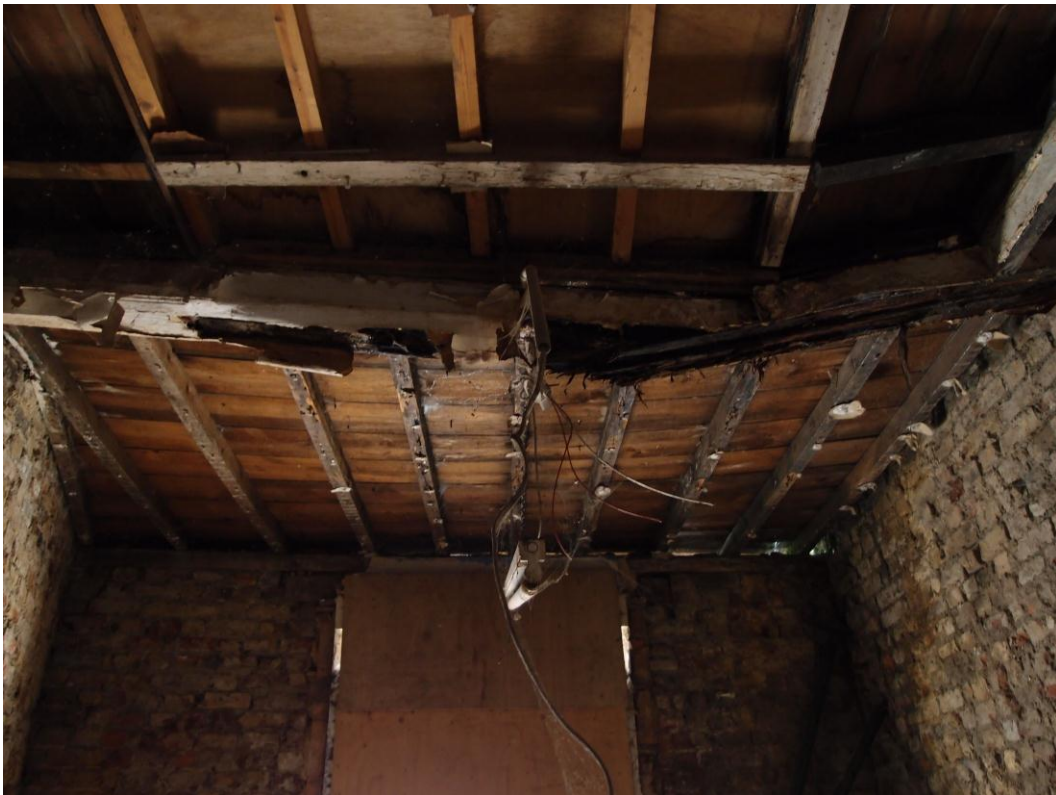
3.3.1 Visual inspection only the main roof joist has broken leaving the roof without any form of support and is in an unsafe condition. Figure 17

**Figure 77 – Rear flat roof structure**

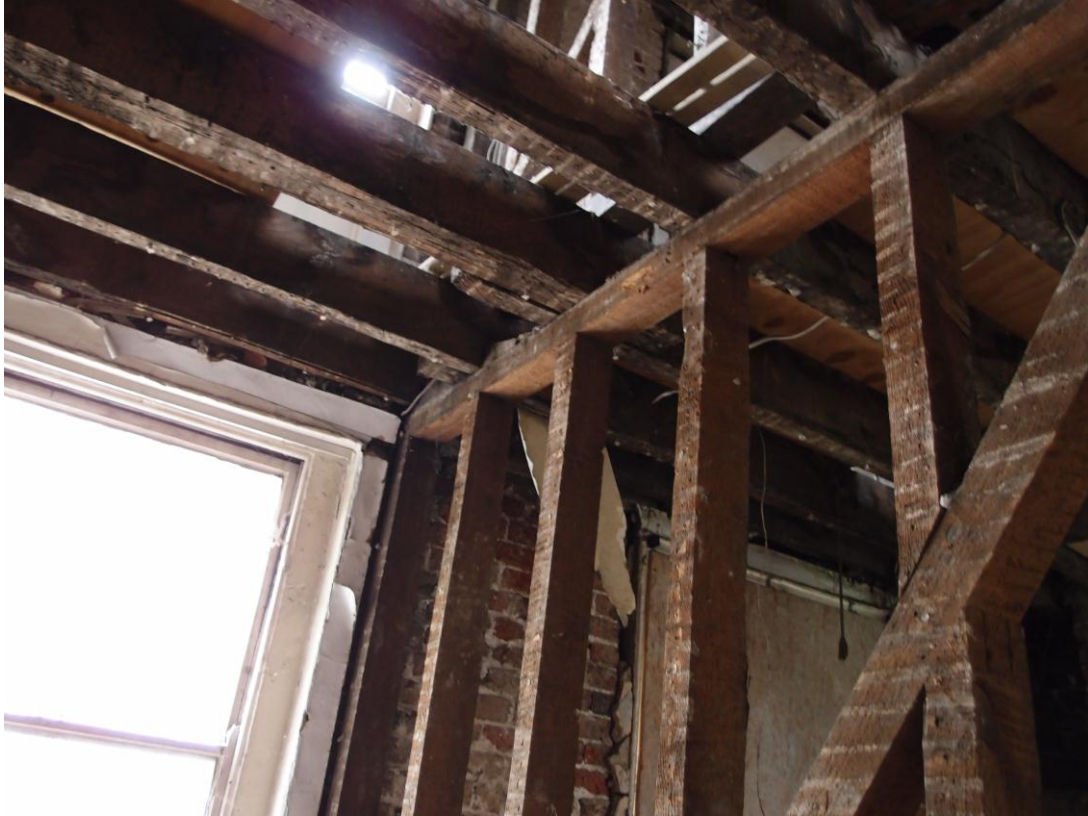
3.4.1 Internal timber partitions appear in fair condition with past alterations in some areas which may require attention. Some signs of insect infestation in isolated areas, advise further investigation. No excessive moisture readings were recorded on areas tested  $\leq 18\%$ . Figure 18

**Figure 18 – Typical internal floor joists & partition**

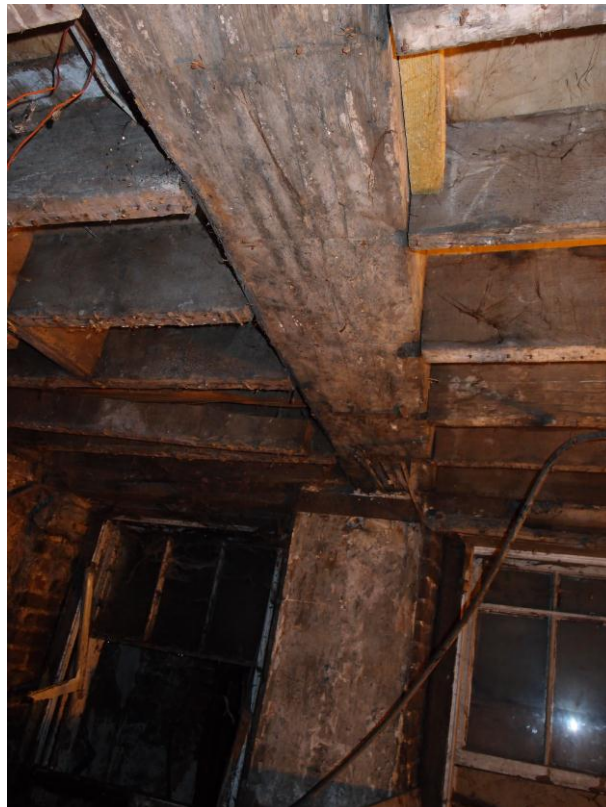
3.5.1 Ground floor joists have been recently replaced to the former yard entrance floor, the remaining floor joists are jointed to a large 320mm X 200mm beam running diagonal from front wall to internal stairs wall. The large beam is showing signs of decay at the internal wall seating along with the wall plate, as these joists are located in the basement area it is worth noting these are exposed to damp atmosphere. Most joists appear in reasonable condition with some historic water staining and surface deposits, one number joist has split to the right hand side of the fire place as shown on attached drawing. Figure 19 & 20

**Figure 89 – Ground floor broken floor joist & large floor beam**

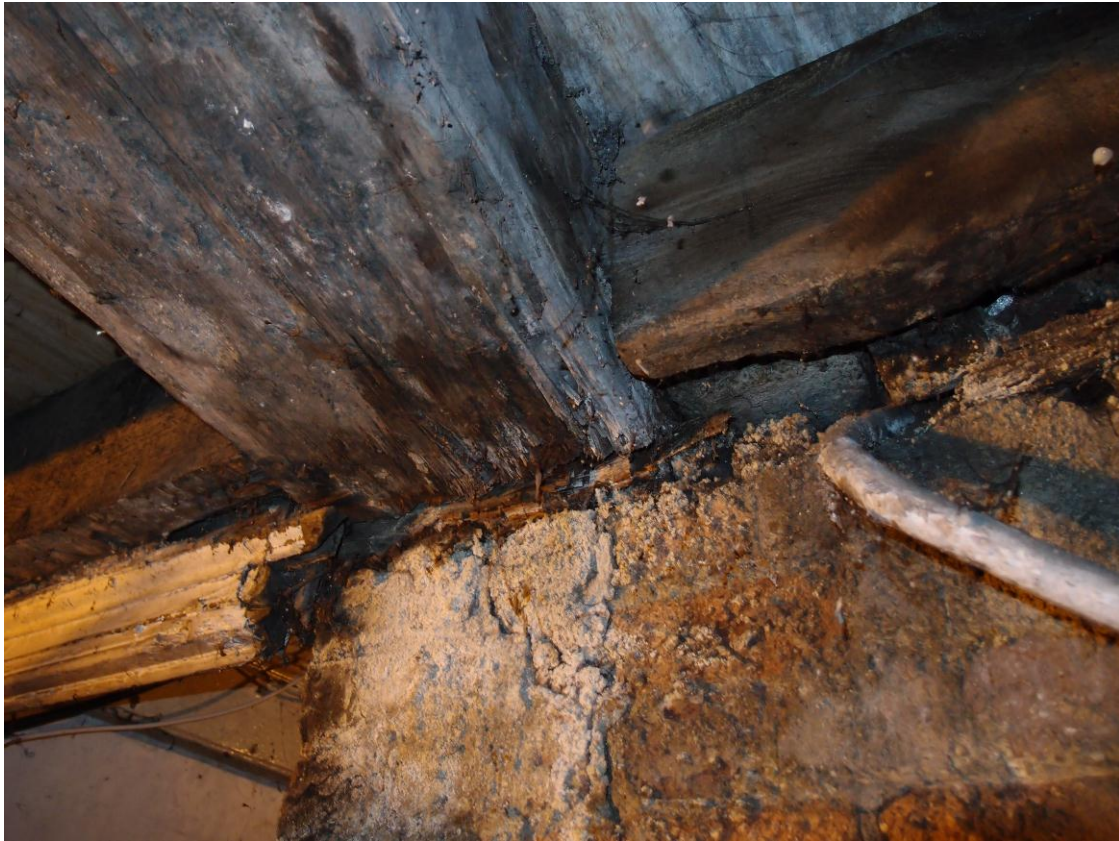
**Figure 20 – Large ground floor beamt showing decay**

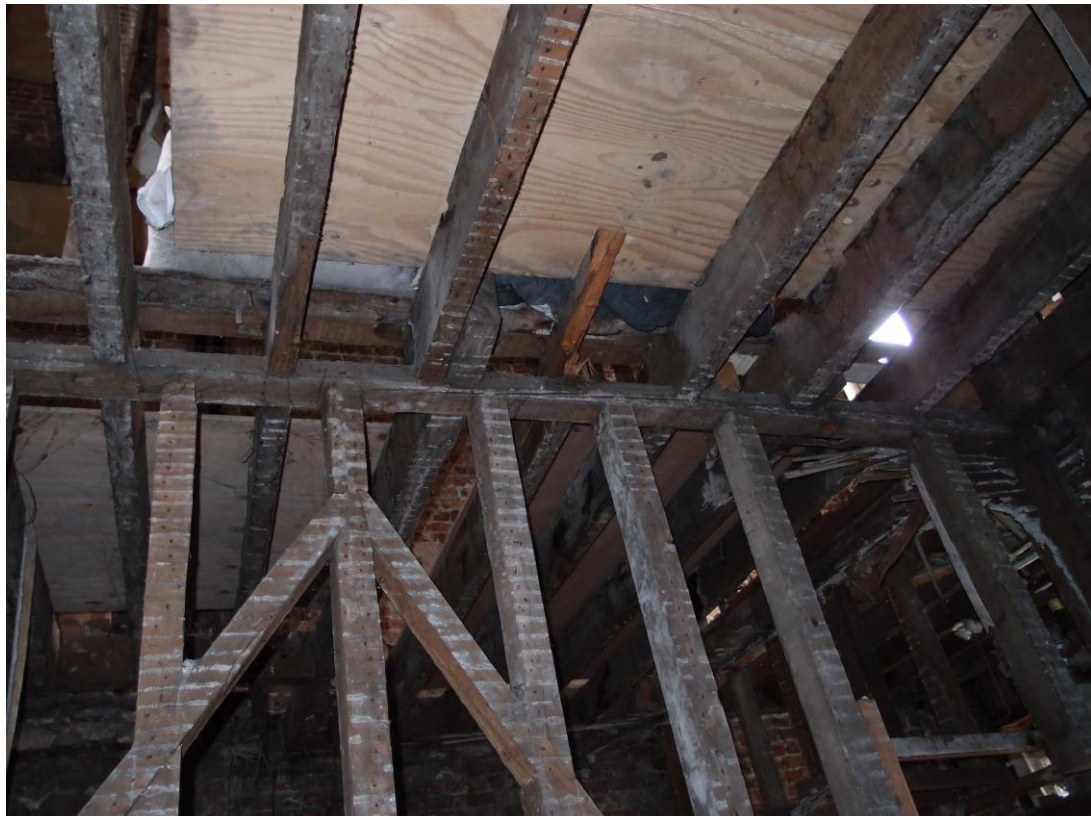
3.5.2 First floor joists appear in reasonable condition with some historic water staining and surface deposits front room has a repeat detail of ground floor with a large 320mm X 200mm beam running from front wall to internal stair wall again this shows signs of decay due to excessive moisture content at stair wall seating along with wall plate no access to this area advise further investigation with one number joist broken to left hand side of fire place. Floor joists in rear extension appear in fair condition. Figure 21 & 22

**Figure 21 – First floor broken floor joist**

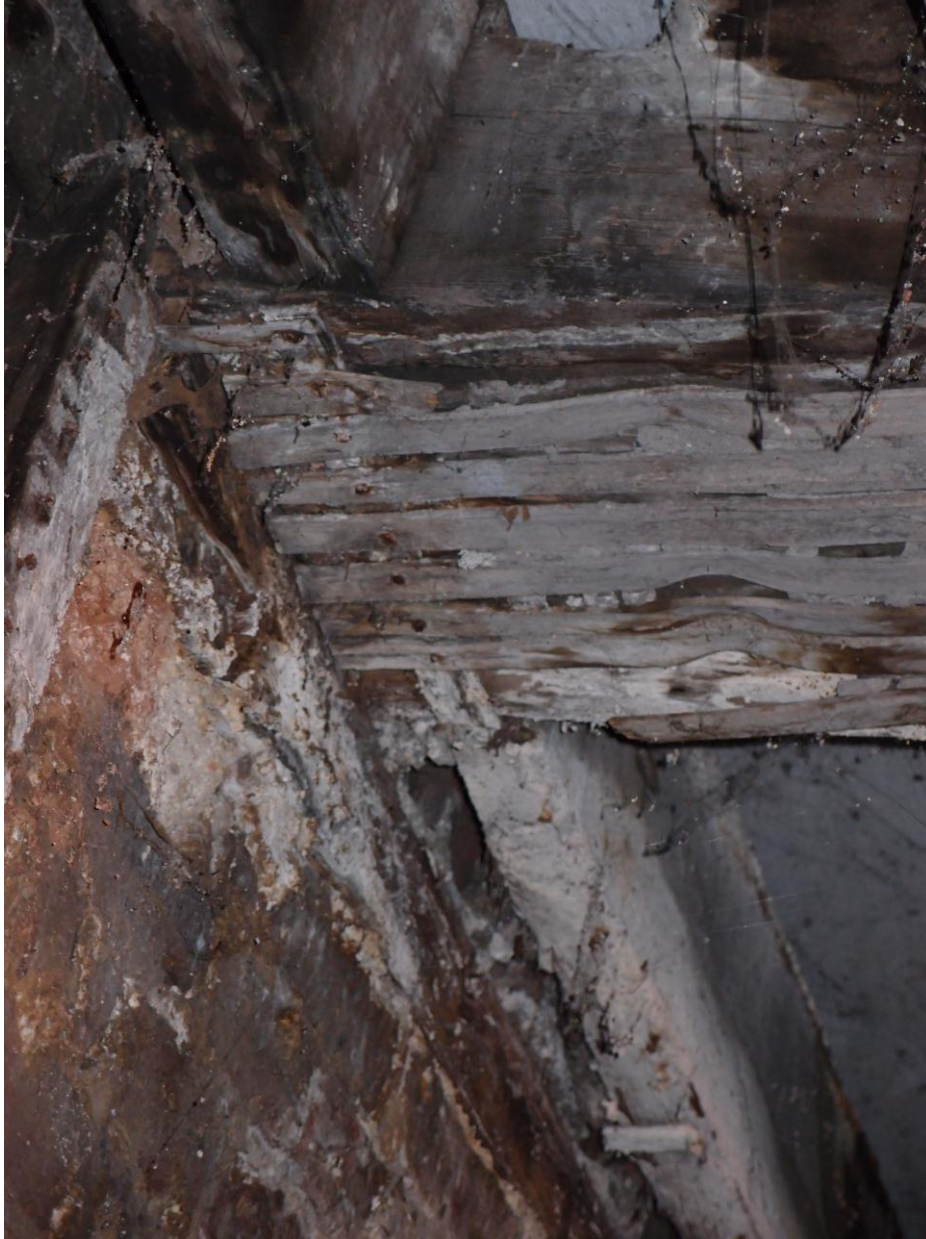
**Figure 22 – First floor large beam at intersection with rear wall**
