**BRICK AND TIMBER CONDITION REPORT**

**65 SWINTON STREET, LONDON, WC1X 9NT**

**Date: 20<sup>th</sup> June 2014**

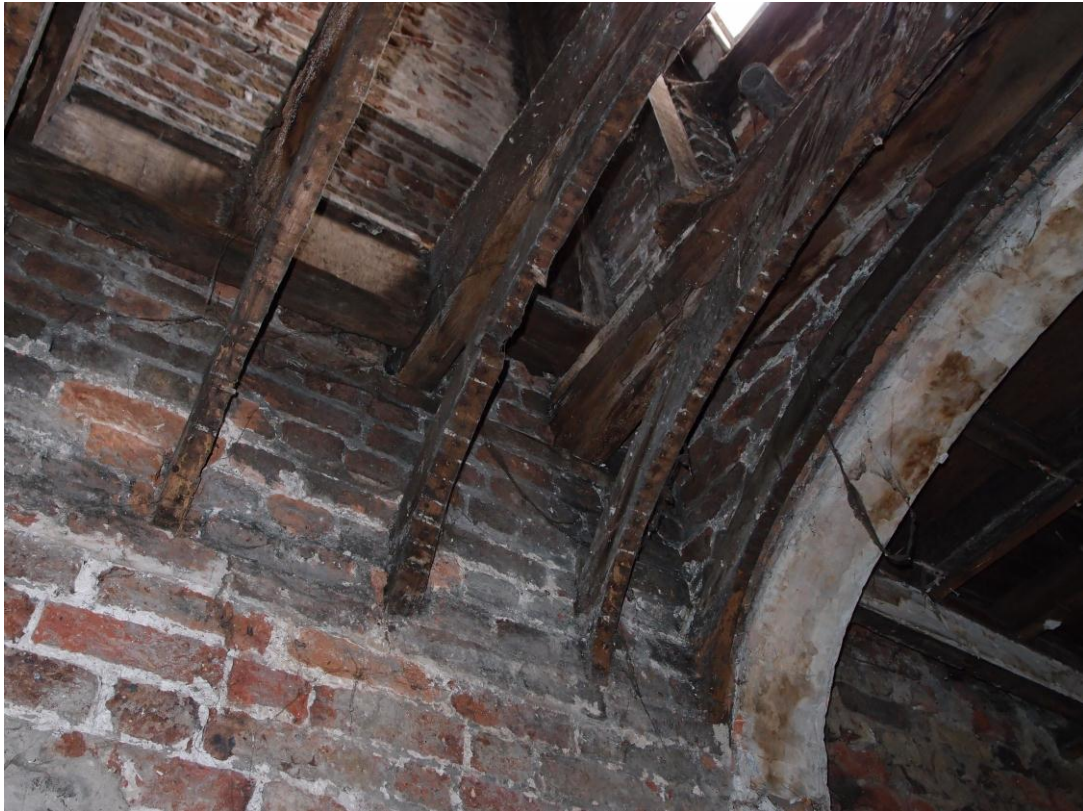
3.5.3 First floor joists to courtyard entrance show signs of historic water staining and surface deposits most joists appear in fair condition. Most of the curved 'arch formers' are showing signs of decay at the seating point in the brickwork in some pieces the decay has progressed. Three joists and 'arch formers' to the rear of the building are showing signs of advanced decay and insect infestation advise further investigation. Figure 23

**Figure 23 – Rear courtyard entrance first floor joists with arch formers**

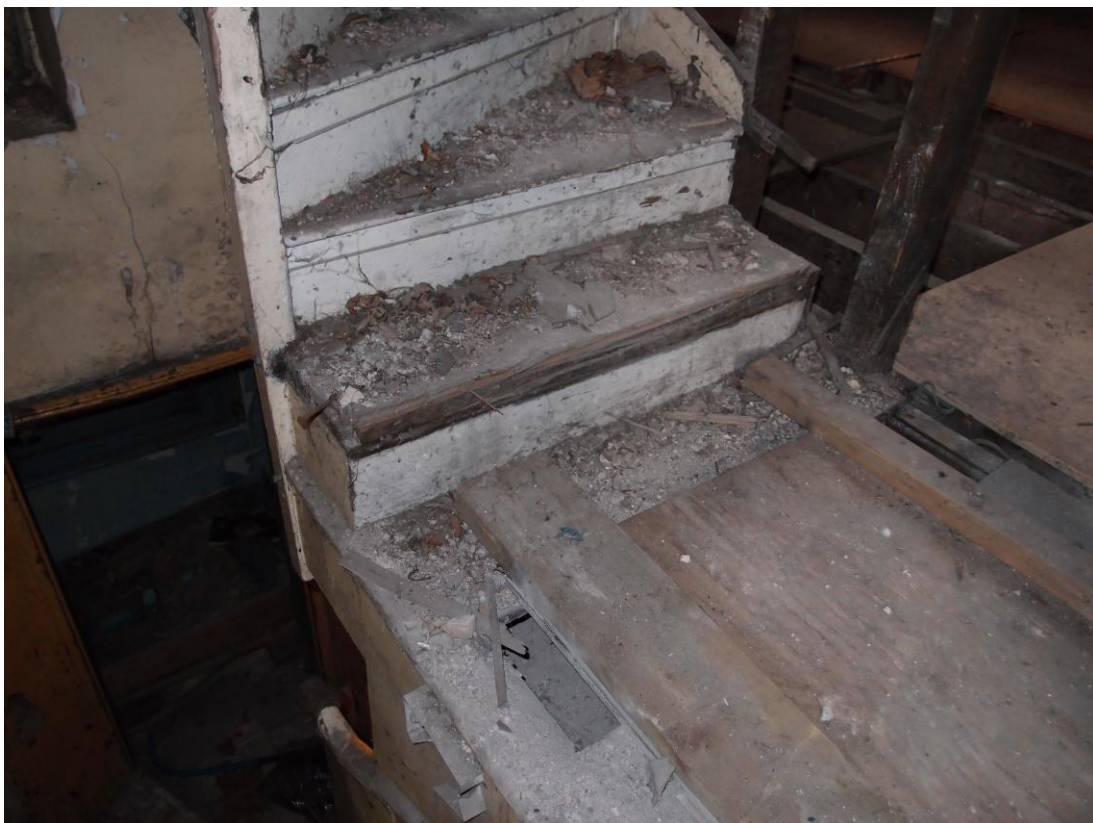
3.6.1 The entire staircase has been very well used and is showing signs of wear and tear throughout. Where exposed timber structure appears in reasonable condition. Figure 24

**Figure 24 – Typical stairs**

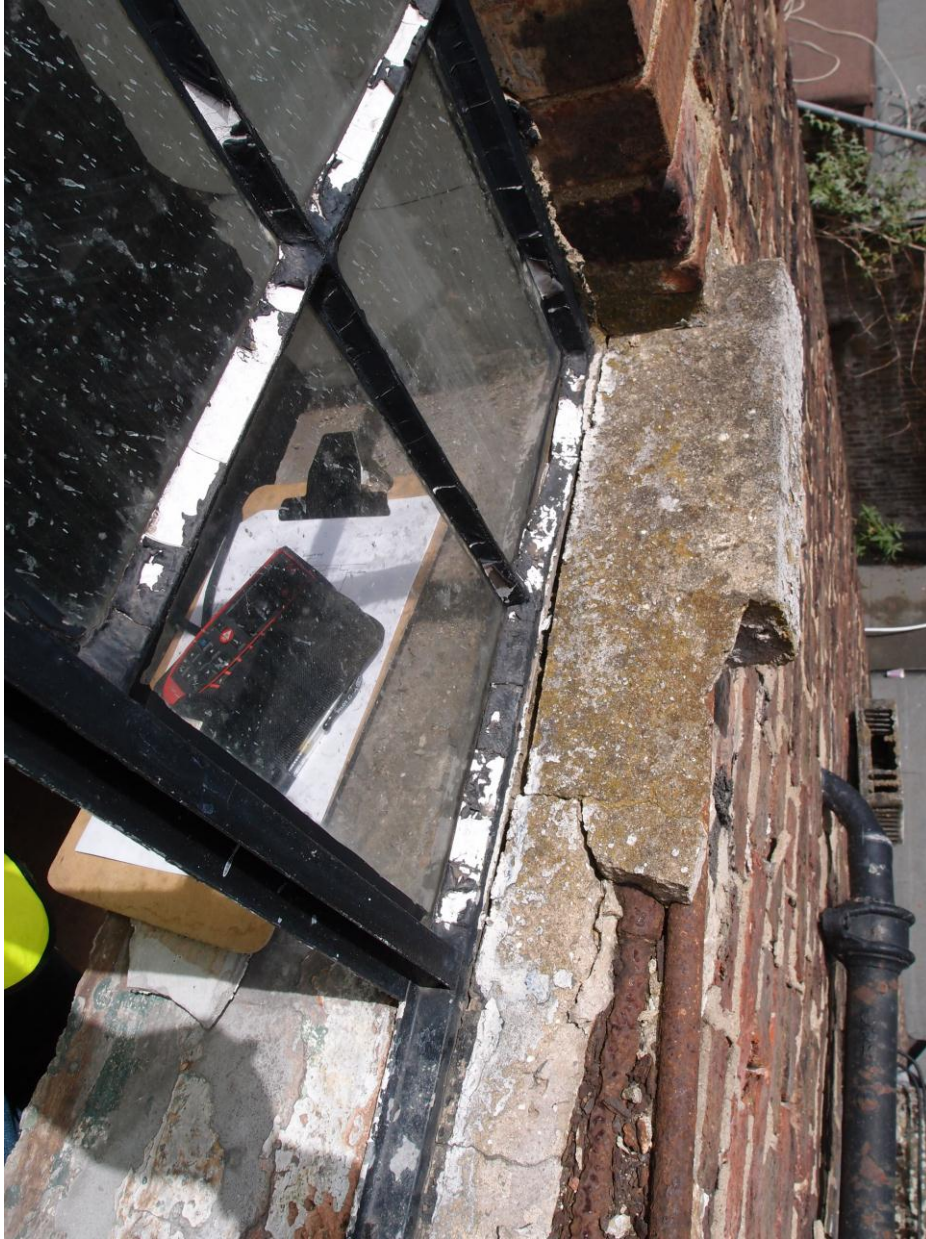
3.7.2 Metal 'Crittall' type windows had no visible signs of recent maintenance or painting, albeit with no visible signs of rot/ decay most of the windows did not appear beyond repair/ restoration. Figure 26

**Figure 25 – Typical metal Crittall window and broken concrete cill**

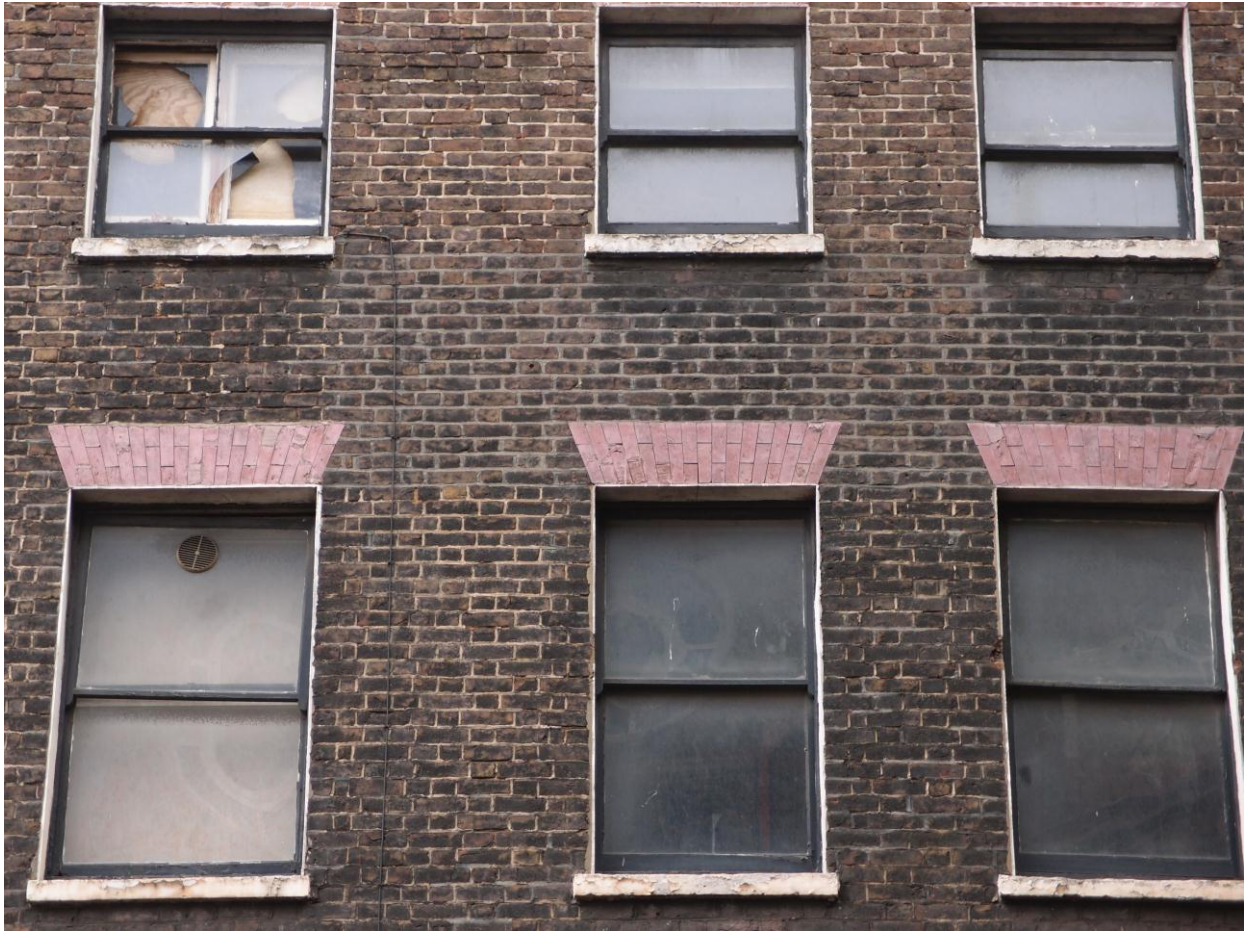
3.7.1 Timber sash windows visual inspection, windows had no visible signs of recent maintenance or painting, albeit with no visible signs of rot/ decay most windows have some misalignment of the opening sash and some windows have become unseated from their original position within the jamb. However most of the windows did not appear beyond repair/ restoration. Figure 25

**Figure 26 – Typical wooden sash window and stone concrete cills**
