TREE SURVEY AND ARBORICULTURAL METHOD STATEMENT 9 Ellerdale Road, London, NW3 6BA

Report in support of an application for the construction of a basement extension
under the existing house and internal refurbishment

Report by Dr Martin Dobson

4 June 2013

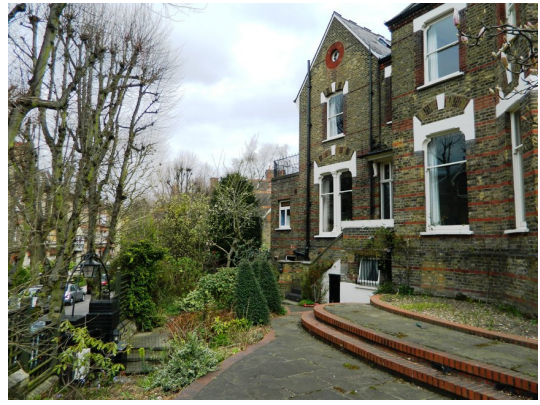
2.5 T1 is a small young Holly which provides boundary screening but otherwise is of no particular importance and is regarded as a low value C grade tree. T2 is a large Myrtle shrub growing in the border and is also regarded as being C grade. Magnolia T3 is a larger ornamental tree which has attractive spring flowers and grows over the pavement of Prince Arthur Road. It is in a prominent position, is easily visible and makes a useful contribution to the street scene. It has therefore regarded as being a moderate value B grade tree.

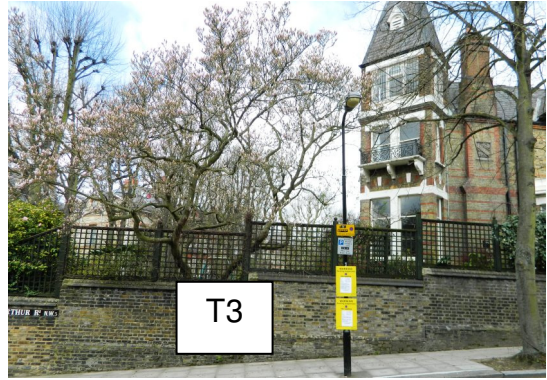
2.6 T4 is a young flowering Prunus which has been pruned poorly in the past and has no special merit. It is considered to be a low value C grade tree. T5 is a multi-stemmed Yew which has been pruned on a regular basis to maintain its size and shape. It provides an attractive evergreen feature within the garden but has no wider landscape importance and has therefore been graded C. A row of six Limes (T6 – T11) and one Acer (T12) are situated in the pavement of Ellerdale Road. They vary in size but have all been pollarded on a regular cycle to control their size (presumably also to reduce their water use and minimise subsidence risk). All of them are regarded as moderate value B grade trees other than T9 which is a much younger and smaller tree and has been graded C. The Lime in the pavement in Prince Arthur Road (T13) has not been pollarded so far and is regarded as a B grade tree.

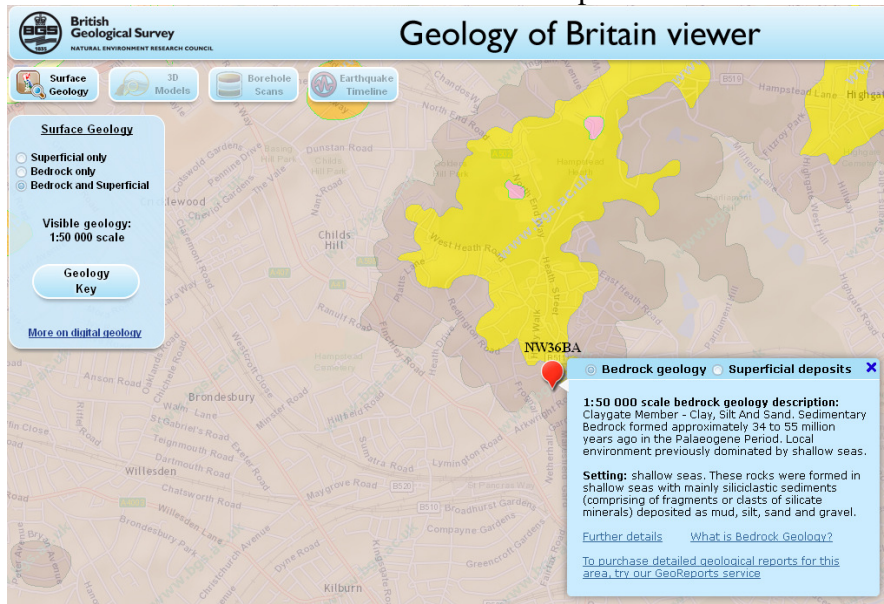
2.7 The British Standard advises at 4.3.1 that soil type should be considered when designing foundations. It appears from the British Geological Survey map (Figure 1) that the site is underlain by potentially shrinkable clays of the Claygate Member and so foundation design will need to be influenced by the proximity of trees. The National House Building Council Chapter 4.2 *Building Near Trees* provides guidance.

Figure 1. Extract from British Geological Survey 1: 50,000 scale geological map indicating that the site is underlain by the Claygate Member (made up of clay, silt and sand). Foundation design will therefore need to take account of the presence of trees.

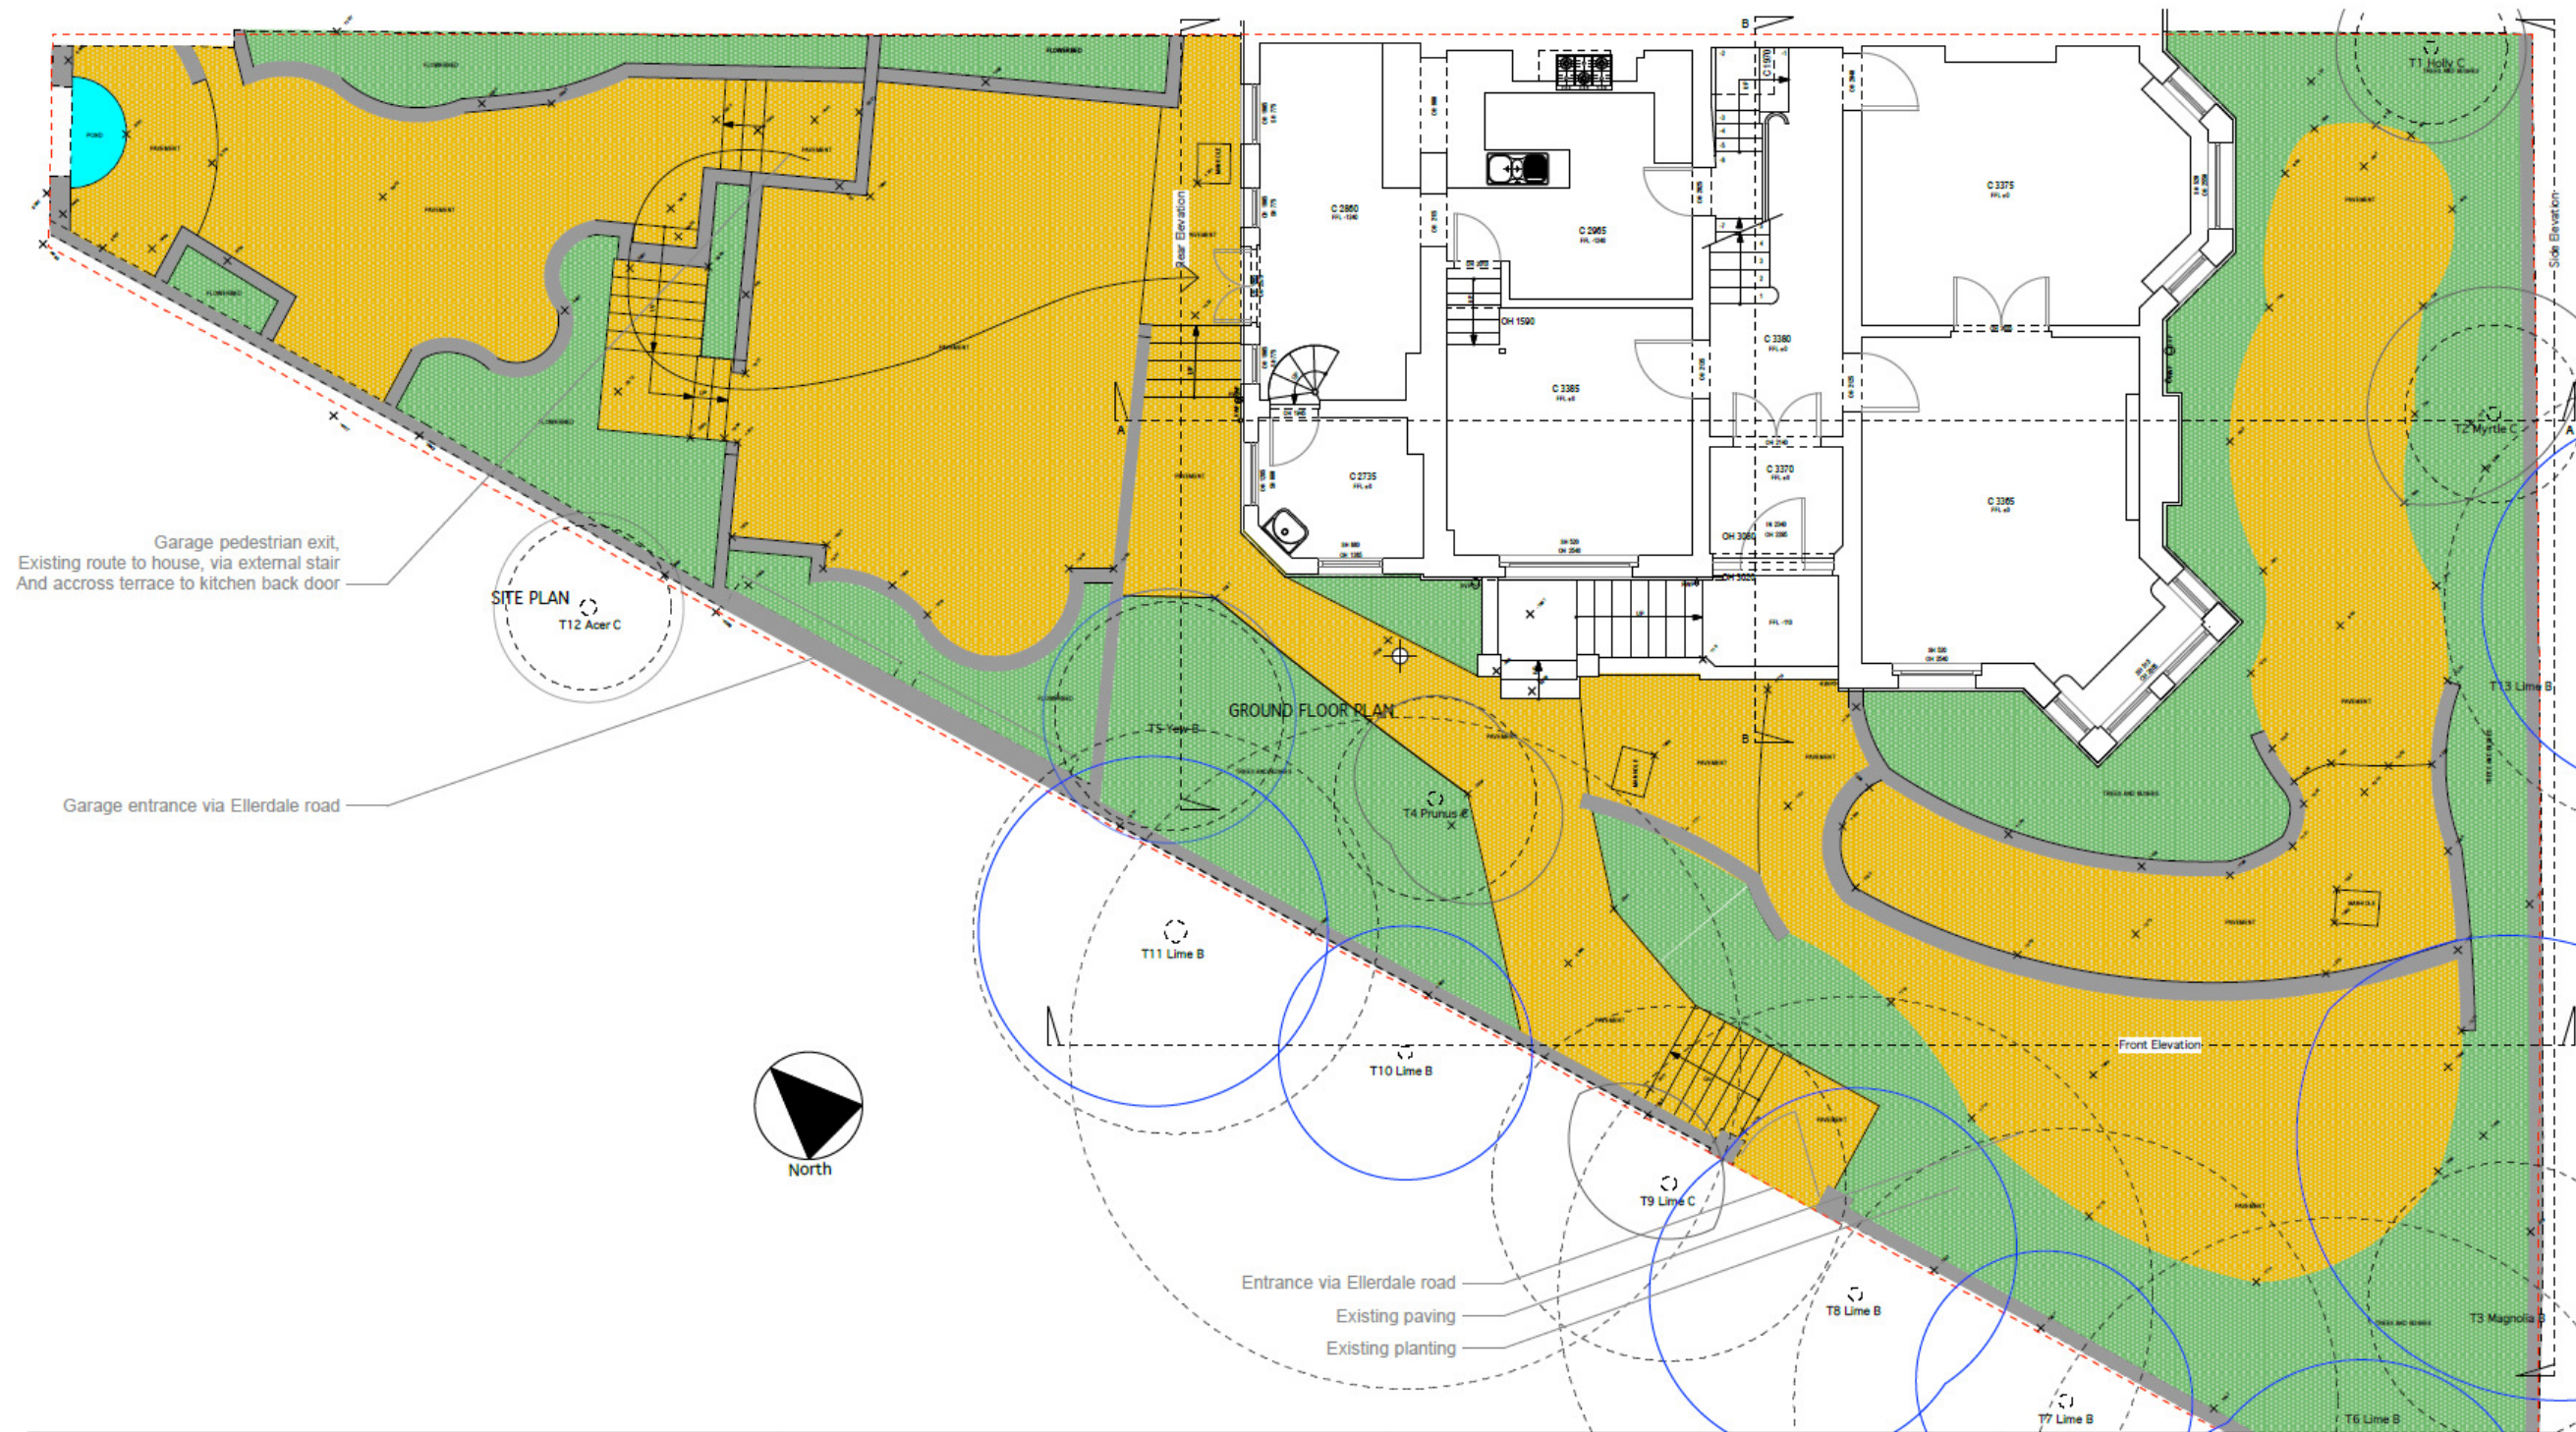
APPENDIX MD2

Existing site survey drawing (ground floor) showing tree numbers, BS5837 colour codes (A – Green, B – Blue, C – Grey, U - Red) and root protection areas (dashed circles)

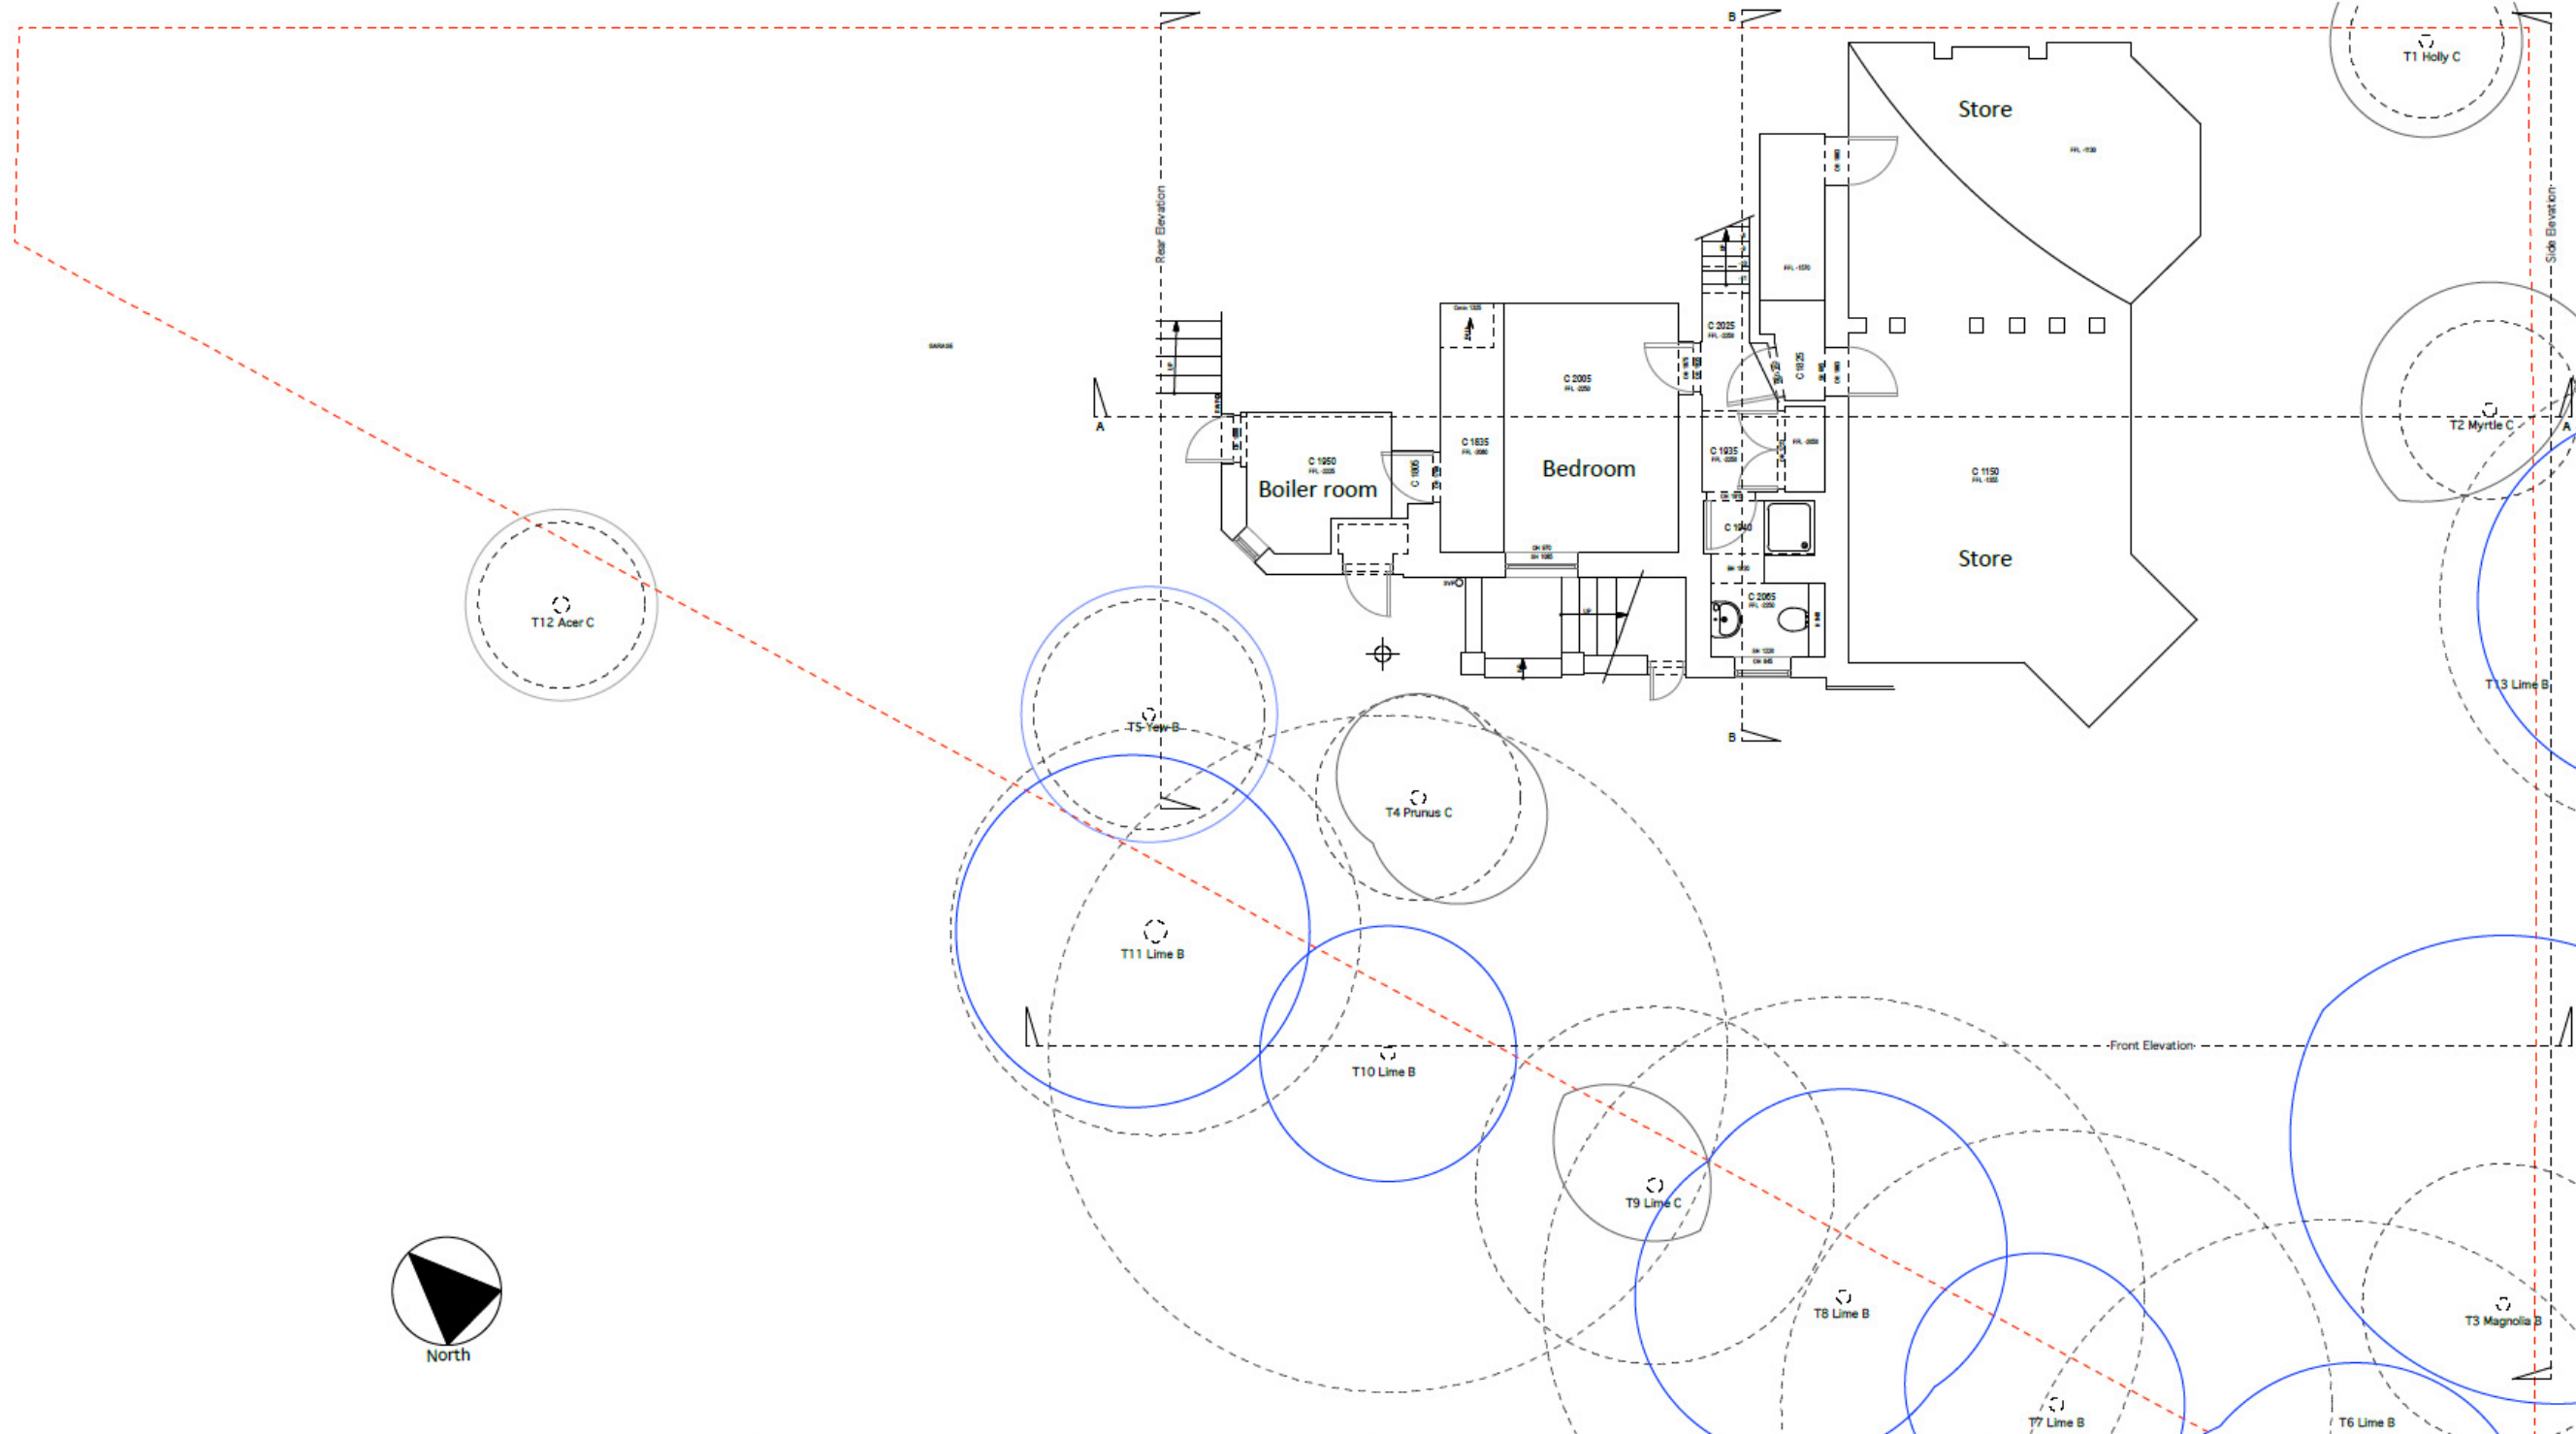
APPENDIX MD3

Site survey drawing (basement) showing tree numbers, BS5837 colour codes (A – Green, B – Blue, C – Grey, U - Red) and root protection areas (dashed circles)

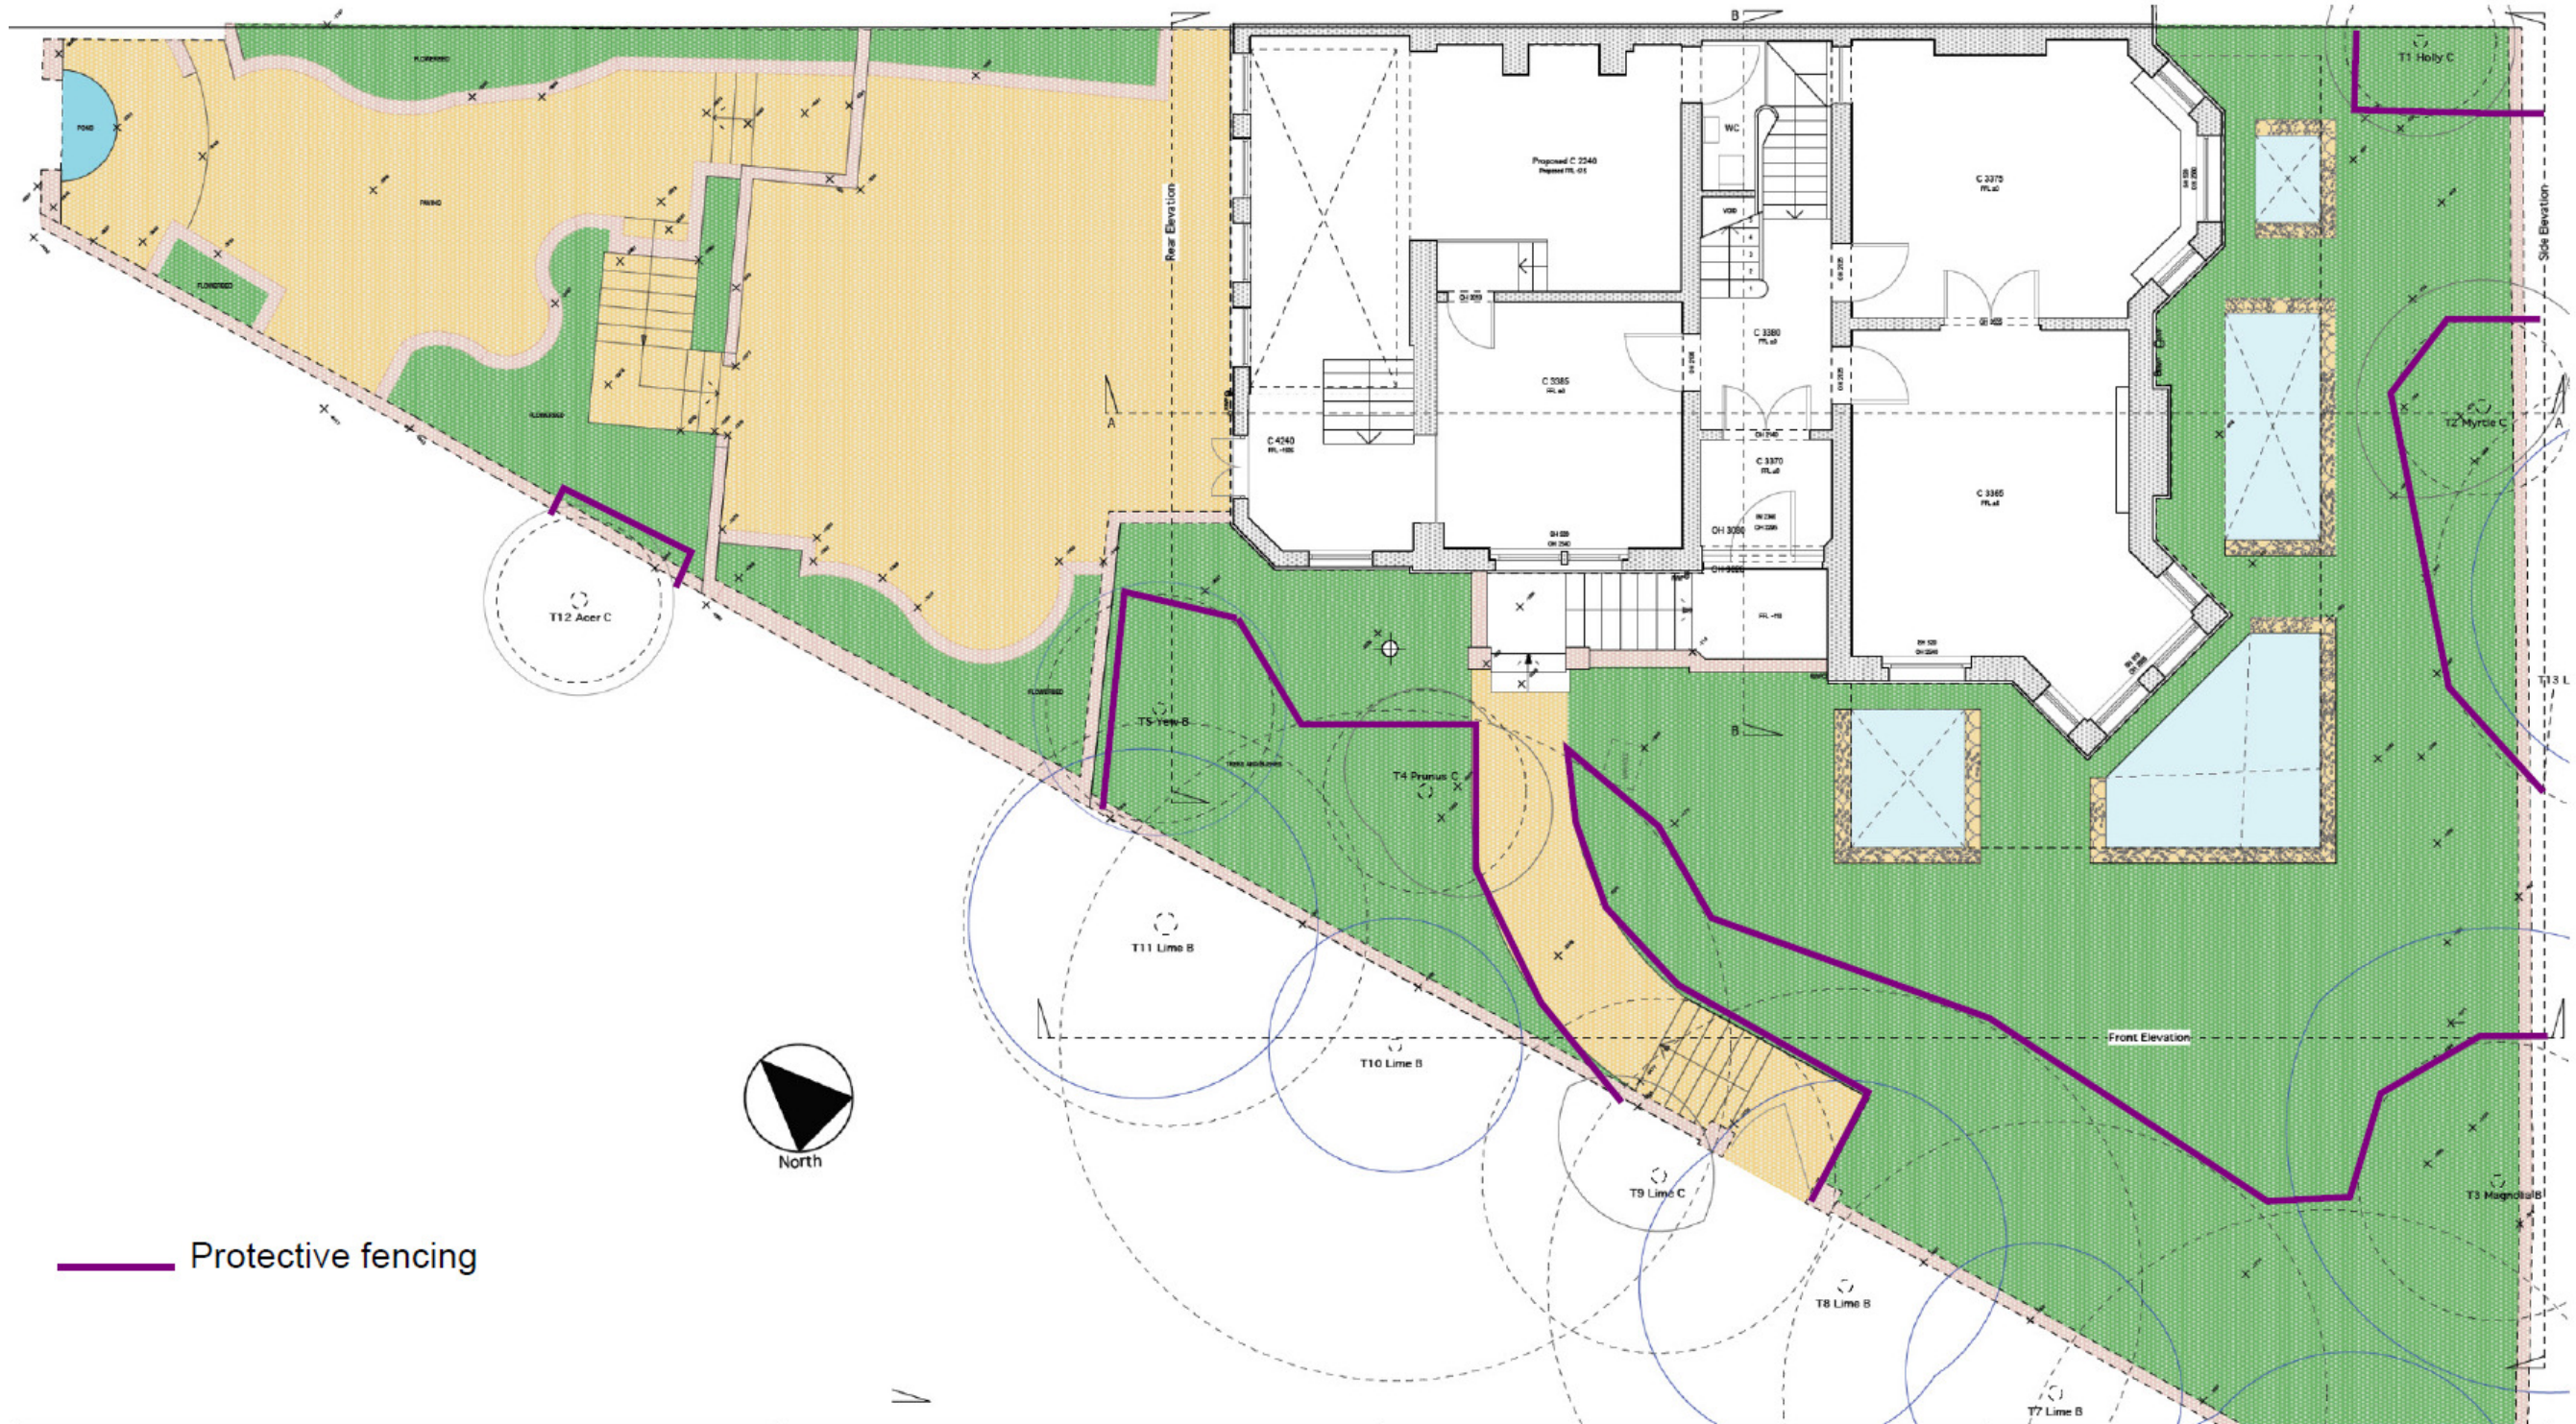
APPENDIX MD5

Proposed tree protection plan (ground floor) showing extent of root protection areas (dashed circles) and positions of protective fencing (purple lines)

- 3.5 The positions of protective fencing are marked as purple lines at **MD5** (ground floor) and **MD6** (basement) and will be erected before any ground works are undertaken or any materials are delivered to site. Fencing will remain in place throughout the construction phase and will only be taken down to allow final landscaping.

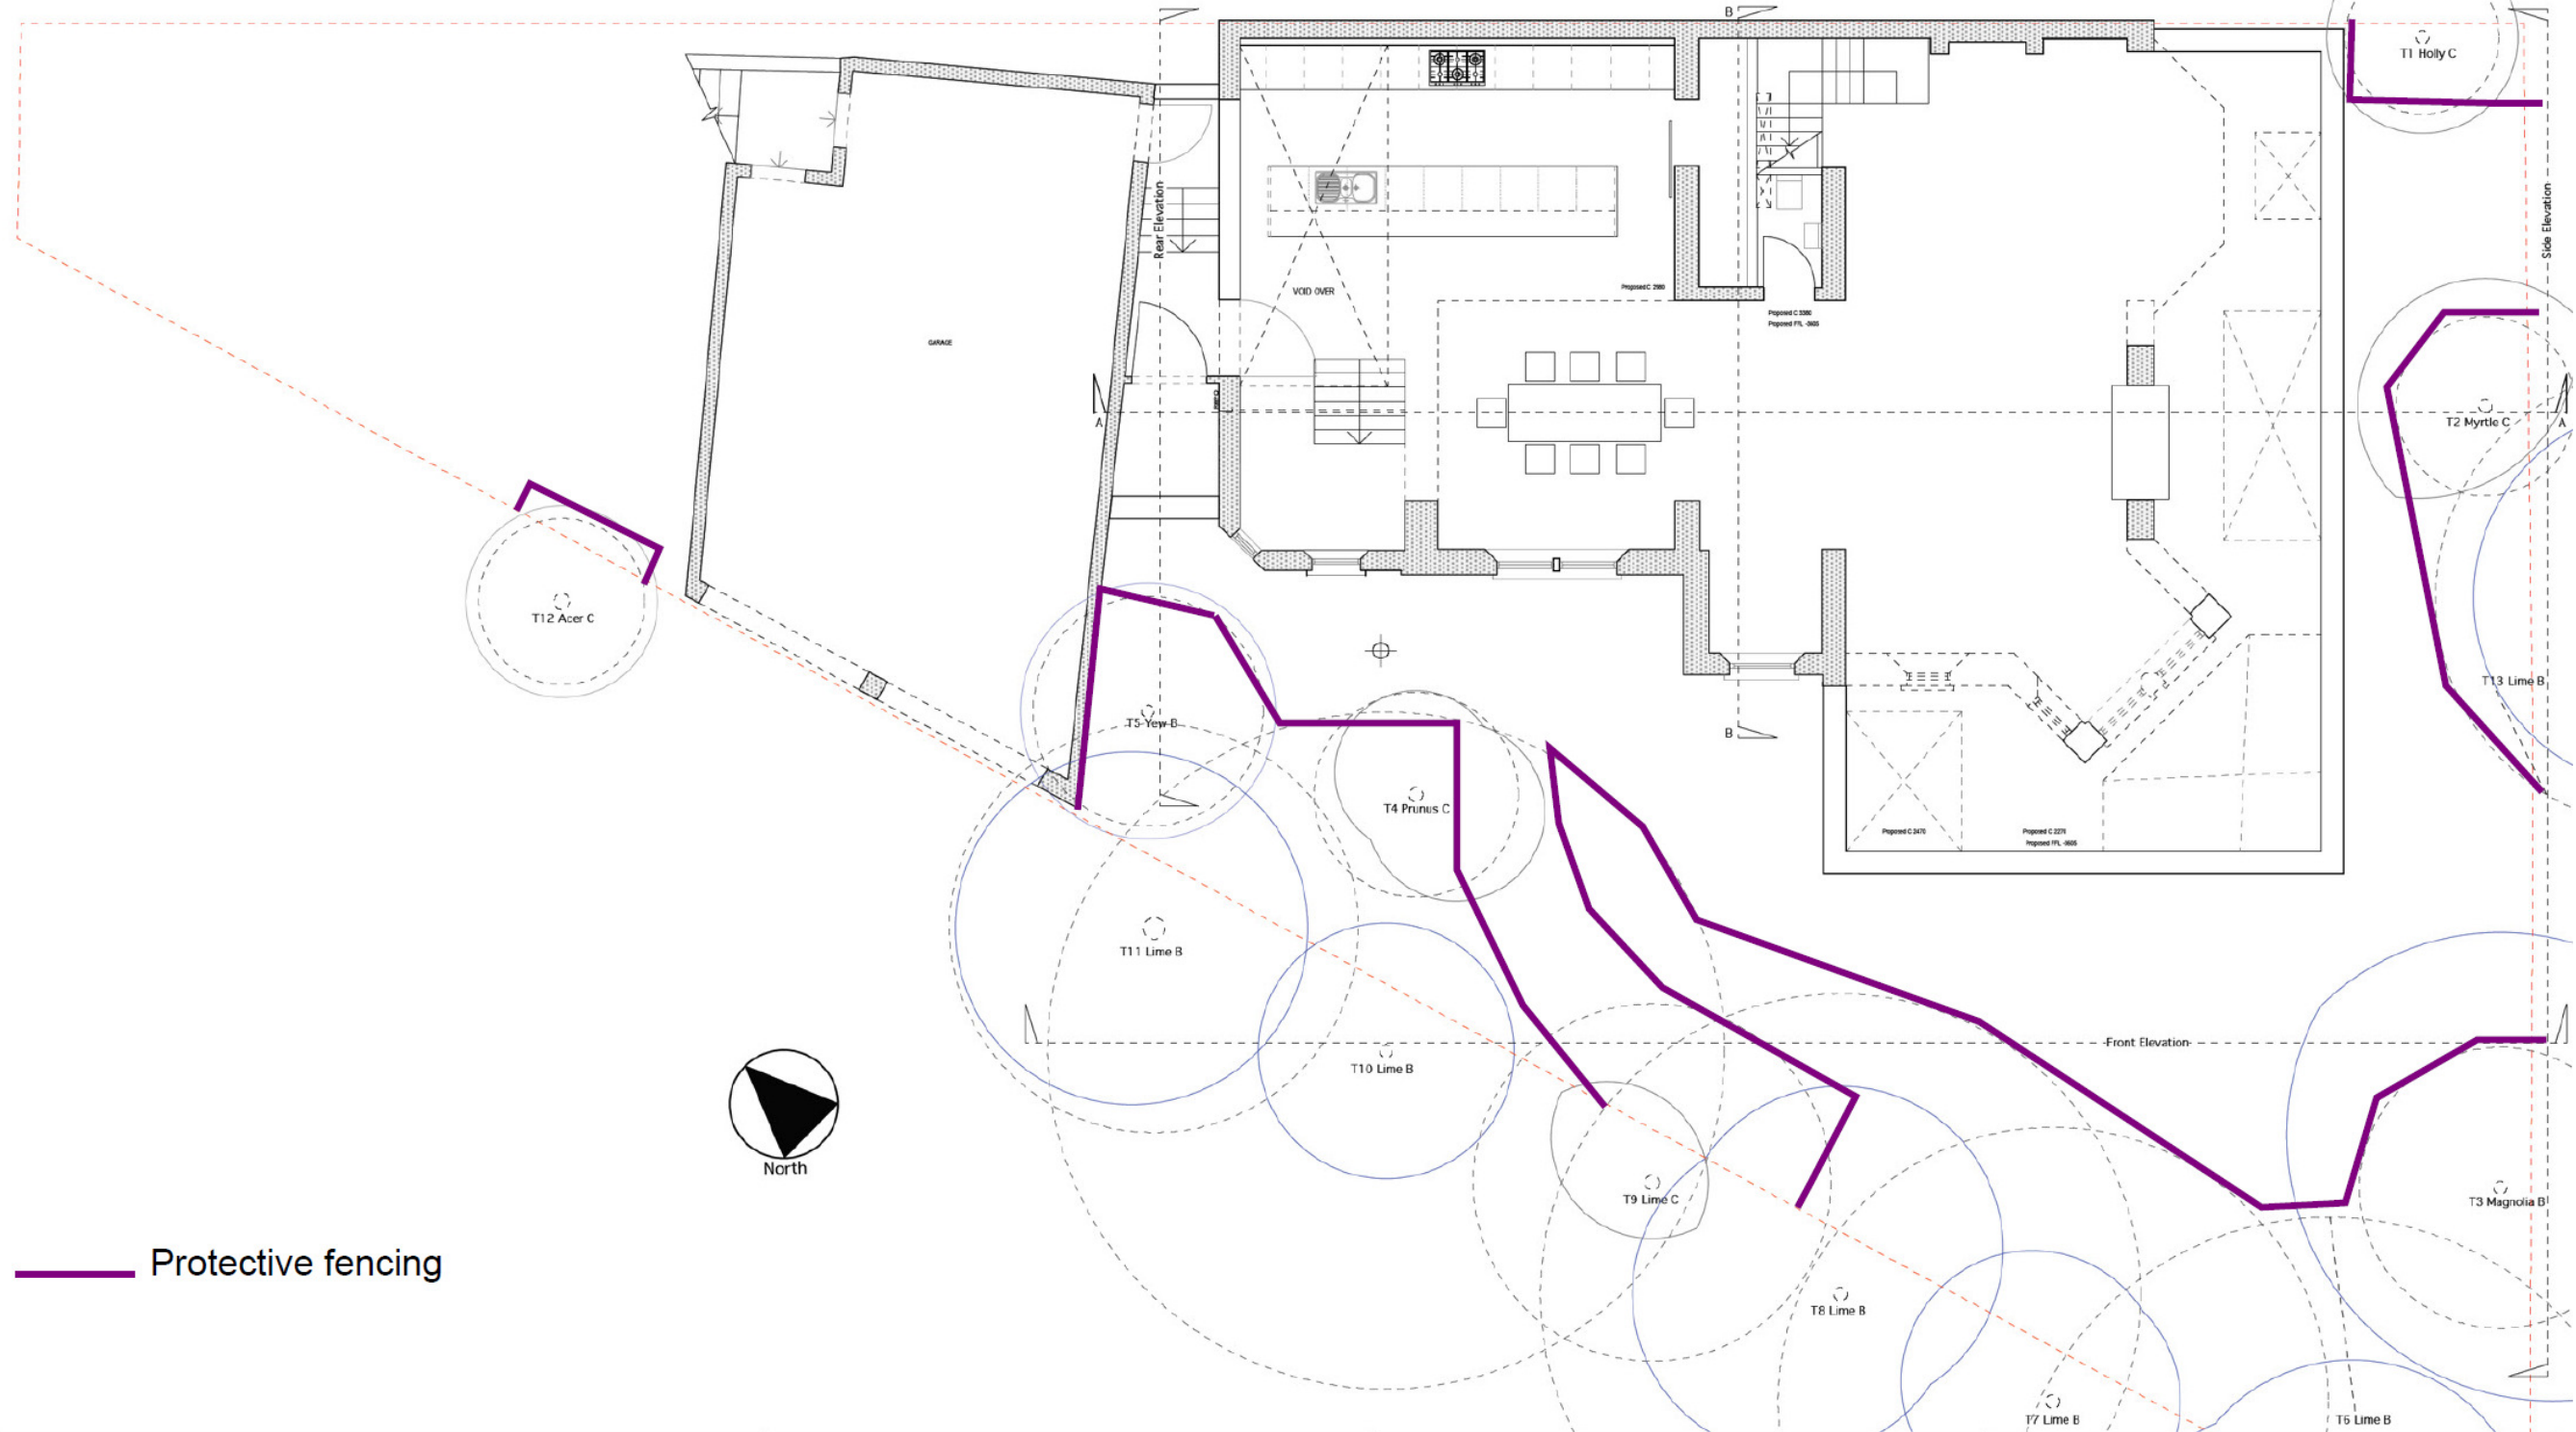
APPENDIX MD6

Proposed tree protection plan (basement floor) showing extent of root protection areas (dashed circles) and positions of protective fencing (purple lines)
