SOAS into Senate House

Information in support of LBC Condition 8

Document Number: 28731-SOAS-A-REP-XXX-XX-006

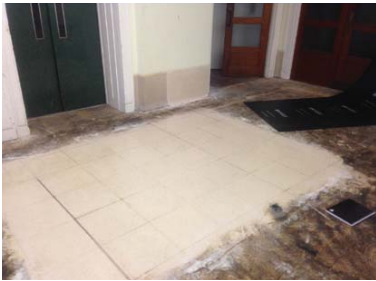
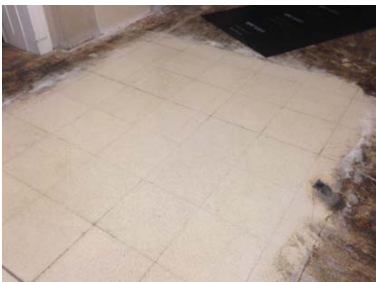
October 2013 - after trial cleaning

An area of the third floor was cleaned, reground and sealed in October 2013 by Marble Master Ltd. The above photographs are of the floor and adjacent skirting once cleaned (left hand column) and additionally as of August 2014, post enabling works and asbestos removal.

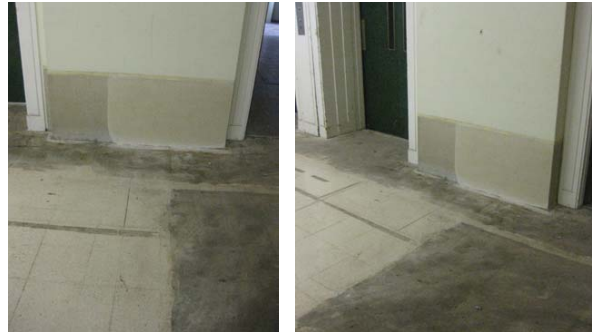
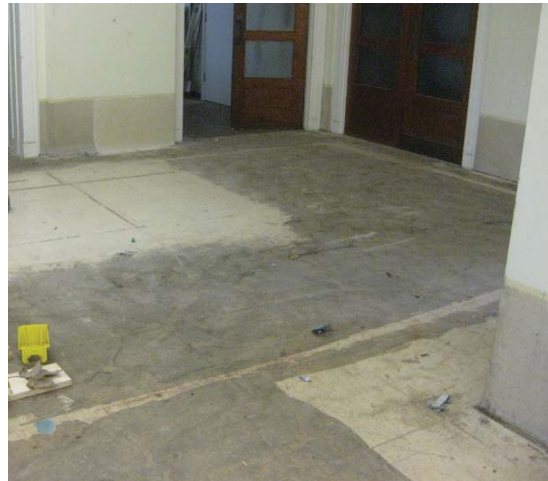
August 2014

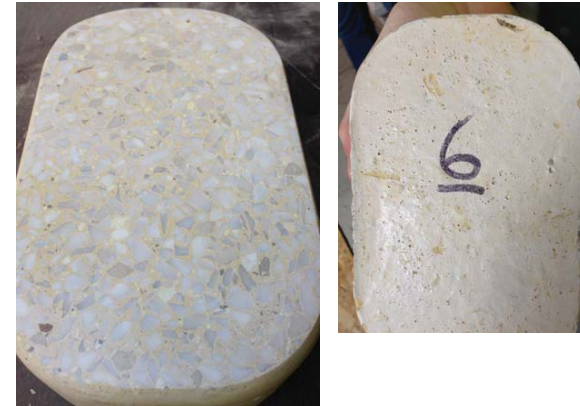
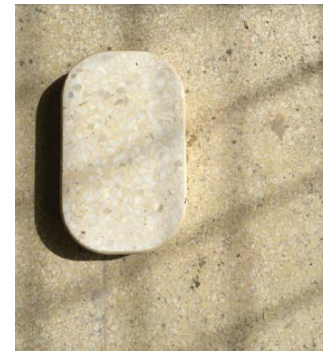
Sample 6
against terrazzo on first floor

It is likely that the existing terrazzo at each level has some variation in mix/colouration. A representative sample of the new terrazzo mix has been prepared, following a visual site inspection by a supplier. This sample (6) is available for review on site.

A sample has yet to be removed from site and analysed for composition. Once it has been agreed that terrazzo can be replaced to the first floor lift lobby area a section will be sent for analysis to finalise the composition and mix of the replacement terrazzo.

Visits to site by potential specialist sub-contractors to review the terrazzo has indicated that there will be a need to incorporate joints within the new areas, the scope of these will need to be reviewed once the specialist sub-contractor is appointed. It is anticipated that joint locations will be needed to mirror any such within the existing or new sub-base to accommodate movement. Crack inducing joints may also be required to bay areas over a specified size.

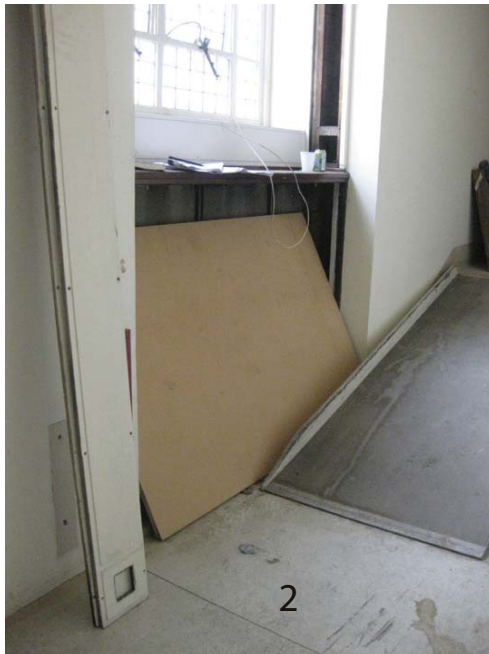
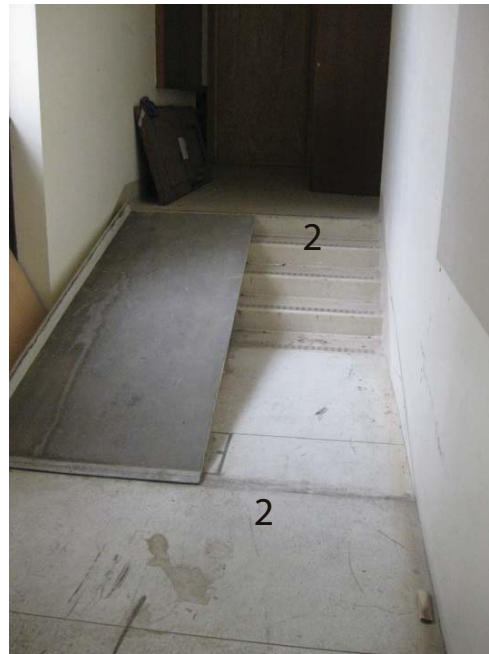
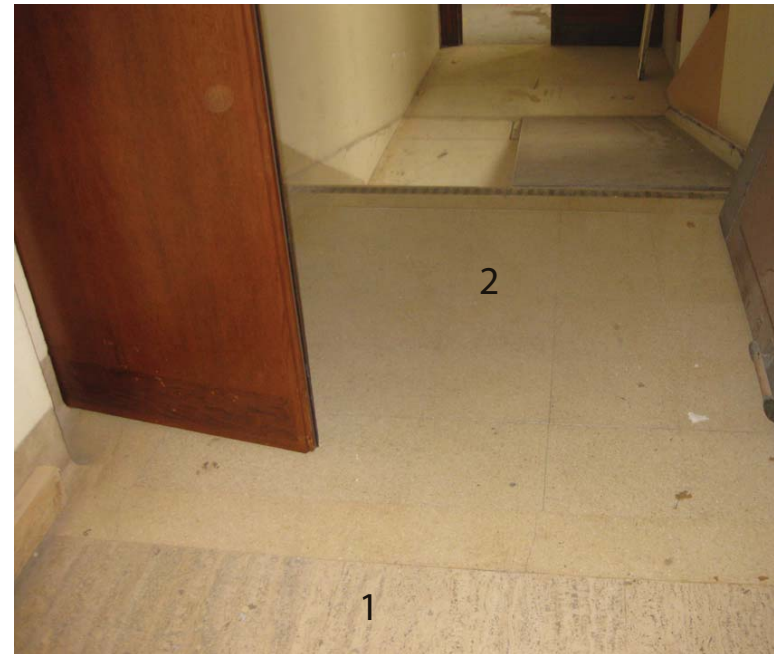
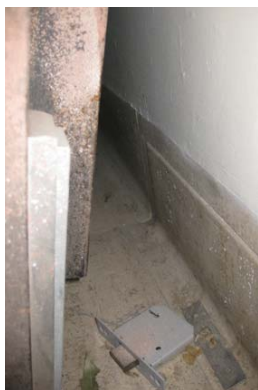
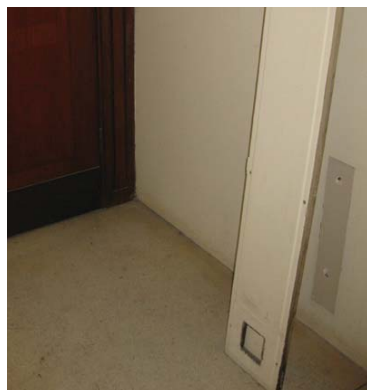
Ground Lobby G05 existing

- 1 existing travertine, unaffected
- 2 existing terrazzo replaced as noted on following page

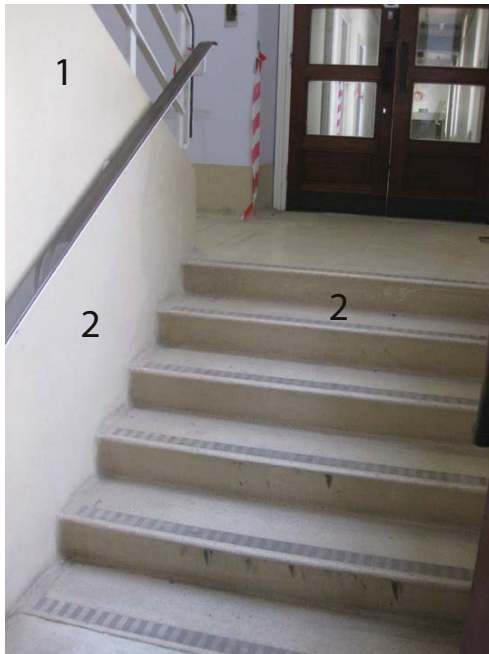
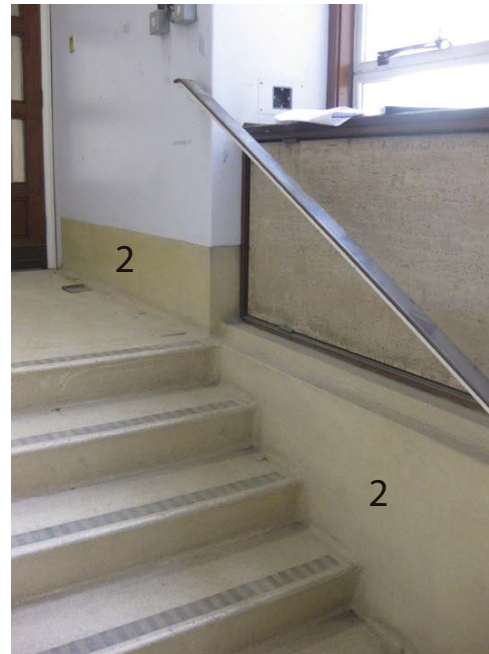
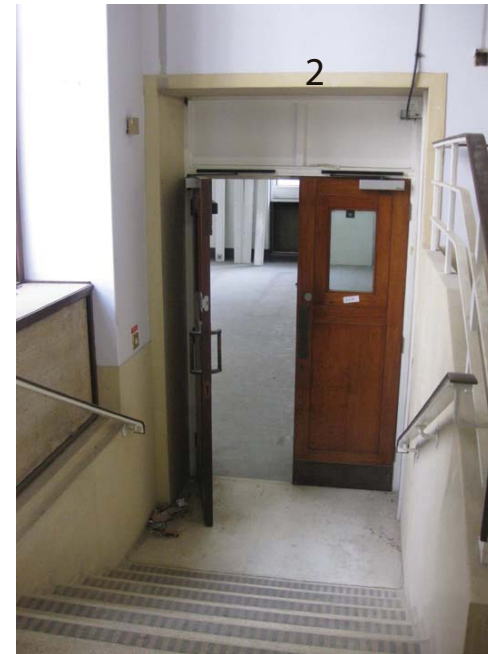
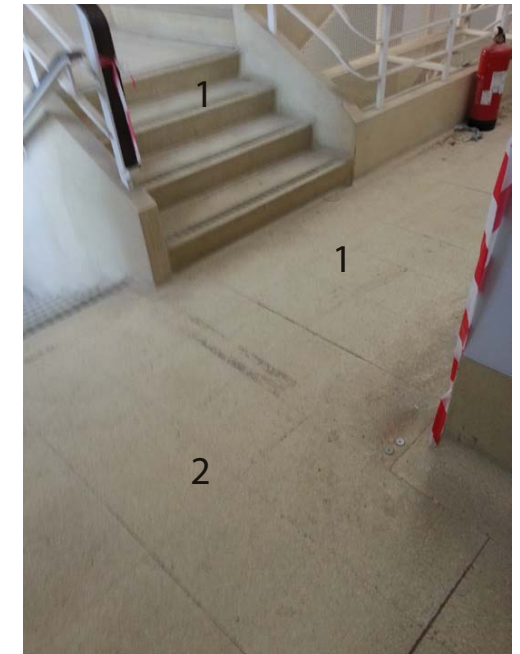
Ground Lobby G21 existing

- 1 existing terrazzo unaffected
- 2 existing terrazzo replaced as noted on following page

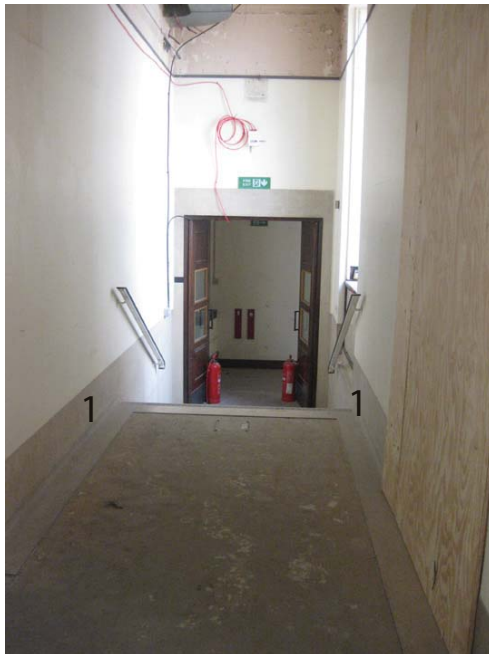
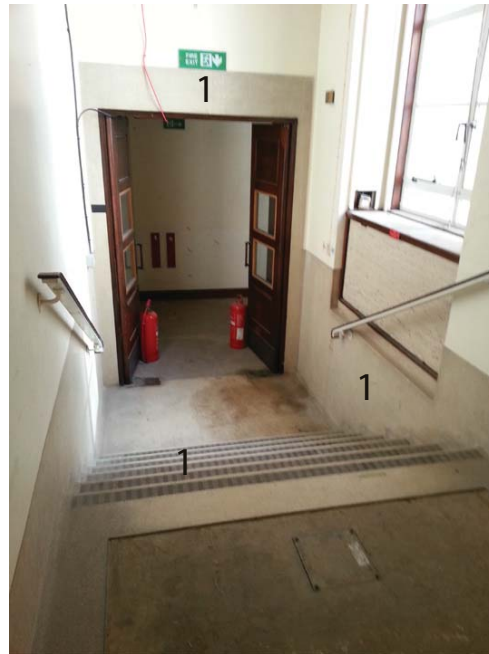
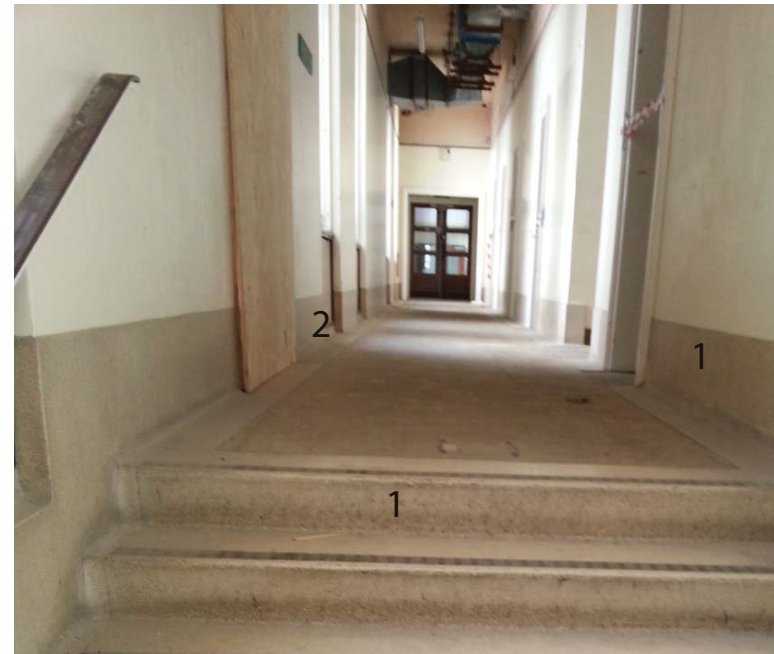
Ground Corridor G12 existing

- 1 existing terrazzo unaffected
- 2 existing terrazzo replaced as noted on following page

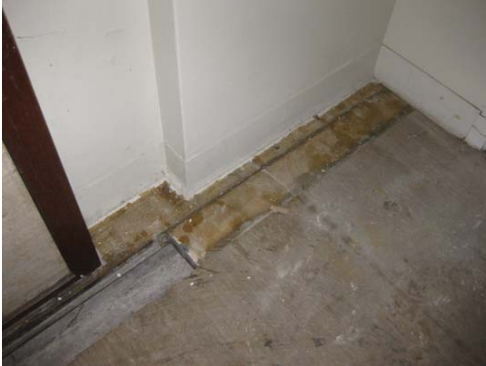
existing terrazzo with vinyl sheet and sheet adhesive. All to be replaced
