Donald Insall Associates

Senate House - North Block
DIA-SOAS-A-REP-XXX-XX-003

Report on Historical Floor Finishes
Revision D
11 September 2014

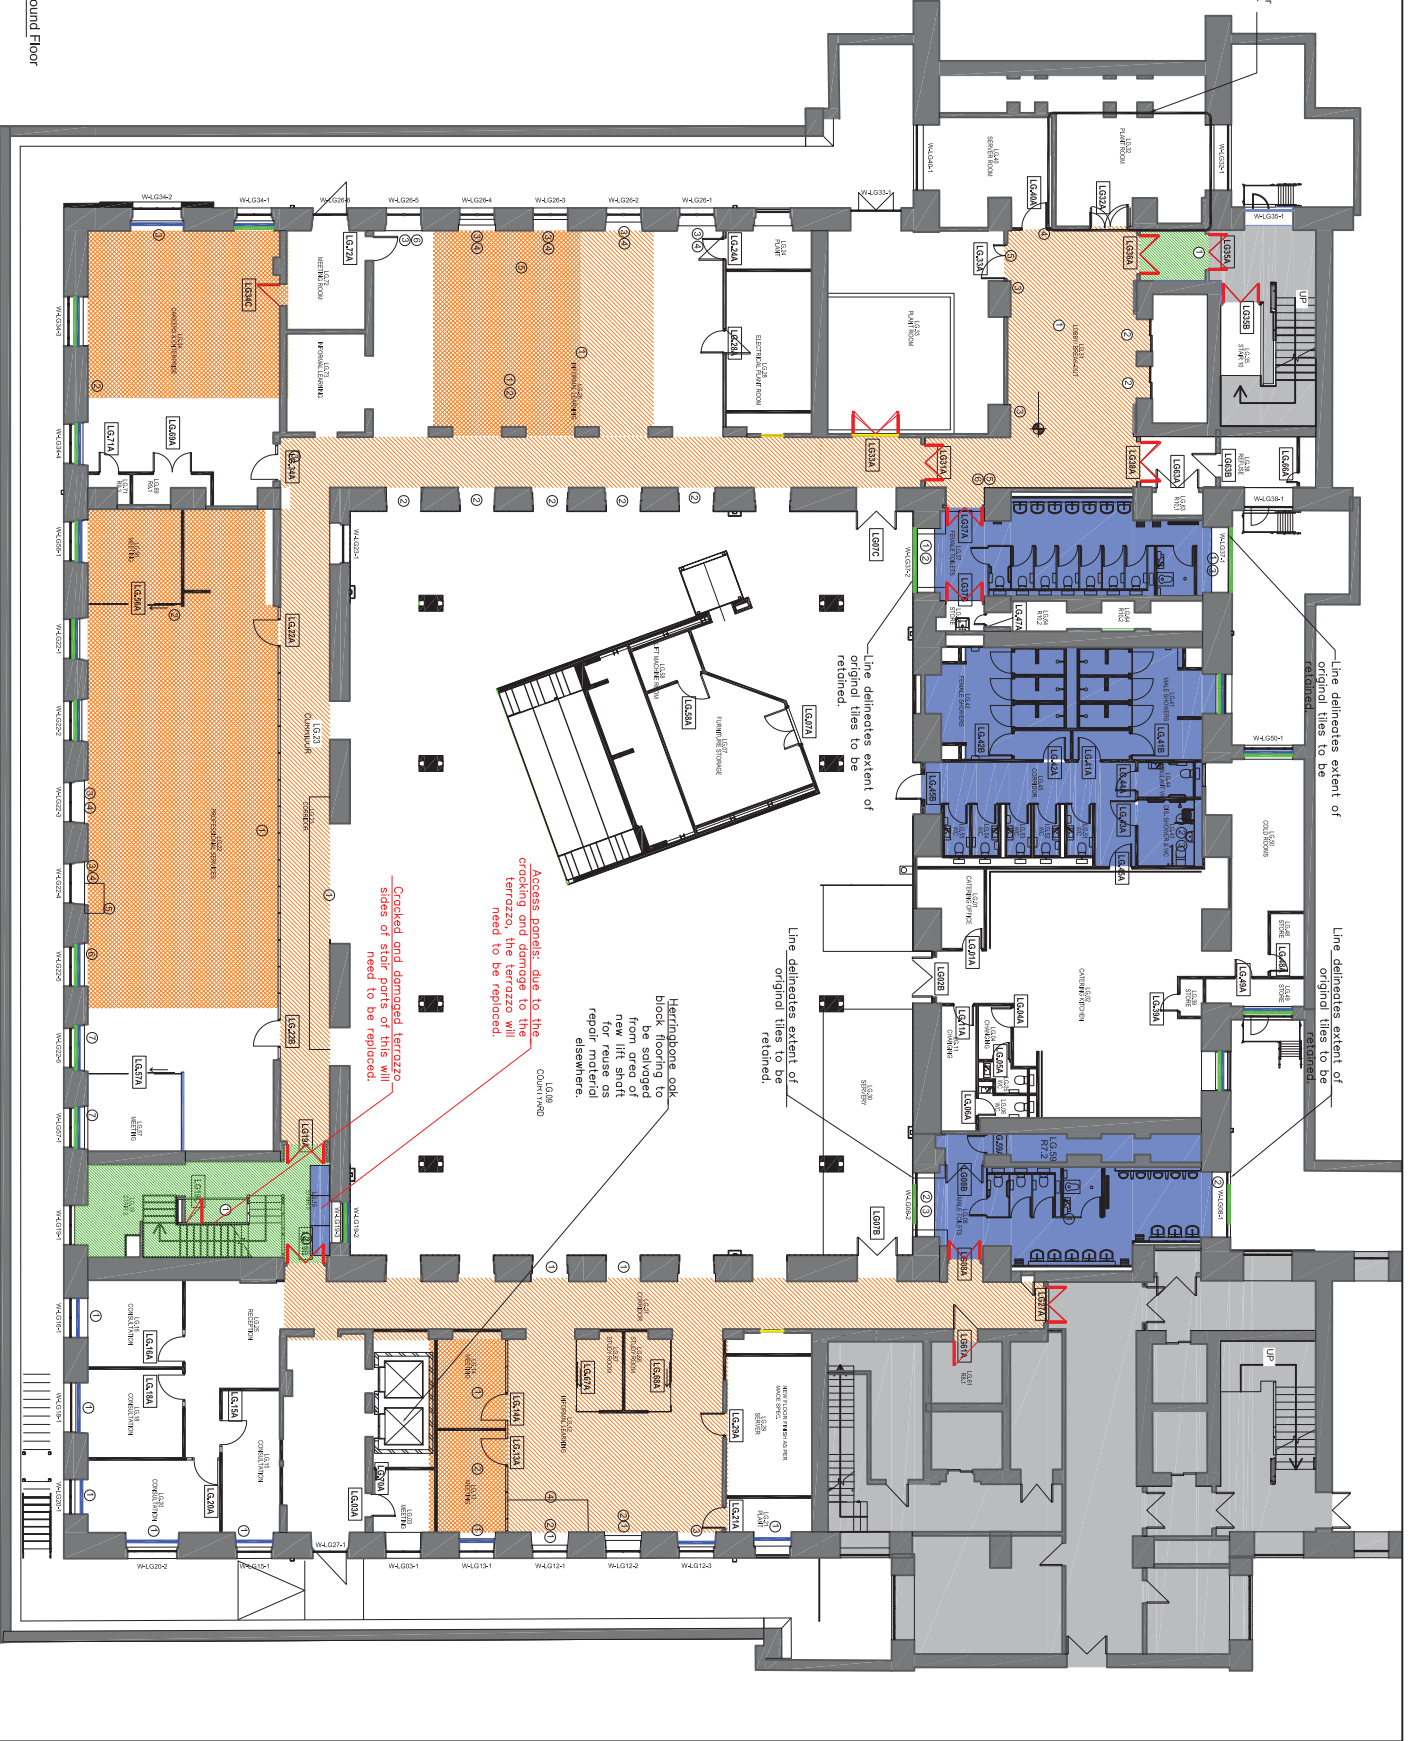
1 Lower Ground Floor
2000/1:100

Herrington oak timber floor to be salvaged in this area for reuse on lower ground floor.
