# HERITAGE DESIGN AND ACCESS STATEMENT

**Project:** Readymoney Fountain  
**Client:** The Royal Parks  
**Title:** Heritage Design and Access Statement  
**Date:** 10 November 2014

**Ref/File No:** HK 2139/3.1

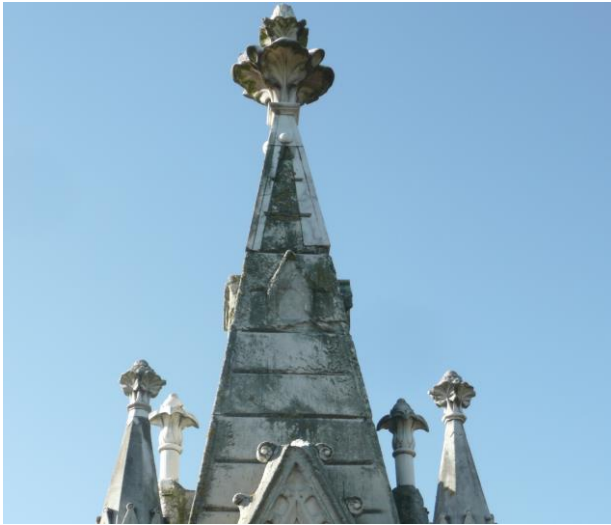
The marble spire and corner pinnacles have had indented marble repairs and some elements;- pinnacles and cusps, have been replaced with new carved pieces. However some parts of the marble in the spire and frieze and other high level stonework look to be open textured and friable. Some spalling is occurring notably on the south facing elevation. Algal growths are widespread on the weathered marble. The small cracks in the marble may be water traps. The finial to the west face pediment is missing.

**Marble spire requiring cleaning and repair.**

The proposed works comprise localised cleaning, minor stone repairs with new matching stone indents to replace the missing pieces, pinning of cracks in balusters and other stones and repointing. The lighting standards will be serviced, repaired and redecorated.

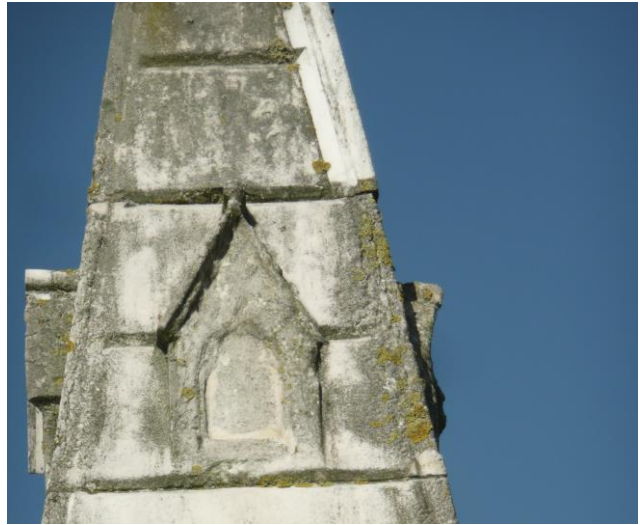
**Worn stone and eroded details.**

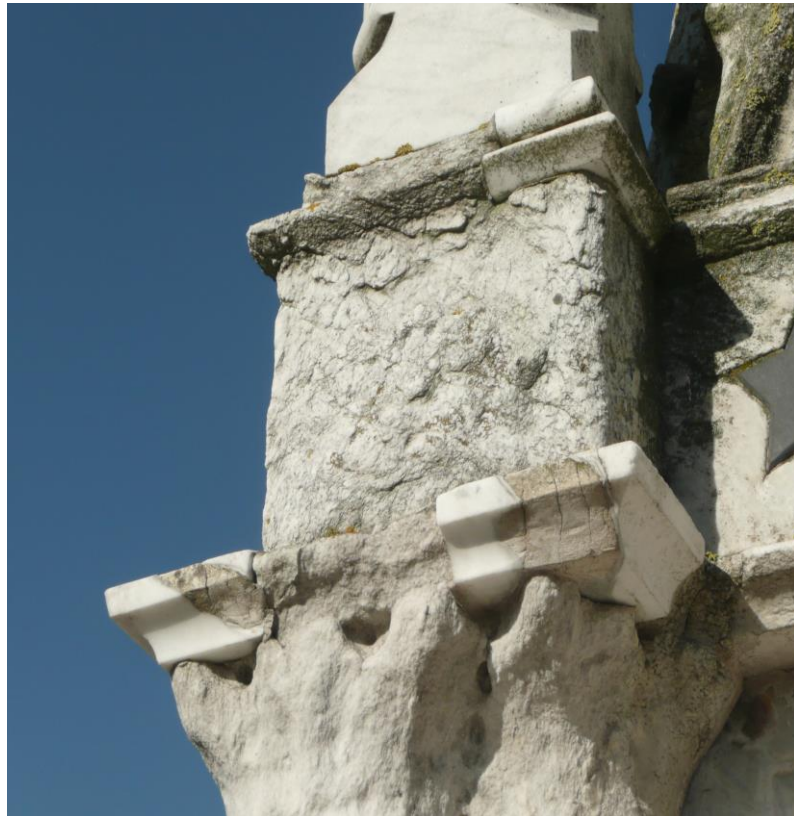
**Eroded stones on southwest corner.**

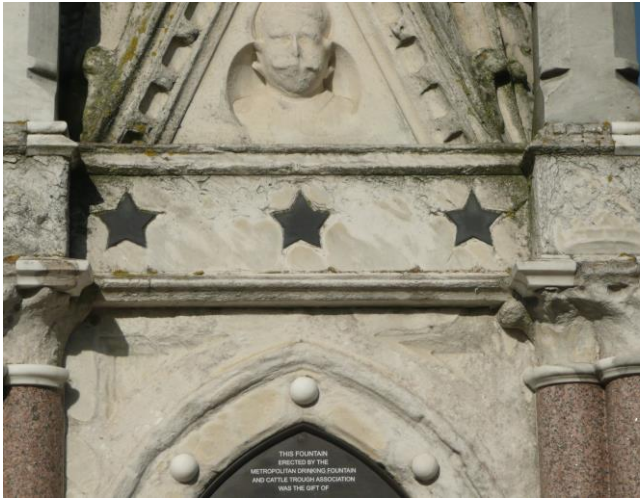
**Decaying marbles on the south elevation.**

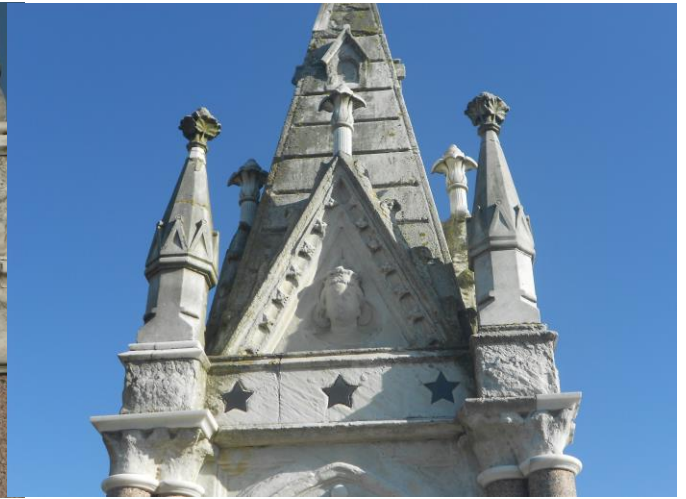
**Decayed marbles on frieze of west elevation.**

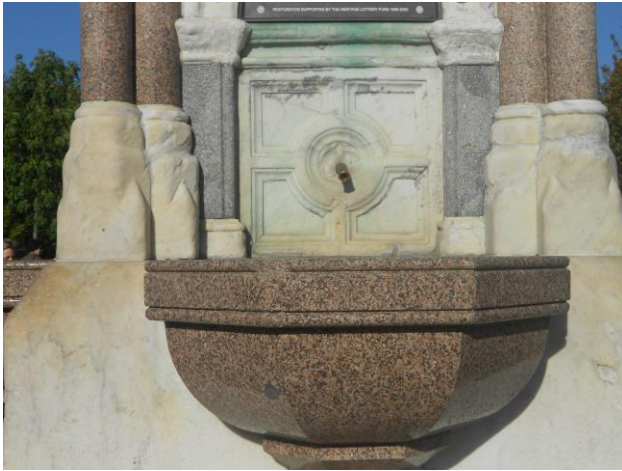
**South Elevation bowl.**

The granite bowls are generally in good condition. All have a build-up of lime scale on the bowl interior. There are open joints at previous repairs and some missing indent repairs. The bronze water spouts were installed in 2000 they do not match the original design. All spouts have automatic sensors that do not function well as the sensor light beam is blinded by the curve of the spout and the spout is handled induce water flow. The spouts are too high/far for most children and many smaller adults and they are used as a grab handles.

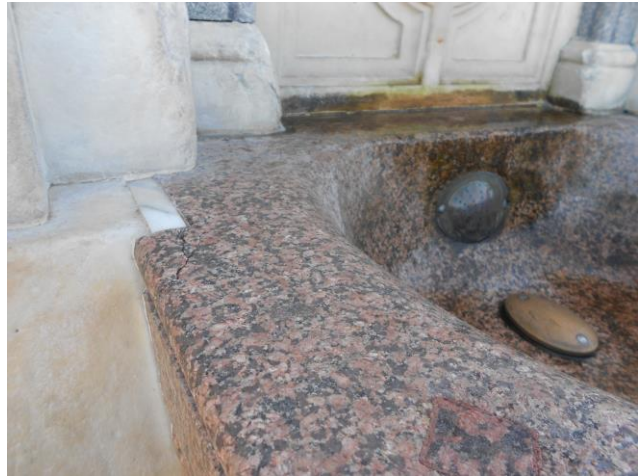
**Water damage to marble and granite.**

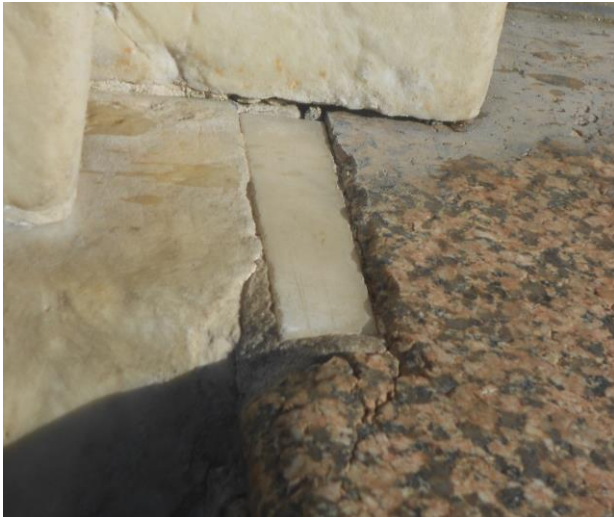
**Failing pointing on previous repairs.**

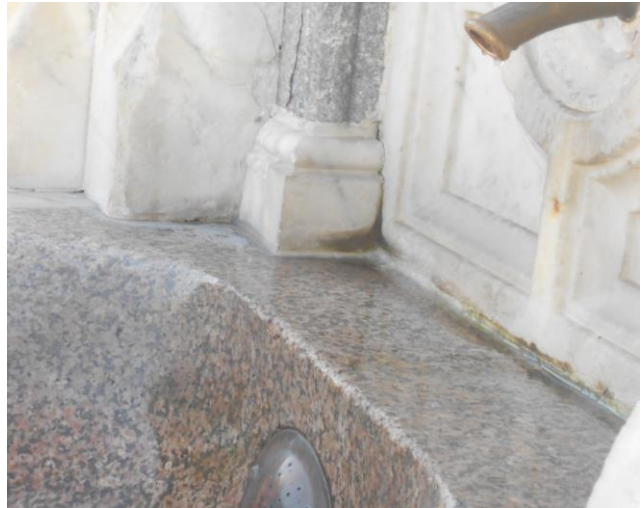
In addition waste water is bleeding through the lower joints in the masonry beneath the bowls. There appears to be a direct link between the level of fountain usage and leakage. The basins backfall into the masonry and excess water accumulates on the basin shelf penetrating the masonry joints in the core construction at the start and end of each discharge and leaks are occurring at the waste outlets.

**Water from spout on basin shelf.**

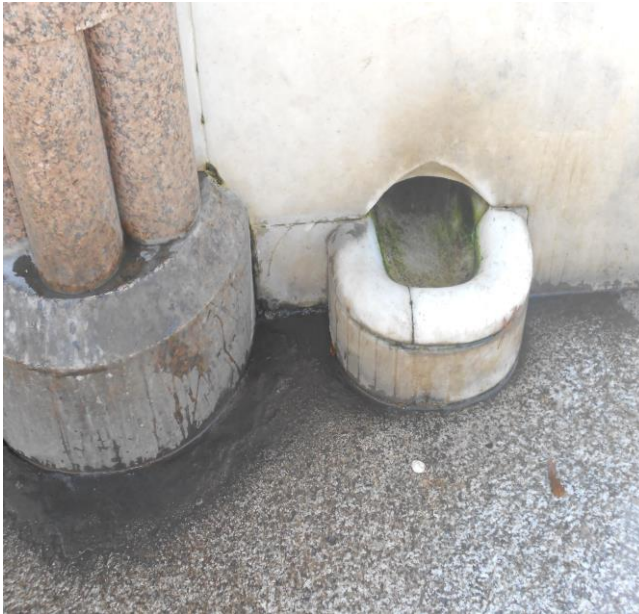
**Leaks though masonry joints on north side.**

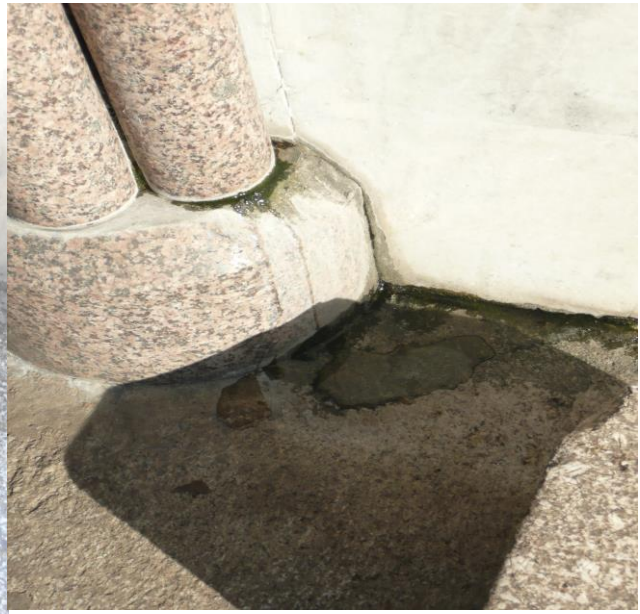
**Active leaks though masonry on west side.**

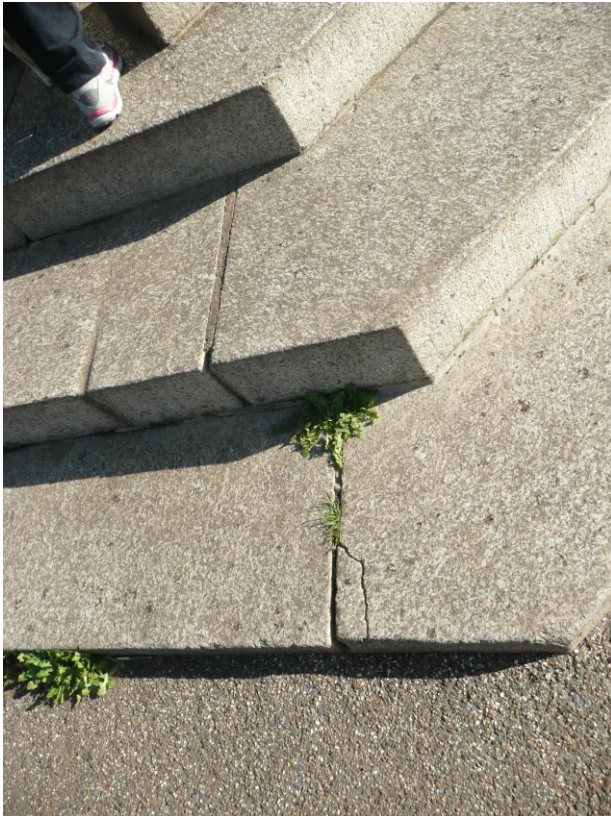
**Open joints and crack on steps**

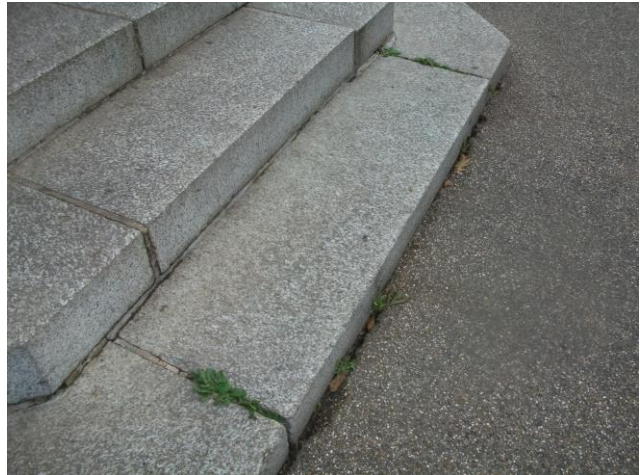
**Weed growths on failing masonry joints**
