Tree Report

- on the condition of a
Beech tree

West Hill Court
Millfield Lane
Highgate
London N6 6JJ

Survey Date: 10th September 2014
Report Date: 6th October 2014
Project no: 675

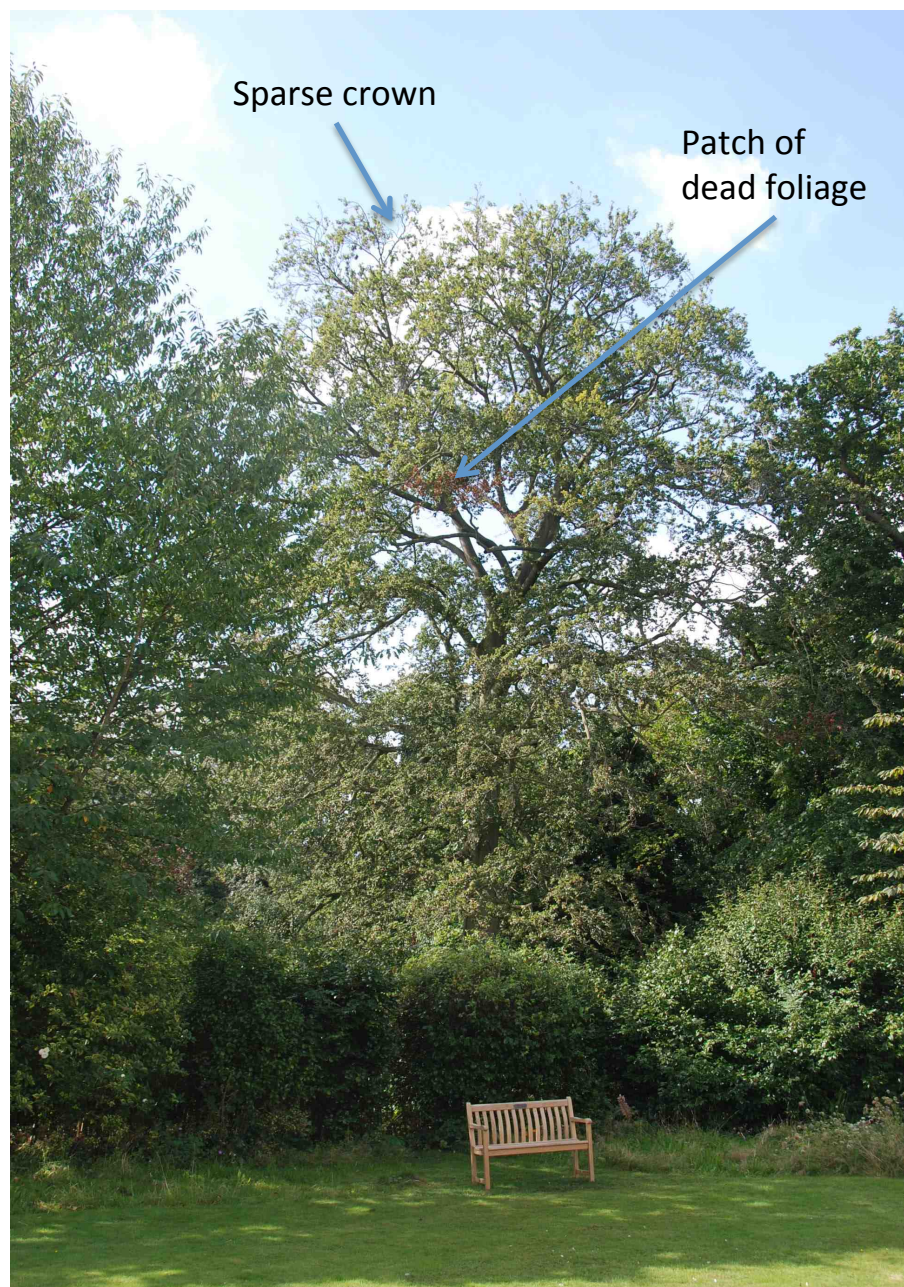
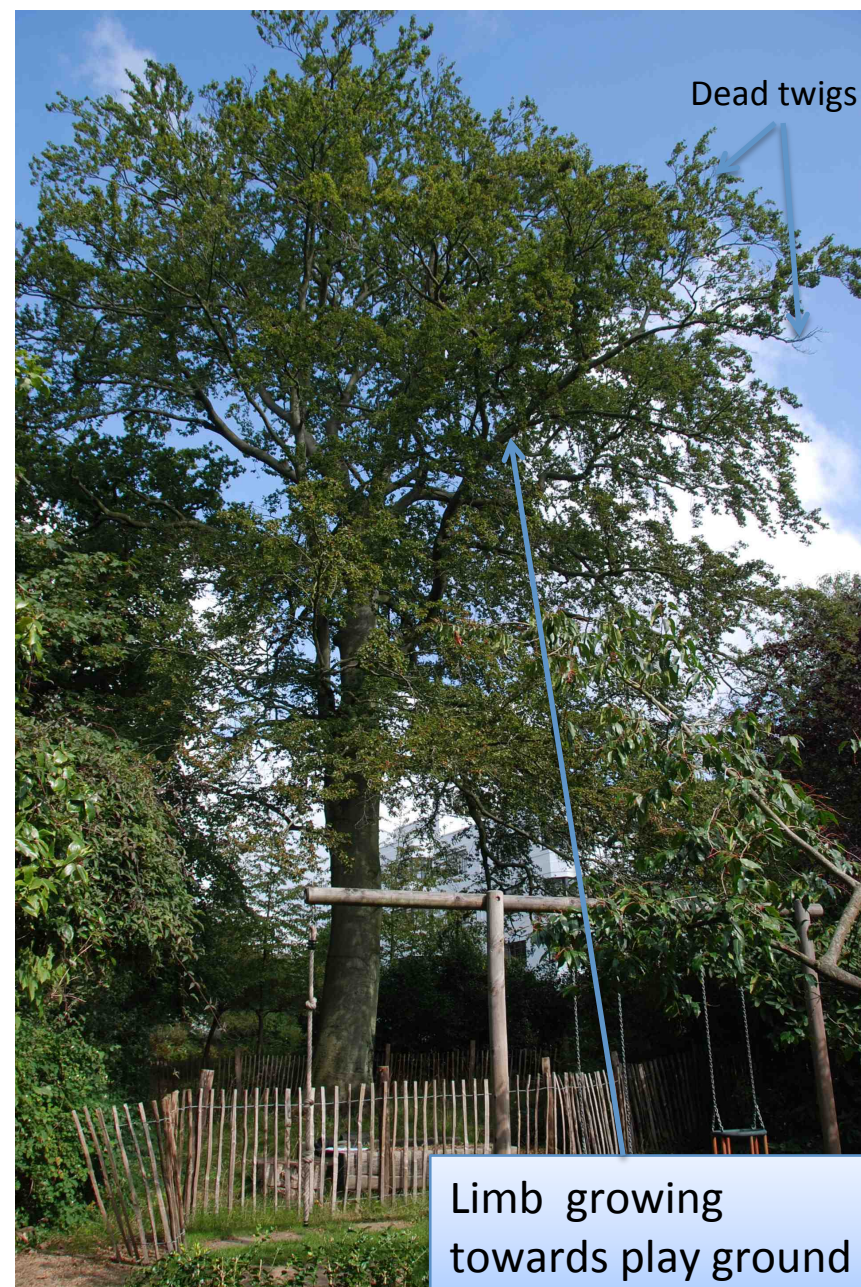
- 4.7** The area immediately under the canopy has been fenced off and future management of the area can dissuade people from entering. There is one lateral limb, growing towards the play ground from the main stem at 7m to the south east – shown in the photo in Appendix Bi) - which could possibly threaten the area, but which could be reduced. Thus although there is a risk of a branch being shed, the chance of someone being underneath – particularly during high winds when failure is most likely – is not high.

- 5.3** Instead, I recommend minor crown reduction and ongoing management as follows:-
- reduce the lateral branch growing from the main stem at 7m towards the play ground by 25%.

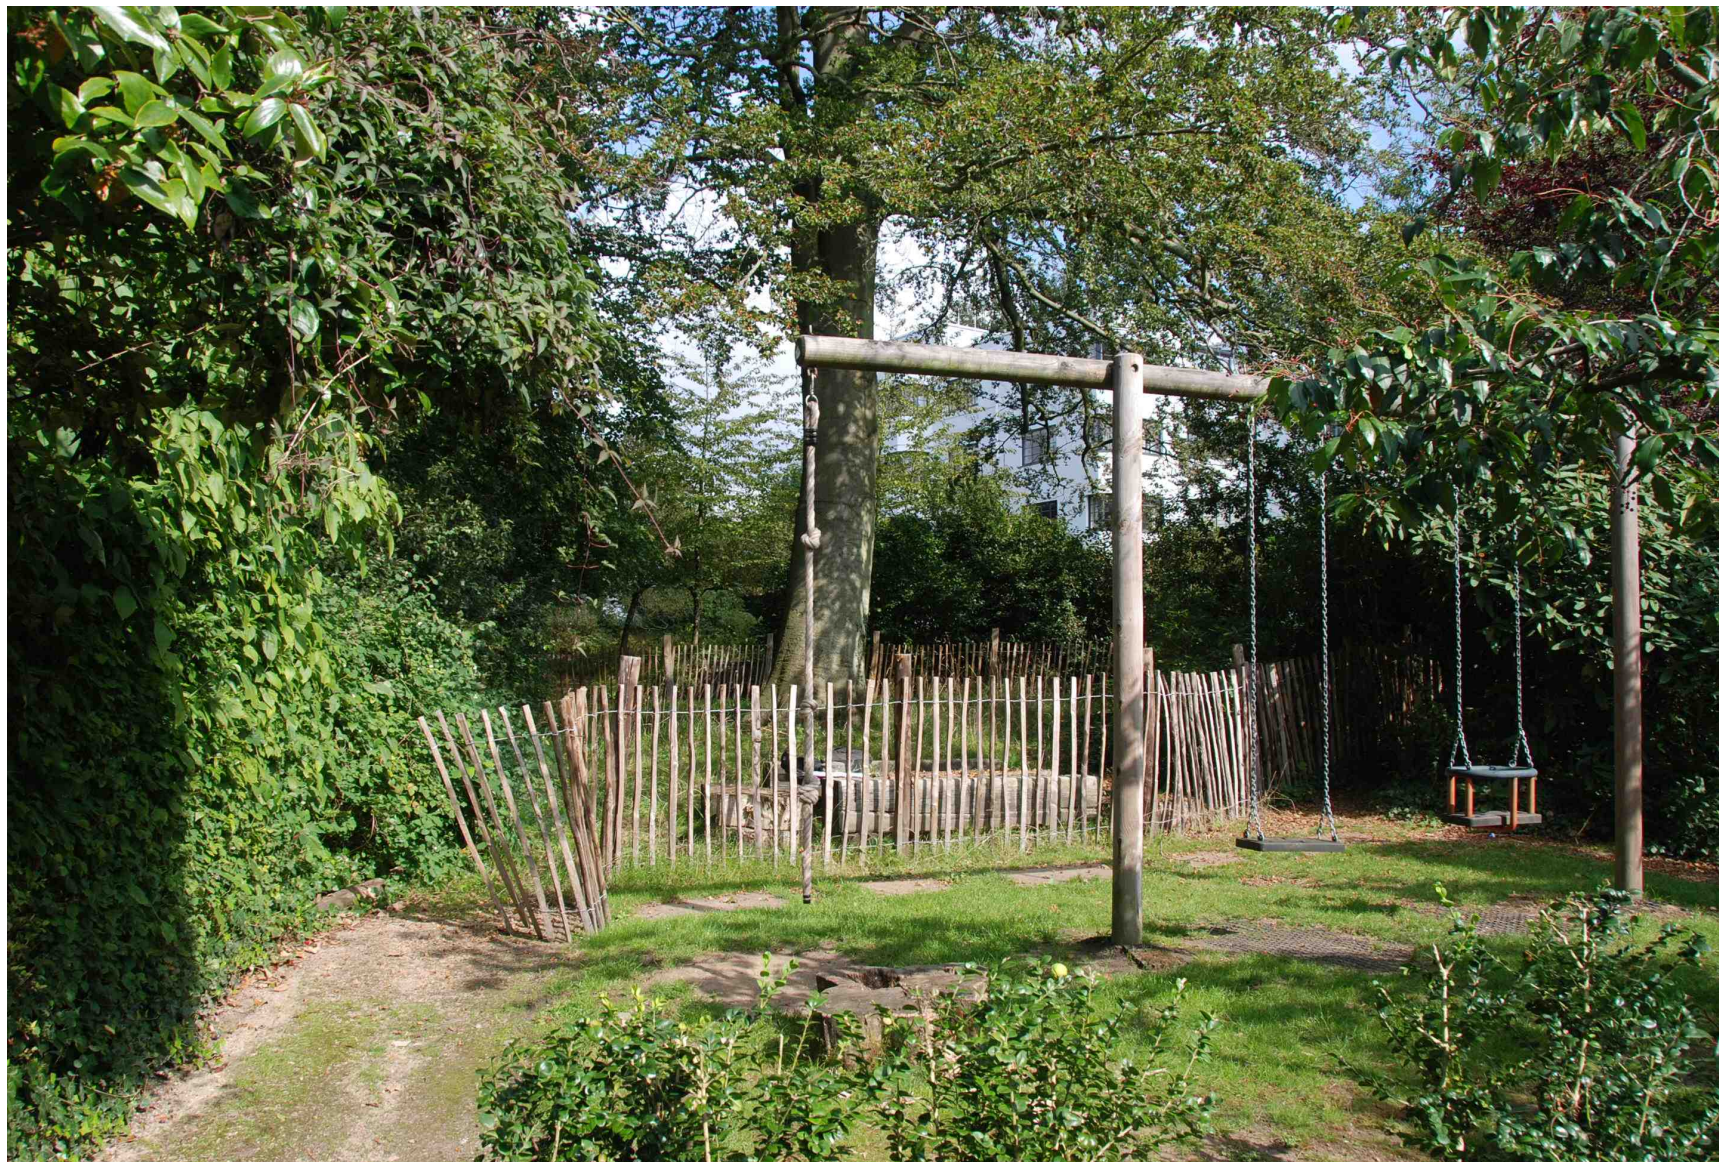
- 3.4** The majority of the area under the canopy is soft landscaping with small trees/mature shrubs and an area of lush grass around the stem. The majority of the area under the canopy is fenced off. There is a children's playground just outside the canopy to the south-east, shown in the photo included as Appendix Bii).

- remove the table/benches, currently within the fenced areas, under the canopy, however the playground can remain.
 - alter the layout of paths so that none run under the canopy.

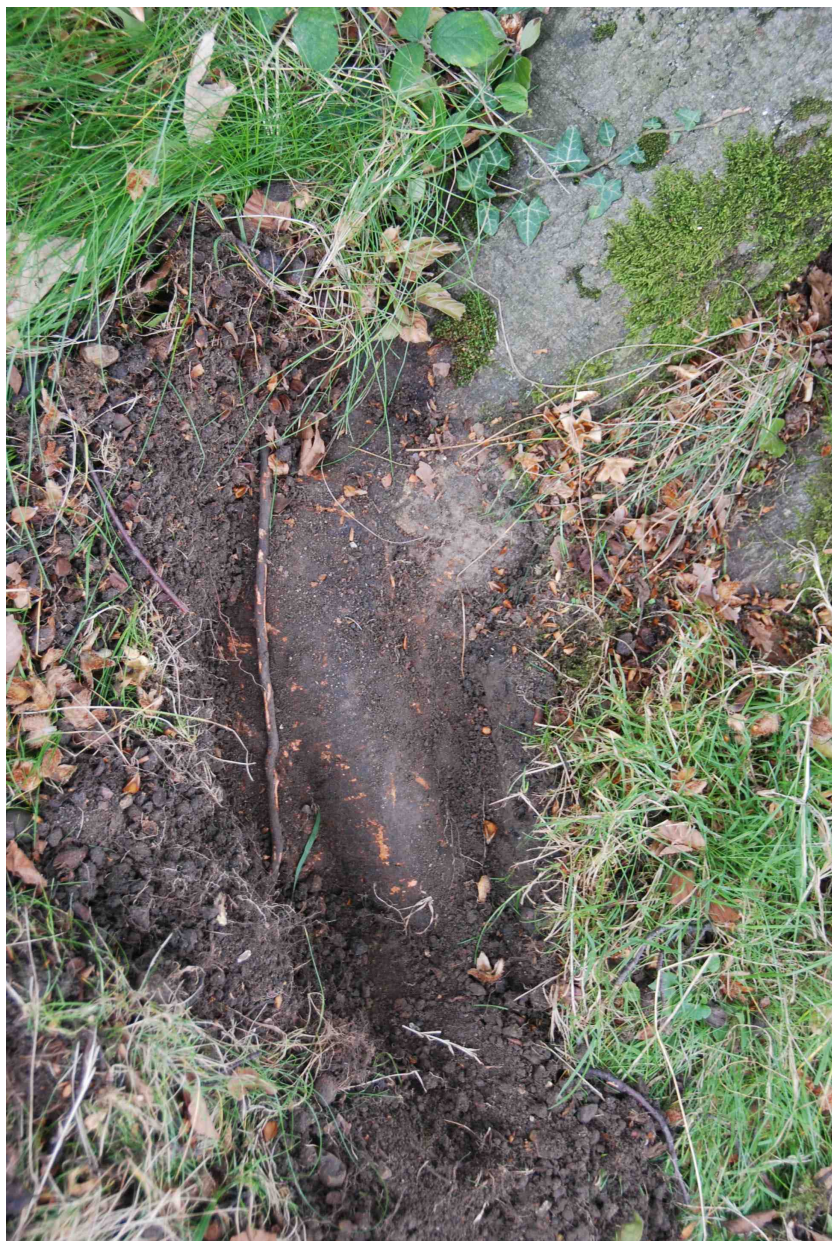
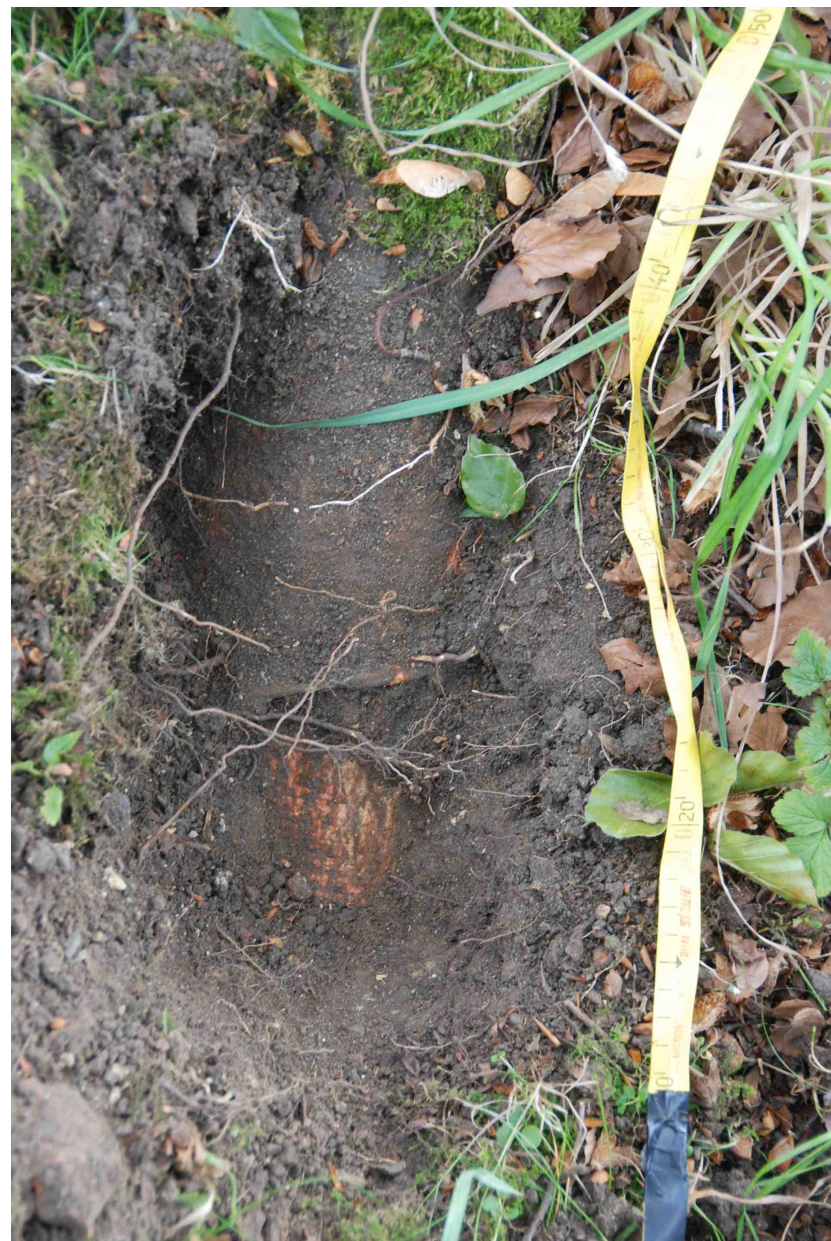
Appendix Biii)

- 3.5** There were no signs of any decay or fungal fruiting bodies around the base, or signs of underlying decay when a sounding hammer was used.
- 3.6** Some limited soil excavation was carried out at two points around the stem of the tree, as shown in the photos included as Appendix Biii). Excavation to a depth of approximately 200mm did not reveal any signs of decay in major roots.

- 4.4** The limited soil excavation carried out did not show any signs of decay. Root excavation with an air spade would establish with more certainty whether there is decay to major structural roots. However, it would be much more difficult to establish the degree of dysfunction in smaller feeder roots and would inevitably cause damage to these smaller fibrous roots.
