Detailed Condition Report

Railings at 7 Fitzroy Square

Prepared by The Great Gate Company

6 June 2014

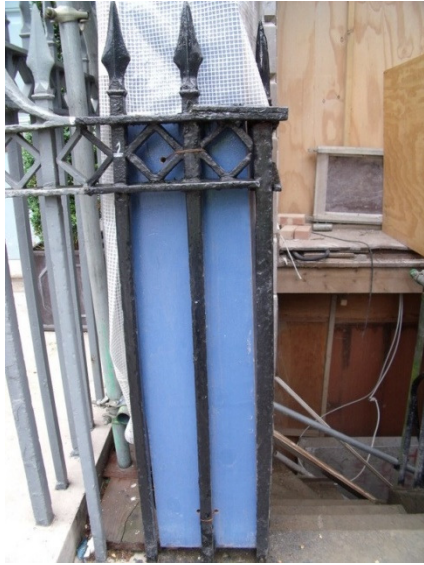
1. Front Railing Left Hand Panel.

Railing	Condition	Recommendation
1. Panel at left hand side of gate, paling 1,2,3 (gate stile).	<p>1.1 Wastage on lower top rail.</p> <p>1.2 Paling 3 is gate stile, railing finial is missing.</p> <p>1.3 Lozenges sound and secure.</p>	<p>See General Comments.</p> <p>Replace finial with casting from good quality existing finial.</p>

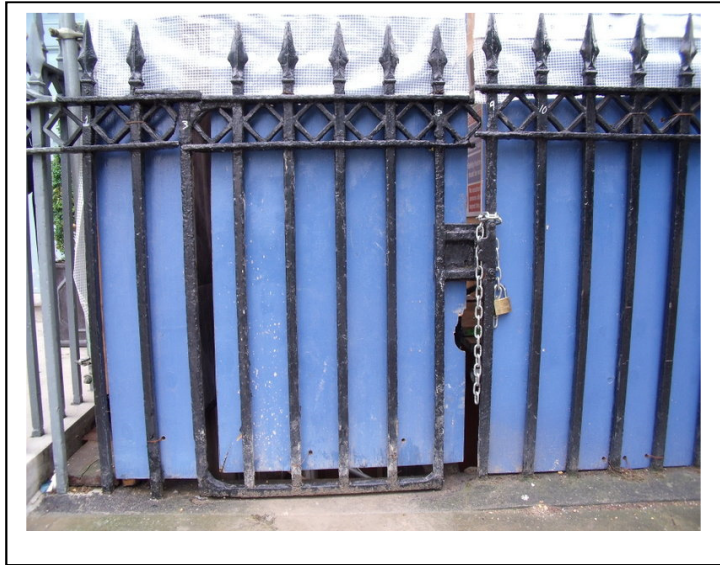
2. Front Railing – Gate
Palings 4, 5, 6, 7, 8, Right Hand Side Stile 9

2. Gate – palings 3, 4, 5, 6, 7, 8, Side Stile 9.	<p>2.1 Gate has dropped.</p> <p>2.2 Original gate lock is missing, a modern lock has been fitted to inside of gate behind horizontal bars of original lock box.</p> <p>2.3 Severe wastage on top face of lower top rail, where each paling goes through the bar, worst at paling 8.</p>	<p>Remove upper securing plate. Lift out gate to clean and repair. Extend hinge pin. Raise gate to required height, reposition and secure.</p> <p>Remove new lock and replace if possible with a mortise lock of a correct size to fit within the original lock box frame. (TBC if this is possible).</p> <p>Replace approximately 150mm of lower top rail at paling 8.</p>

<p>2.4 Minor wastage on top rail of gate, mostly at No. 8 paling.</p> <p>2.5 Lead securing palings into rail has been pushed up /down in places.</p> <p>2.6 Side Stile 9 lock keeper.</p> <p>2.7 All lozenges secure and intact.</p>	<p>See General Comments.</p> <p>Dress to match existing.</p> <p>Remove later addition lock keeper and reinstate original.</p>
--	--	---

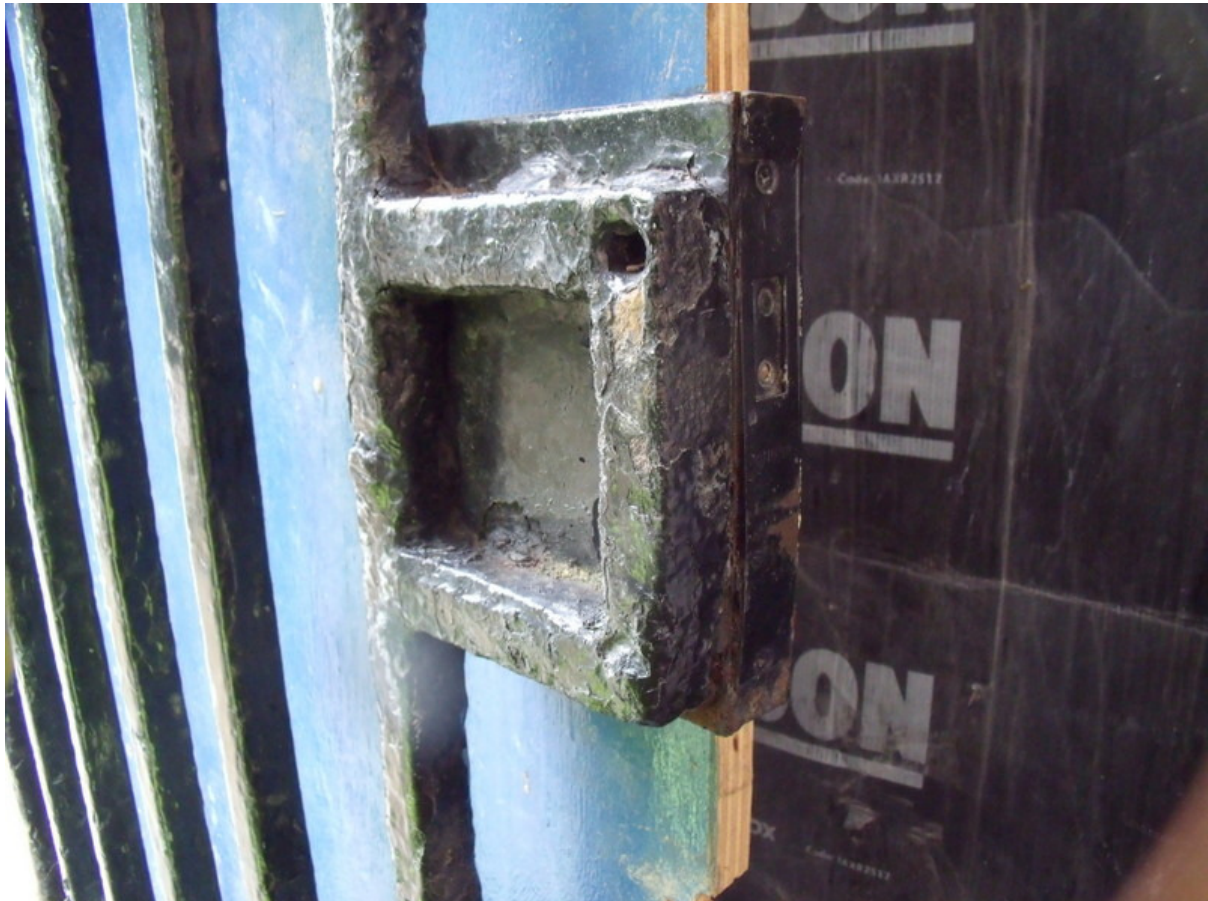
Close up of lock on gate showing original lock frame and newly added modern lock on the inside.

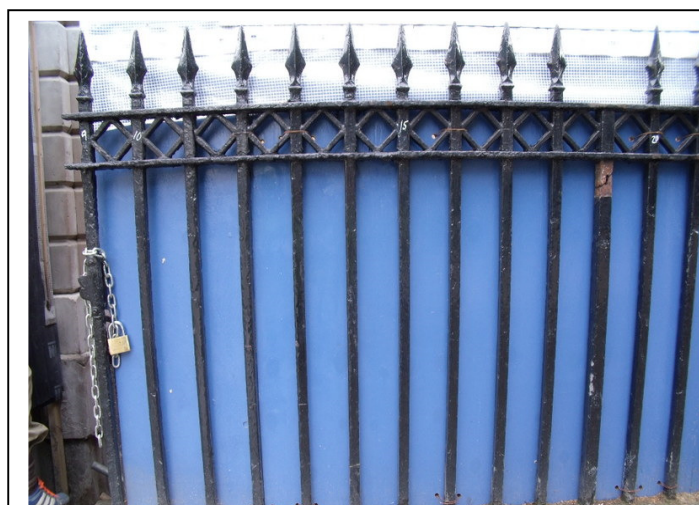
3. Front Railing – Palings 10 – 18, Support Post 19

Railing	Condition	Recommendation
3. Front Railings Palings 10-18. Support Stile 19.	<p>3.1 Top rail is sound. All lozenges intact and fixed.</p> <p>3.2 Lower top rail is wasted on front edge but sound.</p> <p>3.3 Support Stile 19 is missing large finial in style of corner post finial.</p> <p>3.4 Support Stile 19 (imperial 1.5" square) is broken through at fixing point for back stay. Back stay is missing.</p>	<p>See General Comments.</p> <p>Replace with finial from casting of corner post.</p> <p>Replace missing back stay with forged wrought iron stay to match existing on adjacent buildings. At the railing end of the back support stay, use support/bracing plate and attached this to the broken support stile using mechanical fixings to secure the break.</p>

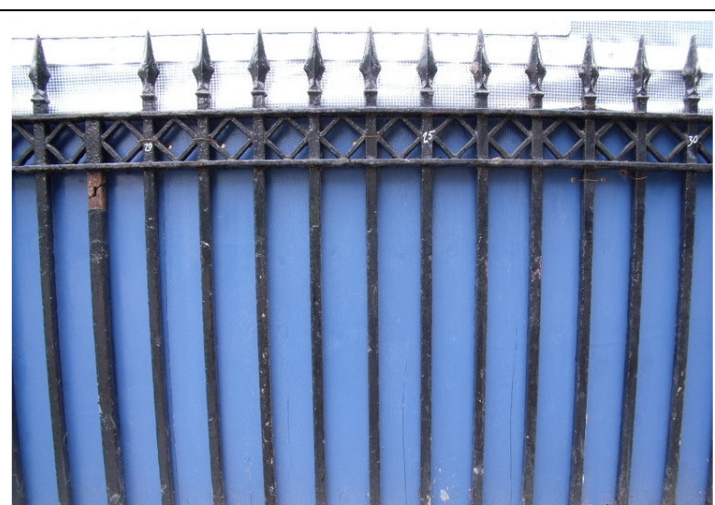
4. Front Railing – Palings 20 -30

4. Front Railing. Palings 20 -30.	<p>4.1 Top rail fairly sound, some wastage at base of finials.</p> <p>4.2 Lower top rail is sound. All lozenges are intact and secure.</p> <p>4.3 All palings are sound.</p>	<p>See General Comments.</p>

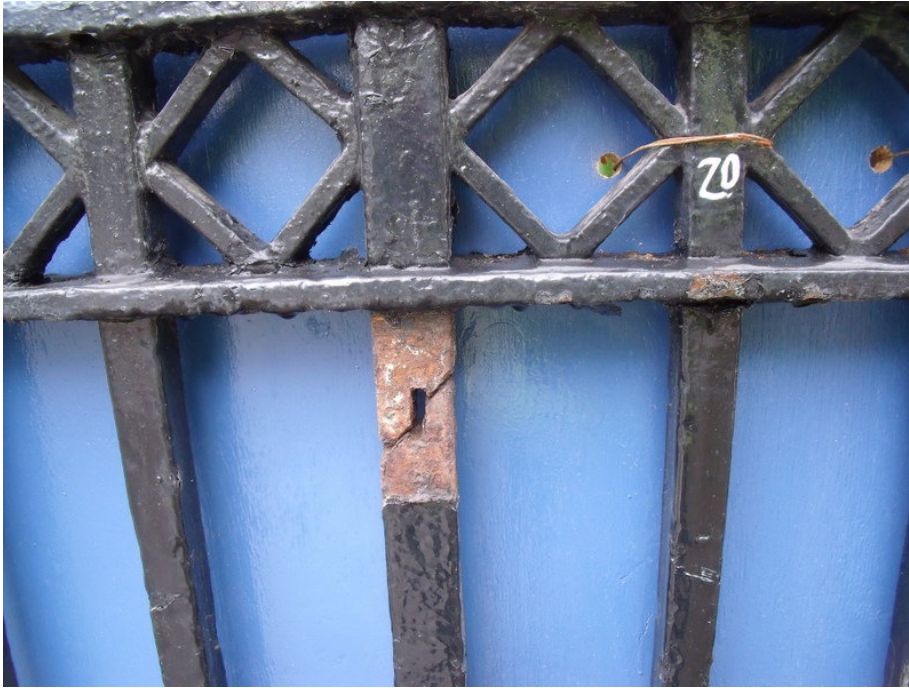
Close up of break at Paling 19, where back stay should be.

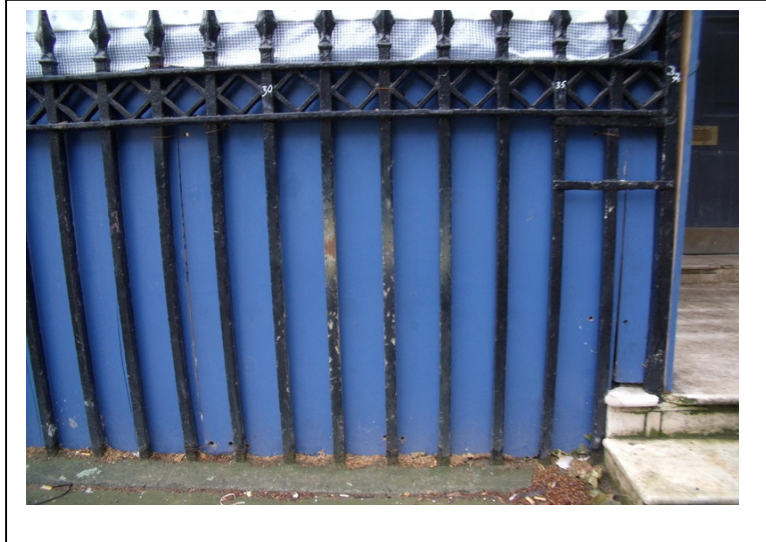
5. Front Railing Palings 31- 36, Corner Support Post 37.

Railing	Condition	Recommendation
<p>5. Palings 31- 36. Corner Support Post 37</p>	<p>5.1 Top rail sound, minor wastage at base of finials. Lozenges on palings 31-35 fixed and intact.</p> <p>5.2 Lozenge between paling 36 and corner support post 37 is damaged probably as a consequence of attempt to weld into position on support post 37.</p> <p>5.3 Top and lower top rail are not securely fixed to corner support post 37. Previous attempts to weld have failed.</p> <p>5.4 Horizontal bars have been fixed to the outside of palings 35, 36, 37 probably in an attempt to stabilise the railing, but not actually providing any structural support.</p> <p>Corner post 37 disappears into the step, which is badly cracked in this area.</p>	<p>Remove evidence of failed welds. Dress to match original profile and secure using mechanical fixings.</p> <p>See 5.2.</p> <p>Remove horizontal bars.</p>

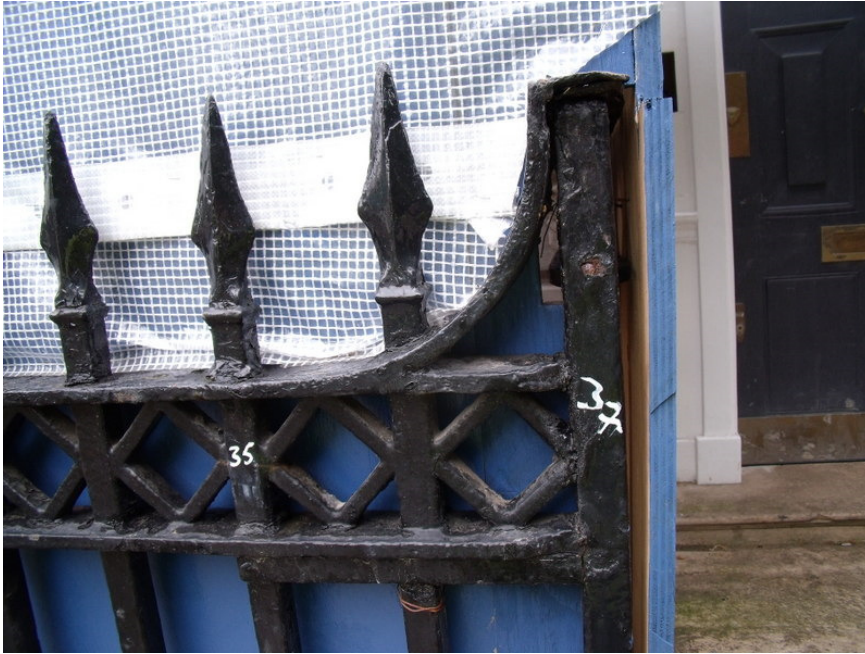
Evidence of previously unsuccessful attempts to weld and fix lozenge and rails.

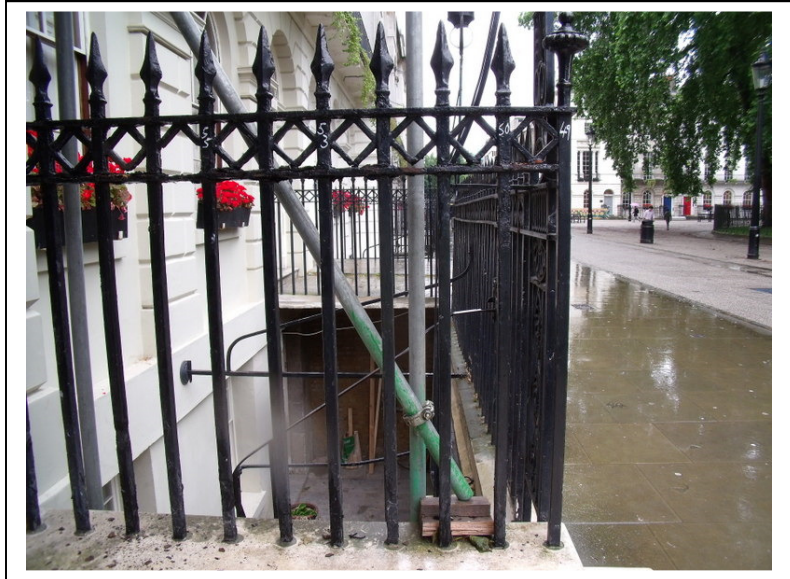
7. Railing at right hand side of front entrance palings 49 – 58.

Railing	Condition	Recommendation
7. Railing at right hand side. Palings 49 – 59. Paling 60 where rail extends into house wall.	7.1 Corner post 49 has been cut and later welded to next door railings.	No action required.

7.2. Top rail is sound. Minor wastage at base of finials.	See General Comments.
	7.3 Lozenge between paling 52 and 53 is broken, with residual part in situ.	Replace complete lozenge.

7.4 Lozenge between paling 55 and 56 is broken and bottom half is missing.	Replace complete lozenge.
	7.5 Lower top rail is completely wasted. There is evidence of previous attempts to repair with widespread remains of epoxy filler along the whole length of this rail with extensive rust. Very little of this rail is likely to be salvageable.	Replace whole length of rail on this section.

7.6 Palings are in satisfactory condition and secured into recently added stone steps with cement based grout.	
	7.7 Lozenge between paling 59 & 60 is broken with the bottom half missing.	Replace complete lozenge.

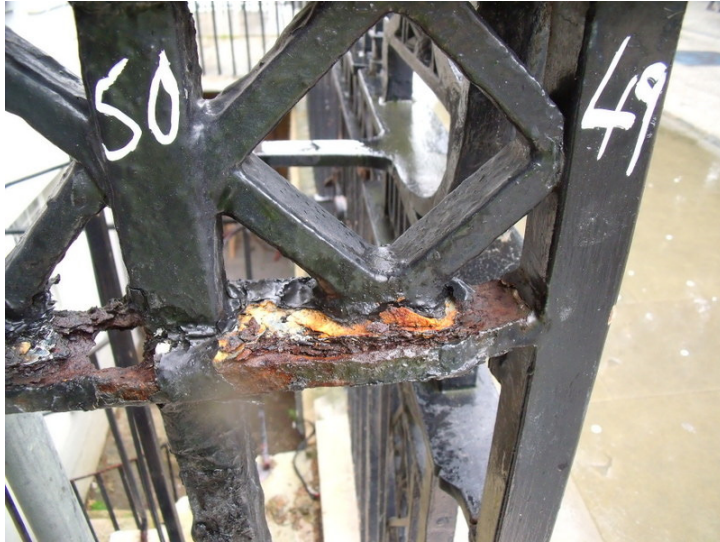
Railing on the right hand side entrance is in a very poor state
