**section 3** conservation  
principles

# section 4 elements

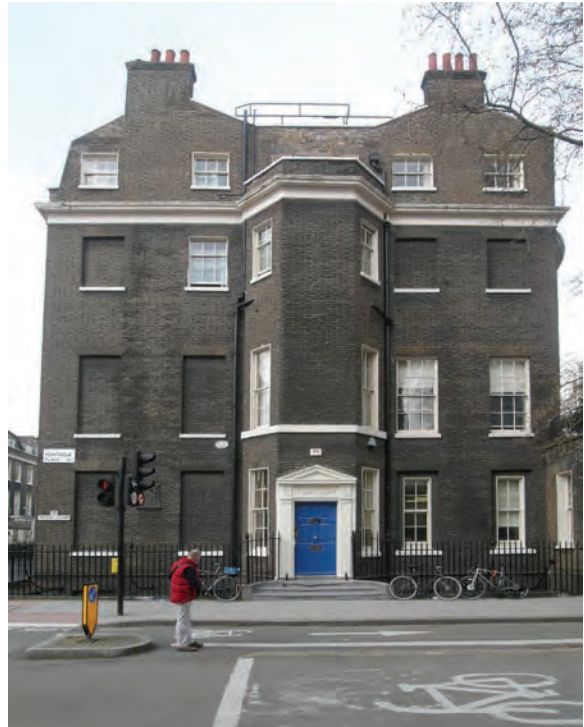
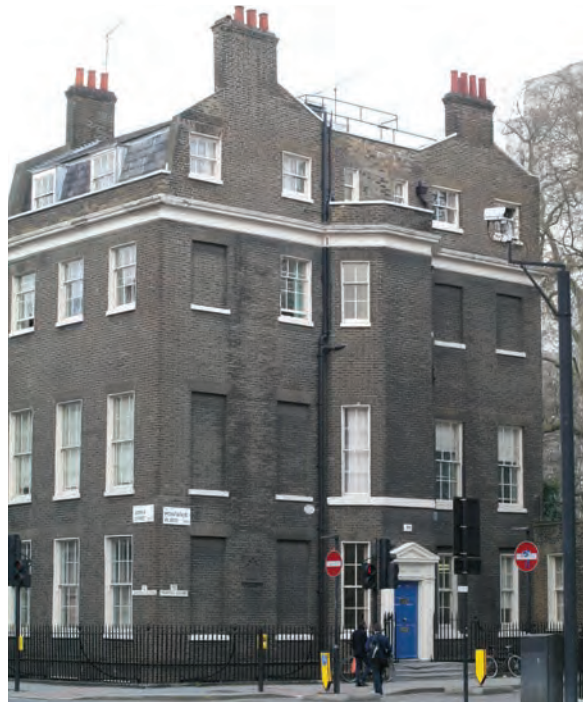
## The Roofs

**Assessment:** High Significance (west roof) and Some Significance (east roof)

- The west roof is visible from Bedford Square. It retains good quality slates that may be original. They are 9mm thick.
- The east roof has modern grey slates with many patched replacements.
- Access to the roof is part of a fire escape route, with handrails that are visible from Bedford Square.
- The roof light over the staircase is a modern and made of plastic.

- Investigations should be carried out to establish the provenance of the west roof slates (3.1).

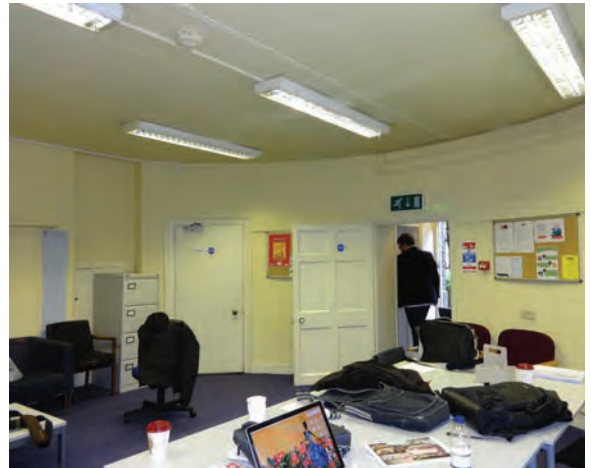
## Ground Floor West

- This space was the original dining room, with a service door directly onto the stairs leading to the basement. The service door is now boarded over.
- The walls have simple panelling.
- The room is now used as a computer room and is hot and inadequately ventilated.
- There is boxing in the location of the original fireplace on the south wall.
- The surface wiring and modern lights detract from the significance.

- Changes should be documented (3.1, 3.3 and 3.5)
- Environmental conditions should be improved wherever practical and feasible (4.11).
- Building defects should be rectified (5.7).
- Investigations should be carried out to determine whether the original fireplace survives behind the boxing. (3.6)

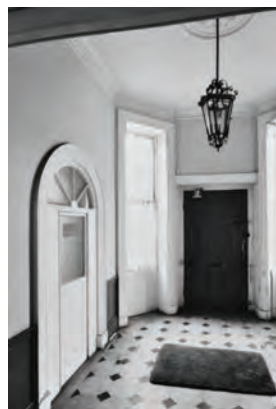
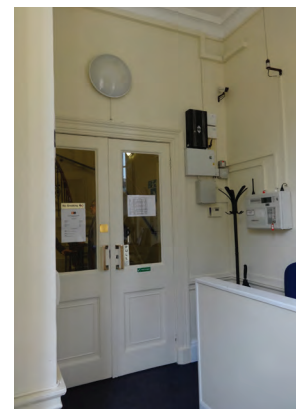
## Staircase

- The stone cantilever staircase and wrought iron handrail which runs from ground floor to third floor level is one of the best features of the house.
- A dome lights the stairwell. There are signs of water damage in the ceiling near the dome.

- There are some cracks between cantilever treads.
- The 1913 photos show black and white marble flooring in the ground floor of the staircase hall. The floor is currently covered with carpet.

- The third floor walls and vinyl flooring are showing signs of wear and tear.

- Changes should be documented (3.1, 3.3 and 3.5)
- Considerations should be given to a suitable replacement of the modern nosing (5.4).
- Considerations should be given to removing the partition at third floor level. (4.2, 5.4)
- Cracks in the between the cantilever tread should be investigated. (5.7)
- Investigations should be made into the cause for the water damaged ceiling (5.5).
